Profile/Photo Observation Report

Date:	09/04/2021	Weather:		Coding:	PACP 7.0
Pipe Length (ft):	189.5	Owner:	City of Hobart	Pre Clean:	Heavy Cleaning
P.O.#:	YES502259	Surveyor:	S. Bucklin	PSR:	P-504-078-077
Customer:	City of Hobart	Clean Date:	09/02/2021	Shape:	C

Street:	North Cavender Street	Flow Control:	Not Controlled
City:	Hobart, IN	Year Renewed:	
Location:	Alley	Tape/Media #:	
Purpose:	Routine Assessment	Dia/Height:	12"
Use:	Sanitary Sewage Pipe	Material:	VCP
Drain Area:		Lining:	
Category:	NA		
Comment:			
Location Details:		Direction of Survey:	Downstream
US MH:	M-504-078	DS MH:	M-504-077
		Total Length Surveyed (ft):	189.5

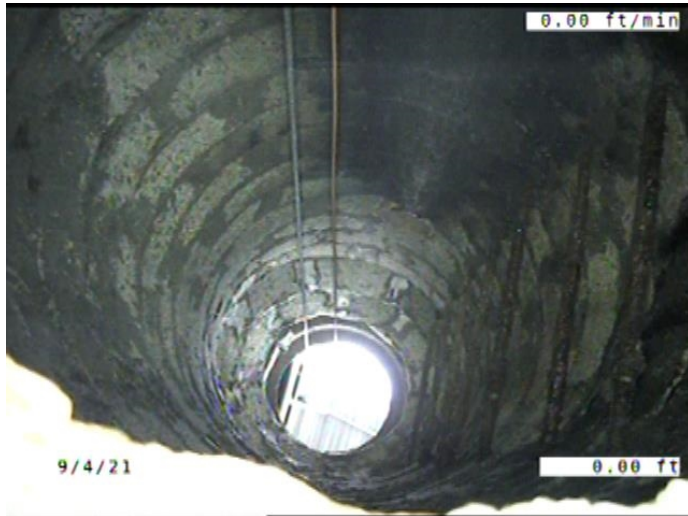
Code: **AMH**
 Description: **Manhole**

Distance (ft): **.0**
 Structural Grade: **0**
 O&M Grade: **0**
 Clock Start/From:
 Clock To:
 1st Value:
 2nd Value:
 Value Percent:
 Continuous Index:
 Within 8" of Joint: **NO**
 Remarks: **M-504-078**

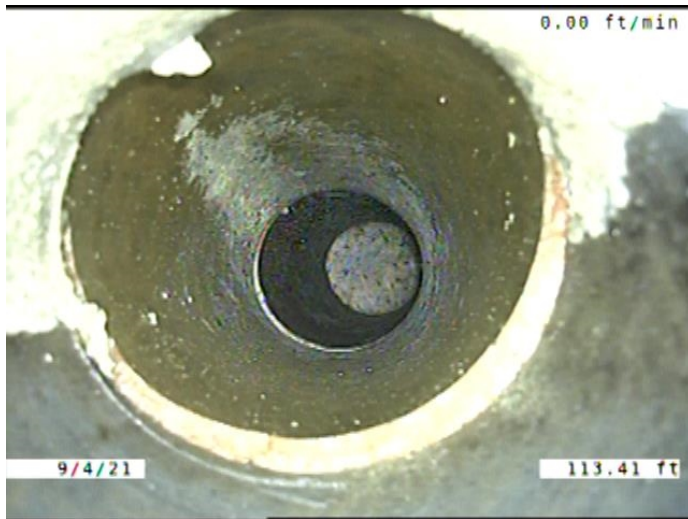
Code: **CM**
 Description: **Crack Multiple**

Distance (ft): **112.5**
 Structural Grade: **3**
 O&M Grade: **0**
 Clock Start/From: **12**
 Clock To: **4**
 1st Value:
 2nd Value:
 Value Percent:
 Continuous Index:
 Within 8" of Joint: **YES**
 Remarks:

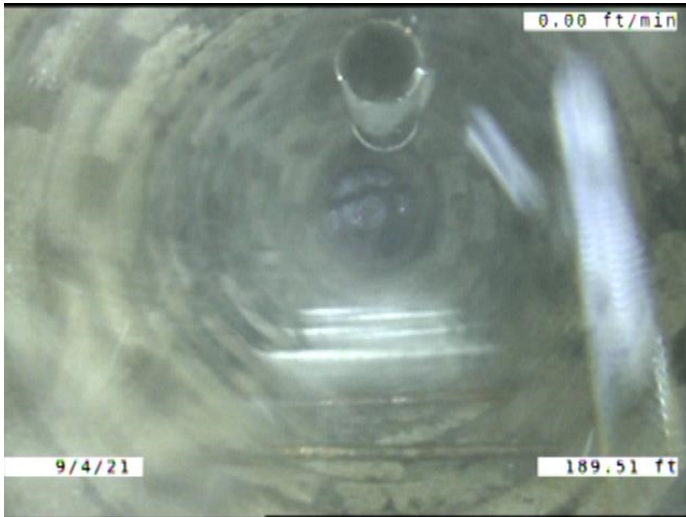
Code: **DSF**
 Description: **Deposits Settled Fine**

Distance (ft): **188.0**
 Structural Grade: **0**
 O&M Grade: **2**
 Clock Start/From: **5**
 Clock To: **7**
 1st Value:
 2nd Value:
 Value Percent: **5.000**
 Continuous Index: **F02**
 Within 8" of Joint: **YES**
 Remarks:
