Profile/Photo Observation Report

Date:	09/04/2021	Weather:		Coding:	PACP 7.0
Pipe Length (ft):	189.5	Owner:	City of Hobart	Pre Clean:	Heavy Cleaning
P.O.#:	YES502259	Surveyor:	S. Bucklin	PSR:	P-504-078-077
Customer:	City of Hobart	Clean Date:	09/02/2021	Shape:	C

Street:	North Cavender Street	Flow Control:	Not Controlled
City:	Hobart, IN	Year Renewed:	
Location:	Alley	Tape/Media #:	
Purpose:	Routine Assessment	Dia/Height:	12"
Use:	Sanitary Sewage Pipe	Material:	VCP
Drain Area:		Lining:	
Category:	NA		
Comment:			
Location Details:		Direction of Survey:	Downstream
US MH:	M-504-078	DS MH:	M-504-077
		Total Length Surveyed (ft):	189.5

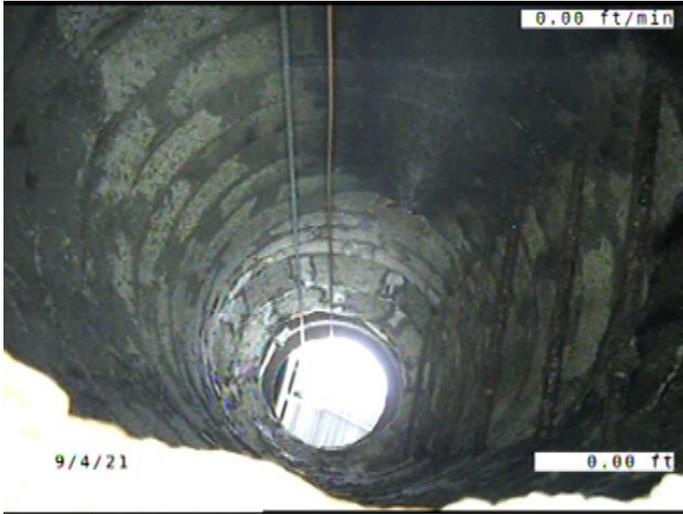
Code: **AMH**
Description: **Manhole**

Distance (ft): **.0**
Structural Grade: **0**
O&M Grade: **0**
Clock Start/From:
Clock To:
1st Value:
2nd Value:
Value Percent:
Continuous Index:
Within 8" of Joint: **NO**
Remarks: **M-504-078**

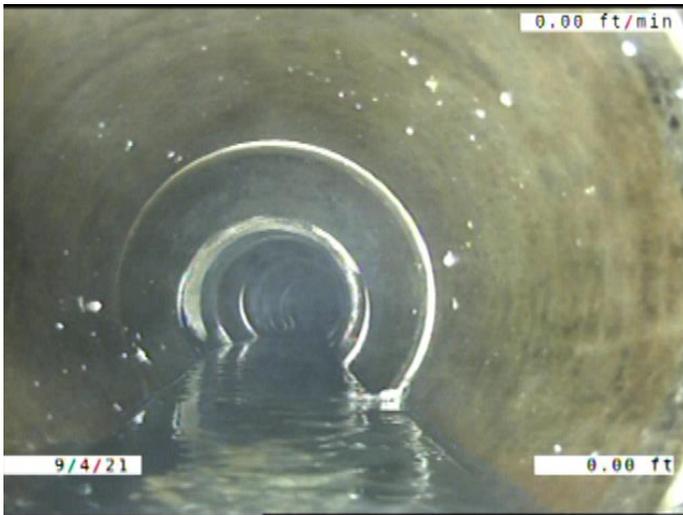
Code: **MWL**
Description: **Miscellaneous Water Level**

Distance (ft): **.0**
Structural Grade: **0**
O&M Grade: **0**
Clock Start/From:
Clock To:
1st Value:
2nd Value:
Value Percent: **5.000**
Continuous Index:
Within 8" of Joint: **NO**
Remarks:

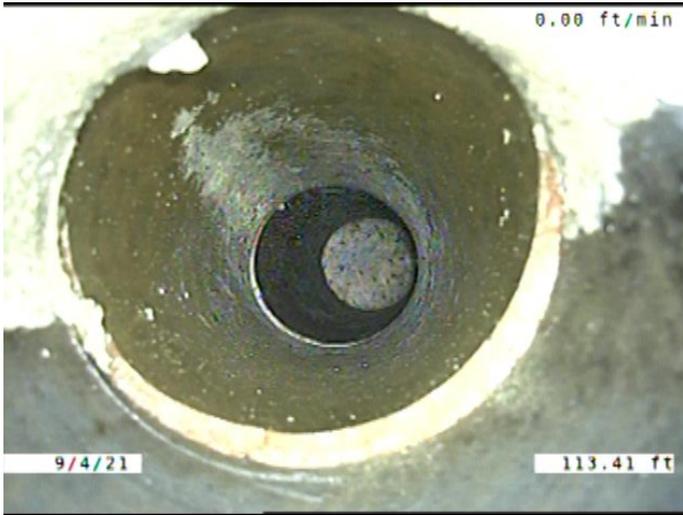
Code: **TFC**
Description: **Tap Factory Capped**

Distance (ft): **113.4**
Structural Grade: **0**
O&M Grade: **0**
Clock Start/From: **12**
Clock To:
1st Value: **6.000**
2nd Value:
Value Percent:
Continuous Index:
Within 8" of Joint: **YES**
Remarks:

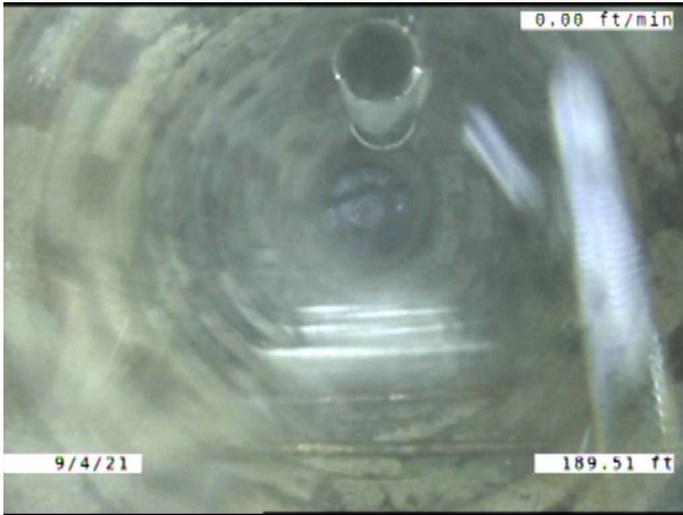
Code: **AMH**
Description: **Manhole**

Distance (ft): **189.5**
Structural Grade: **0**
O&M Grade: **0**
Clock Start/From:
Clock To:
1st Value:
2nd Value:
Value Percent:
Continuous Index:
Within 8" of Joint: **NO**
Remarks: **M-504-077**
