Profile/Photo Observation Report

Date:	04/18/2018	Weather:		Coding:	PACP 6.0
Pipe Length (ft):	167.1	Owner:	NA	Pre Clean:	Not Known
P.O.#:		Surveyor:	Byrd Fitzgerald	PSR:	P-504-090-089
Customer:		Clean Date:	01/01/1900	Shape:	C

Street:	Summerlin	Flow Control:	Not Controlled
City:	Hobart, IN	Year Renewed:	
Location:	Light Highway	Tape/Media #:	
Purpose:	Not Known	Dia/Height:	12"
Use:	Sanitary	Material:	VCP
Drain Area:	NA	Lining:	
Category:	NA		
Comment:

Location Details:		Direction of Survey:	Downstream
US MH:	M-504-089	DS MH:	M-504-090
		Total Length Surveyed (ft):	25.1

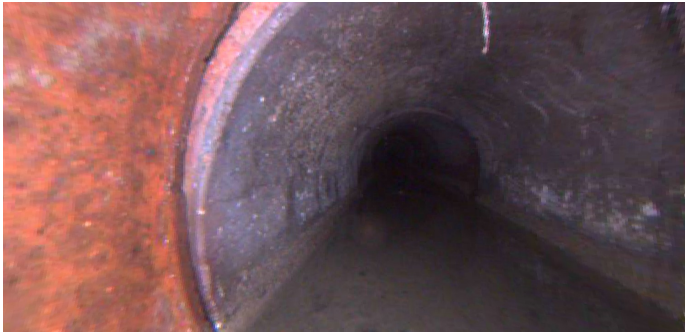
Code: **AMH**
Description: **Manhole**

Distance (ft): **.0**
Structural Grade: **0**
O&M Grade: **0**
Clock Start/From:
Clock To:
1st Value:
2nd Value:
Value Percent:
Continuous Index:
Within 8" of Joint: **NO**
Remarks: **M-504-089**

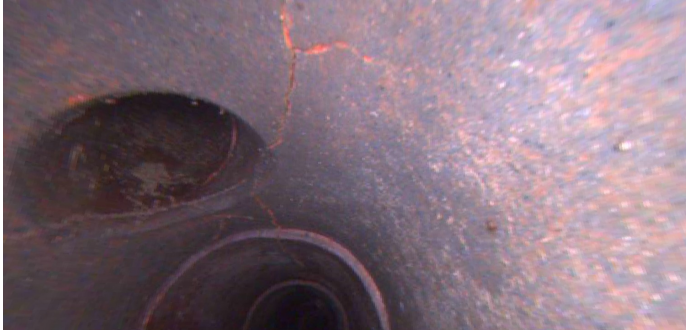
Code: **TF**
Description: **Tap Factory**

Distance (ft): **18.8**
Structural Grade: **0**
O&M Grade: **0**
Clock Start/From: **11**
Clock To:
1st Value: **4.000**
2nd Value:
Value Percent:
Continuous Index:
Within 8" of Joint: **YES**
Remarks:

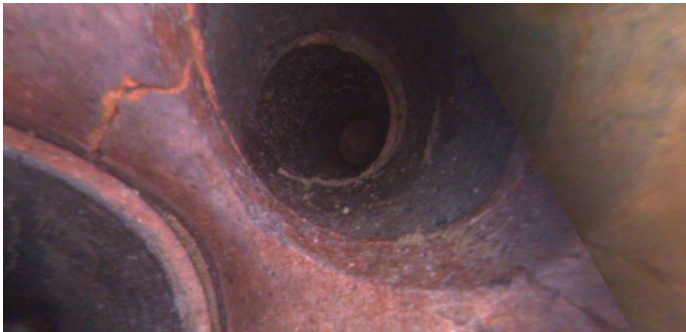
Code: **TF**
Description: **Tap Factory**

Distance (ft): **21.4**
Structural Grade: **0**
O&M Grade: **0**
Clock Start/From: **1**
Clock To:
1st Value: **4.000**
2nd Value:
Value Percent:
Continuous Index:
Within 8" of Joint: **YES**
Remarks:
