## **Profile/Photo Observation Report**

RUBUTICS
Date: Pipe Length (ft):	09/11/2021 231.0	Weather: Owner:	City of Hobart	0	PACP 7.0 Light Cleaning
P.O.#:	YES502259	Surveyor:	S. Bucklin		P-504-102-101
Customer:	City of Hobart	, Clean Date:	08/27/2021		с
Street:	North Delaware St	reet	Flow Control:	Not Controlled	
City:	Hobart, IN		Year Renewed:		
Location:	Alley		Tape/Media #:		
Purpose:	Routine Assessme	nt	Dia/Height:	10"	
Use:	Sanitary Sewage P	ipe	Material:	СР	
Drain Area:			Lining:	None	
Category:	NA				
Comment:					
Location Details	:		Direction of Survey	: Upstream	
US MH:	M-504-101	DS MH:	M-504-102	Total Length Surveyed (ft):	207.4
)&M Index:	1.97	O&M Quick:	4136	O&M Rating:	154.00
tructural Index:	2.97	 Structural Qui	ck: 514A	Structural Rating:	116.00
verall Index:	2.31	Overall Quick:	54.44	Overall Rating:	270.00

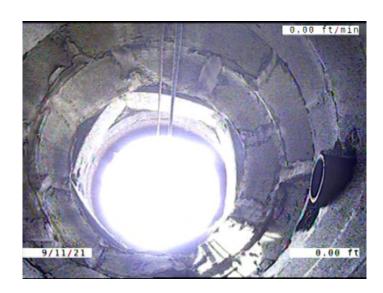
Code: Description:	AMH Manhole
Distance (ft): Structural Grade: O&M Grade: Clock Start/From: Clock To: 1st Value: 2nd Value: Value Percent: Continuous Index: Within 8" of Joint:	.0 0 0
Remarks:	M-504-102

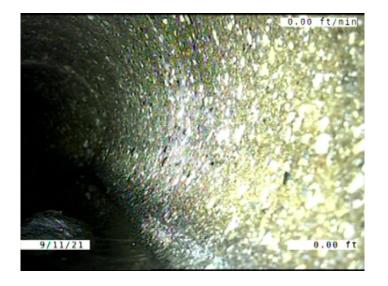
Code: Description:	MWL Miscellaneous Water Level
Distance (ft):	.0
Structural Grade:	0
O&M Grade:	0
Clock Start/From:	
Clock To:	
1st Value:	
2nd Value:	
Value Percent:	5.000
Continuous Index:	
Within 8" of Joint:	NO
Remarks:

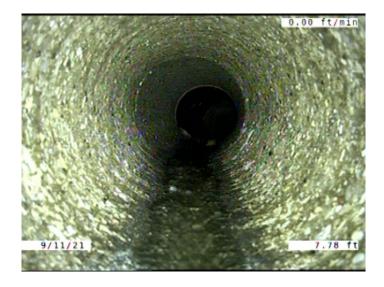
Code: Description:	LU Line Up
Distance (ft):	7.8
Structural Grade:	0
O&M Grade:	1
Clock Start/From:	
Clock To:	
1st Value:	
2nd Value:	
Value Percent:	10.000
Continuous Index:	
Within 8" of Joint:	NO
Remarks:

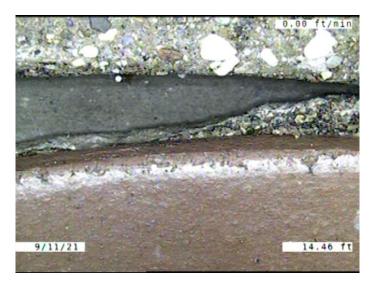
MMC Miscellaneous Material Change
14.5
0
0
NO
CONCRETE TO VCP

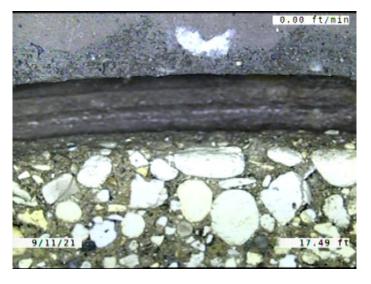
Code:	ММС
Description:	Miscellaneous Material Change
Distance (ft):	17.5
Structural Grade	: 0
O&M Grade:	0
Clock Start/From	:
Clock To:	
1st Value:	
2nd Value:	
Value Percent:	
Continuous Inde	x:
Within 8" of Join	t: NO
Remarks:	VCP TO CONCRETE

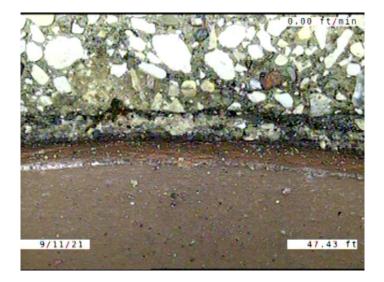
Code: Description:	MMC Miscellaneous Material Change
Distance (ft):	47.4
Structural Grade:	0
O&M Grade:	0
Clock Start/From:	
Clock To:	
1st Value:	
2nd Value:	
Value Percent:	
Continuous Index:	
Within 8" of Joint:	NO
Remarks:	CONCRETE TO VCP

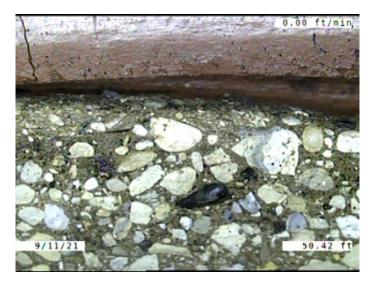
Code: MMC Description: **Miscellaneous Material Change** 50.4 Distance (ft): Structural Grade: 0 O&M Grade: 0 Clock Start/From: Clock To: 1st Value: 2nd Value: Value Percent: Continuous Index: Within 8" of Joint: NO Remarks: **VCP TO CONCRETE**

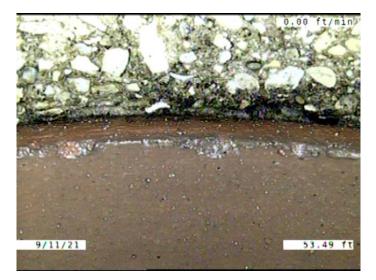
Code: Description:	MMC Miscellaneous Material Change
Distance (ft):	53.5
Structural Grade:	0
O&M Grade:	0
Clock Start/From:	
Clock To:	
1st Value:	
2nd Value:	
Value Percent:	
Continuous Index:	
Within 8" of Joint:	NO
Remarks:	CONCRETE TO VCP

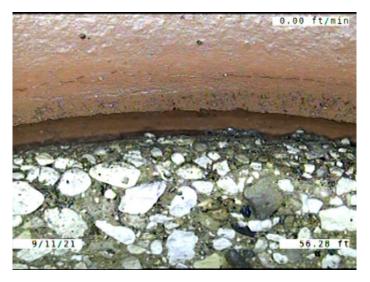
Code: Description:	MMC Miscellaneous Material Change
Distance (ft):	56.3
Structural Grade:	0
O&M Grade:	0
Clock Start/From:	
Clock To:	
1st Value:	
2nd Value:	
Value Percent:	
Continuous Index:	
Within 8" of Joint:	NO
Remarks:	VCP TO CONCRETE

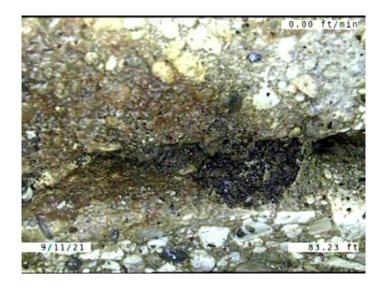
Code: Description:	DAE Deposits Attached Encrustation
Distance (ft): Structural Grade: O&M Grade: Clock Start/From: Clock To: 1st Value:	83.2 0 2 3 9
2nd Value: Value Percent: Continuous Index: Within 8" of Joint: Remarks:	5.000 YES

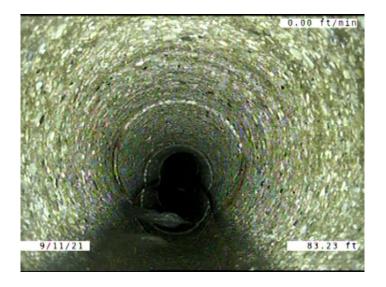
Code: Description:	MWLS Miscellaneous Water Level Sag
Distance (ft):	83.2
Structural Grade:	2
O&M Grade:	0
Clock Start/From:	
Clock To:	
1st Value:	
2nd Value:	
Value Percent:	15.000
Continuous Index:	S04
Within 8" of Joint:	NO
Remarks:

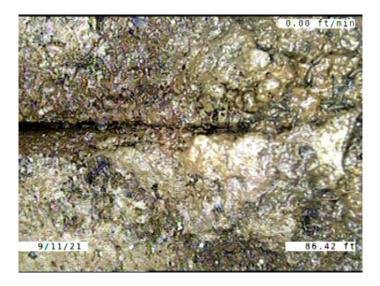
Code: Description:	DAE Deposits Attached Encrustation
Distance (ft):	86.4
Structural Grade:	0
O&M Grade:	2
Clock Start/From:	2
Clock To:	10
1st Value:	
2nd Value:	
Value Percent:	5.000
Continuous Index:	
Within 8" of Joint:	YES
Remarks:

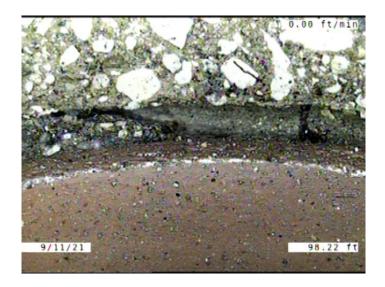
Code: Description:	MMC Miscellaneous Material Change
Distance (ft):	98.2
Structural Grade:	0
O&M Grade:	0
Clock Start/From:	
Clock To:	
1st Value:	
2nd Value:	
Value Percent:	
Continuous Index:	
Within 8" of Joint:	NO
Remarks:	CONCRETE TO VCP

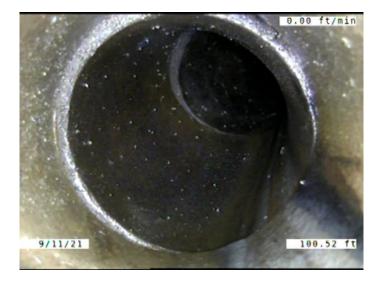
Code:	TF
Description:	Tap Factory
Distance (ft):	100.5
Structural Grade:	0
O&M Grade:	0
Clock Start/From:	1
Clock To:	
1st Value:	4.000
2nd Value:	
Value Percent:	
Continuous Index:	
Within 8" of Joint:	YES
Remarks:

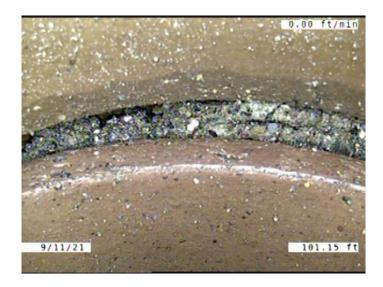
Code: Description:	JOM Joint Offset Medium
Distance (ft):	101.1
Structural Grade:	3
O&M Grade:	0
Clock Start/From:	
Clock To:	
1st Value:	
2nd Value:	
Value Percent:	
Continuous Index:	
Within 8" of Joint:	NO
Remarks:

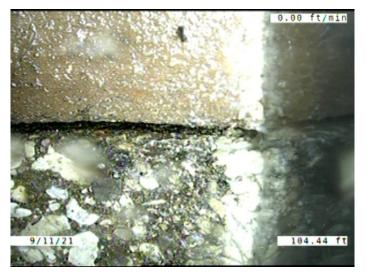
Code: MMC Description: **Miscellaneous Material Change** Distance (ft): 104.4 Structural Grade: 0 0 O&M Grade: Clock Start/From: Clock To: 1st Value: 2nd Value: Value Percent: Continuous Index: Within 8" of Joint: NO Remarks: **VCP TO CONCRETE**

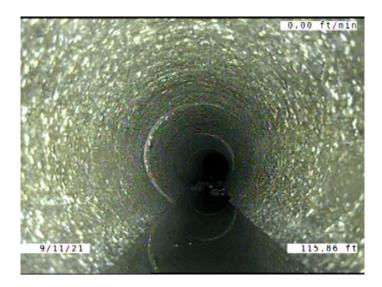
Code: Description:	MWLS Miscellaneous Water Level Sag
Distance (ft):	115.9
Structural Grade:	2
O&M Grade:	0
Clock Start/From:	
Clock To:	
1st Value:	
2nd Value:	
Value Percent:	15.000
Continuous Index:	F04
Within 8" of Joint:	NO
Remarks:

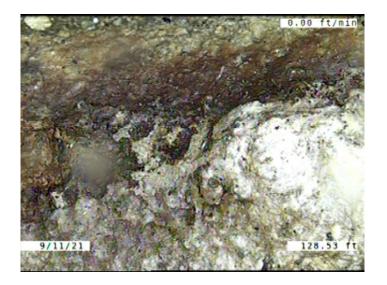
Code: Description:	DAE Deposits Attached Encrustation
Distance (ft):	128.5
Structural Grade:	0
O&M Grade:	2
Clock Start/From:	8
Clock To:	10
1st Value:	
2nd Value:	
Value Percent:	5.000
Continuous Index:	
Within 8" of Joint:	YES
Remarks:

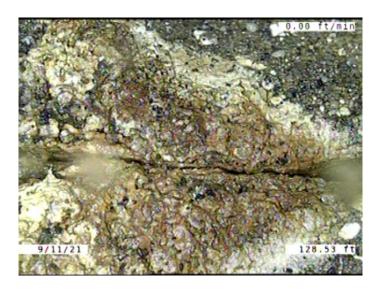
Code: Description:	DAE Deposits Attached Encrustation
Distance (ft): Structural Grade: O&M Grade: Clock Start/From: Clock To: 1st Value: 2nd Value:	128.5 0 2 2 4
Value Percent: Continuous Index:	5.000
Within 8" of Joint: Remarks:	YES

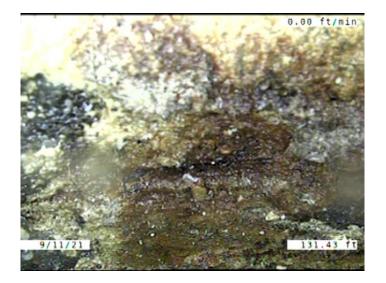
Code: Description:	DAE Deposits Attached Encrustation
Distance (ft):	131.4
Structural Grade:	0
O&M Grade:	2
Clock Start/From:	8
Clock To:	11
1st Value:	
2nd Value:	
Value Percent:	5.000
Continuous Index:	
Within 8" of Joint:	YES
Remarks:

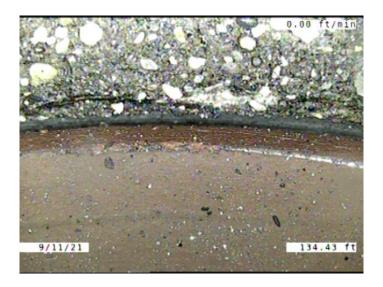
Code: Description:	MMC Miscellaneous Material Change
Distance (ft): Structural Grade: O&M Grade: Clock Start/From: Clock To: 1st Value: 2nd Value: Value Percent: Continuous Index: Within 8" of Joint:	134.4 0 0
Remarks:	CONCRETE TO VCP

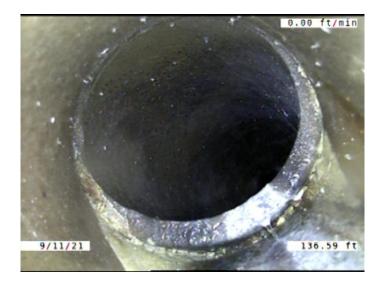
Code: Description:	TF Tap Factory
Distance (ft):	136.6
Structural Grade:	0
O&M Grade:	0
Clock Start/From:	1
Clock To:	
1st Value:	4.000
2nd Value:	
Value Percent:	
Continuous Index:	
Within 8" of Joint:	YES
Remarks:

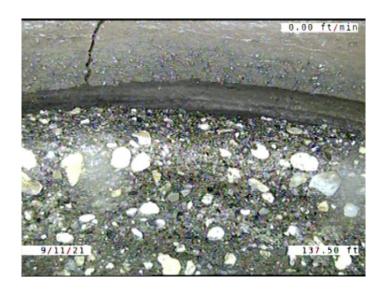
Code: Description:	MMC Miscellaneous Material Change
Distance (ft):	137.5
Structural Grade:	0
O&M Grade:	0
Clock Start/From:	
Clock To:	
1st Value:	
2nd Value:	
Value Percent:	
Continuous Index:	
Within 8" of Joint:	NO
Remarks:	VCP TO CONCRETE

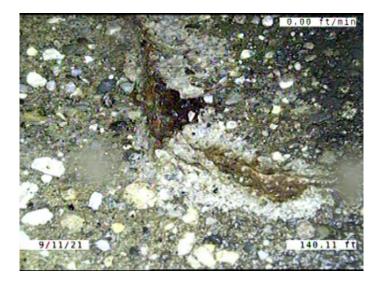
Code: Description:	ISB Infiltration Stain Barrel
Distance (ft):	140.1
Structural Grade:	0
O&M Grade:	1
Clock Start/From:	8
Clock To:	9
1st Value:	
2nd Value:	
Value Percent:	
Continuous Index:	
Within 8" of Joint:	YES
Remarks:

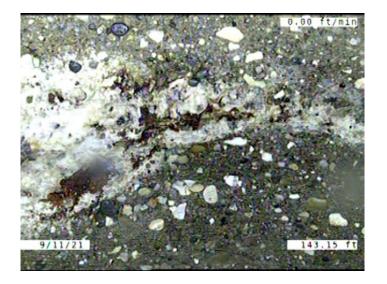
Code: Description:	DAE Deposits Attached Encrustation
Distance (ft):	143.1
Structural Grade:	0
O&M Grade:	2
Clock Start/From:	7
Clock To:	5
1st Value:	
2nd Value:	
Value Percent:	5.000
Continuous Index:	
Within 8" of Joint:	NO
Remarks:

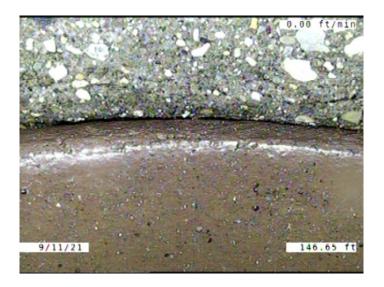
Code: Description:	MMC Miscellaneous Material Change
Distance (ft):	146.6
Structural Grade:	0
O&M Grade:	0
Clock Start/From:	
Clock To:	
1st Value:	
2nd Value:	
Value Percent:	
Continuous Index:	
Within 8" of Joint:	NO
Remarks:	CONCRETE TO VCP

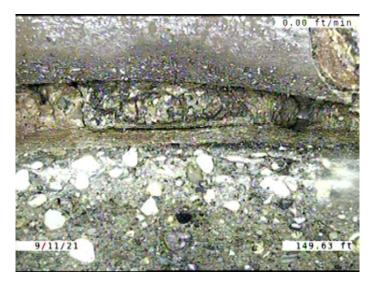
Code: MMC Description: **Miscellaneous Material Change** Distance (ft): 149.6 Structural Grade: 0 O&M Grade: 0 Clock Start/From: Clock To: 1st Value: 2nd Value: Value Percent: Continuous Index: Within 8" of Joint: NO Remarks: VCP TO CONCRETE

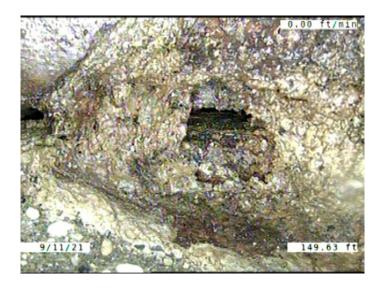
Code: Description:	DAE Deposits Attached Encrustation
Distance (ft): Structural Grade: O&M Grade: Clock Start/From: Clock To: 1st Value: 2nd Value: Value Percent: Continuous Index:	149.6 0 2 9 5 5.000
Within 8" of Joint: Remarks:	YES

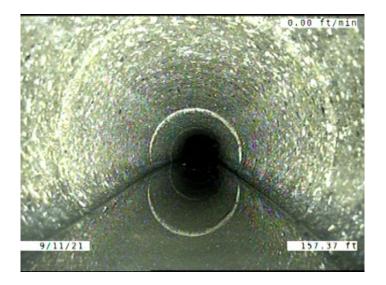
Code: Description:	MWLS Miscellaneous Water Level Sag
Distance (ft):	157.4
Structural Grade:	2
O&M Grade:	0
Clock Start/From:	
Clock To:	
1st Value:	
2nd Value:	
Value Percent:	10.000
Continuous Index:	S05
Within 8" of Joint:	NO
Remarks:

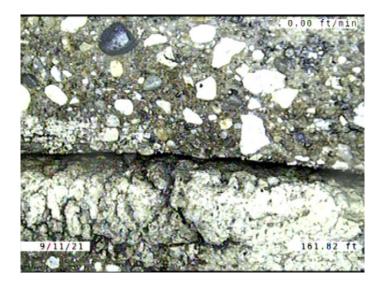
Code: Description:	DAE Deposits Attached Encrustation
Distance (ft):	161.8
Structural Grade:	0
O&M Grade:	2
Clock Start/From:	9
Clock To:	3
1st Value:	
2nd Value:	
Value Percent:	5.000
Continuous Index:	
Within 8" of Joint:	YES
Remarks:

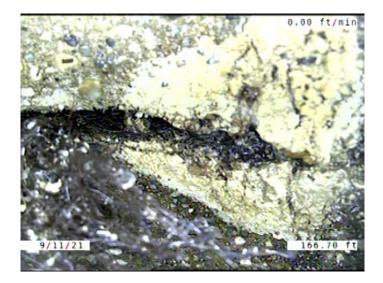
Code: Description:	DAE Deposits Attached Encrustation
Distance (ft):	166.7
Structural Grade:	0
O&M Grade:	2
Clock Start/From:	2
Clock To:	3
1st Value:	
2nd Value:	
Value Percent:	5.000
Continuous Index:	
Within 8" of Joint:	YES
Remarks:

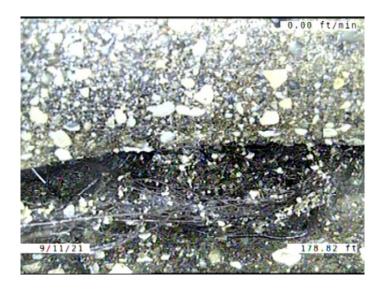
Code: Description:	RFJ Roots Fine Joint
Distance (ft):	178.8
Structural Grade:	0
O&M Grade:	1
Clock Start/From:	8
Clock To:	10
1st Value:	
2nd Value:	
Value Percent:	
Continuous Index:	
Within 8" of Joint:	YES
Remarks:

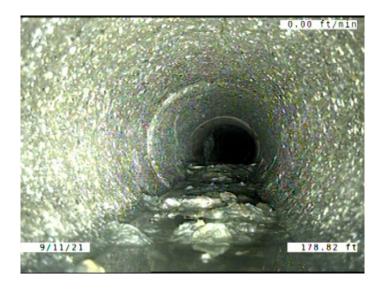
Code: Description:	MWLS Miscellaneous Water Level Sag
Distance (ft):	178.8
Structural Grade:	2
O&M Grade:	0
Clock Start/From:	
Clock To:	
1st Value:	
2nd Value:	
Value Percent:	10.000
Continuous Index:	F05
Within 8" of Joint:	NO
Remarks:

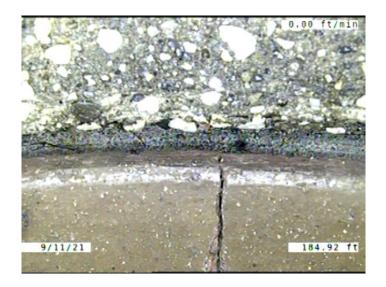
Code: Description:	MMC Miscellaneous Material Change
Distance (ft):	184.9
Structural Grade:	0
O&M Grade:	0
Clock Start/From:	
Clock To:	
1st Value:	
2nd Value:	
Value Percent:	
Continuous Index:	
Within 8" of Joint:	NO
Remarks:	CONCRETE TO VCP

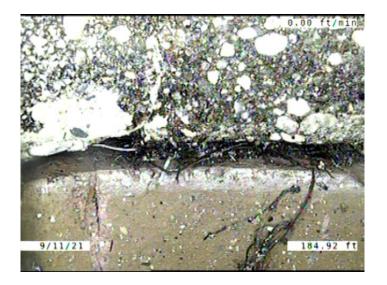
Code: Description:	RFJ Roots Fine Joint
Distance (ft):	184.9
Structural Grade:	0
O&M Grade:	1
Clock Start/From:	9
Clock To:	10
1st Value:	
2nd Value:	
Value Percent:	
Continuous Index:	
Within 8" of Joint:	YES
Remarks:

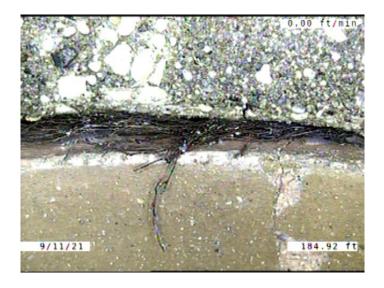
Code: Description:	RFJ Roots Fine Joint
Distance (ft):	184.9
Structural Grade:	0
O&M Grade:	1
Clock Start/From:	1
Clock To:	4
1st Value:	
2nd Value:	
Value Percent:	
Continuous Index:	
Within 8" of Joint:	YES
Remarks:

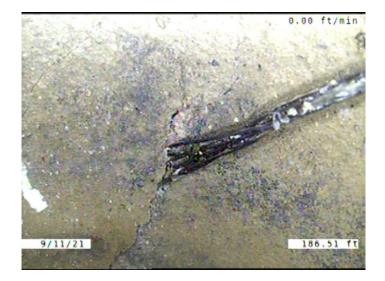
Code:	RFB
Description:	<b>Roots Fine Barrel</b>
Distance (ft):	186.5
Structural Grade:	0
O&M Grade:	2
Clock Start/From:	2
Clock To:	
1st Value:	
2nd Value:	
Value Percent:	
Continuous Index:	
Within 8" of Joint:	NO
Remarks:

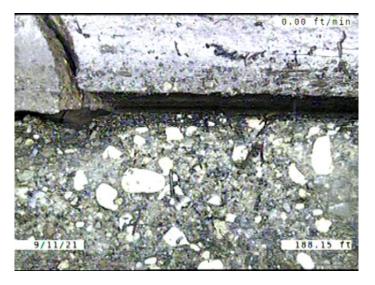
Code: MMC Description: **Miscellaneous Material Change** Distance (ft): 188.2 Structural Grade: 0 O&M Grade: 0 Clock Start/From: Clock To: 1st Value: 2nd Value: Value Percent: Continuous Index: Within 8" of Joint: NO Remarks: **VCP TO CONCRETE**

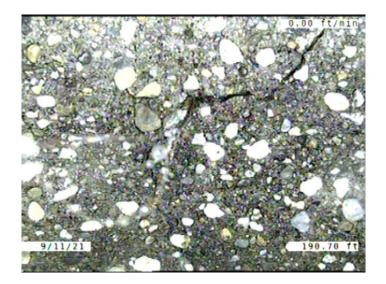
Code: Description:	RFB Roots Fine Barrel
Distance (ft): Structural Grade: O&M Grade: Clock Start/From: Clock To: 1st Value: 2nd Value: Value Percent: Continuous Index: Within 8" of Joint: Remarks:	190.7 0 2 11

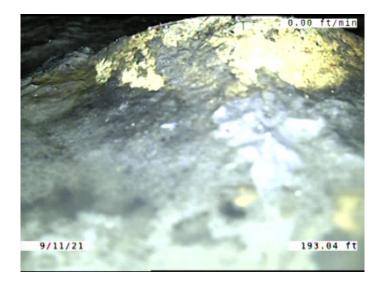
Code: Description:	OBM Obstruction Pipe Material in Invert
Distance (ft):	193.0
Structural Grade:	0
O&M Grade:	2
Clock Start/From:	5
Clock To:	7
1st Value:	
2nd Value:	
Value Percent:	10.000
Continuous Index:	
Within 8" of Joint:	YES

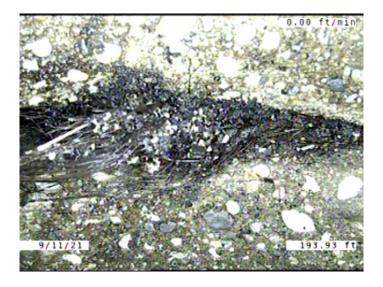
Code: Description:	RFJ Roots Fine Joint
Distance (ft):	193.9
Structural Grade:	0
O&M Grade:	1
Clock Start/From:	8
Clock To:	9
1st Value:	
2nd Value:	
Value Percent:	
Continuous Index:	
Within 8" of Joint:	YES
Remarks:

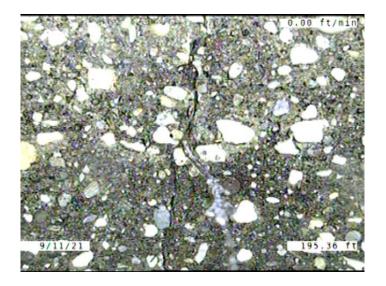
Code: Description:	RFB Roots Fine Barrel
Distance (ft):	195.4
Structural Grade:	0
O&M Grade:	2
Clock Start/From:	12
Clock To:	
1st Value:	
2nd Value:	
Value Percent:	
Continuous Index:	
Within 8" of Joint:	NO
Remarks:

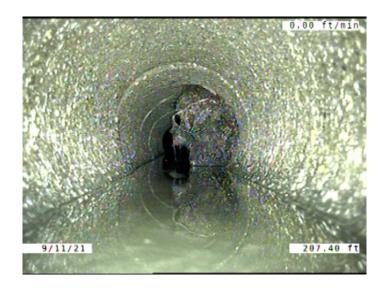
Code:	DSF
Description:	Deposits Settled Fine
Distance (ft): Structural Grade: O&M Grade: Clock Start/From: Clock To: 1st Value: 2nd Value: Value Percent: Continuous Index: Within 8" of Joint: Remarks:	207.4 0 2 5 7 5.000 F01 YES
