RedZone
ROBOTICS

Street:	North Delaware Street		Flow Control:	Not Controlled	
City:	Hobart, IN		Year Renewed:		
Location:	Alley		Tape/Media #:		
Purpose:	Routine Assessment		Dia/Height:	10"	
Use:	Sanitary Sewage Pipe		Material:	CP	
Drain Area:			Lining:	None	
Category:	NA				
Comment:					
Location Details:			Direction of Survey:	Upstream	
US MH:	M-504-101	DS MH:	M-504-102	Total Length Surveyed (ft):	207.4

O&M Index:	1.97	O&M Quick:	4136	O&M Rating:	154.00
Structural Index:	2.97	Structural Quick:	514A	Structural Rating:	116.00
Overall Index:	2.31	Overall Quick:	514A	Overall Rating:	270.00

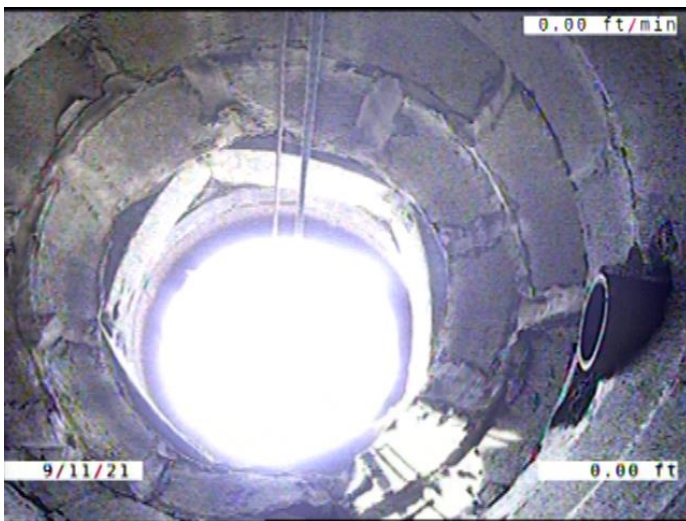
Code: **AMH**
Description: **Manhole**

Distance (ft): **.0**
Structural Grade: **0**
O&M Grade: **0**
Clock Start/From:
Clock To:
1st Value:
2nd Value:
Value Percent:
Continuous Index:
Within 8" of Joint: **NO**
Remarks: **M-504-102**

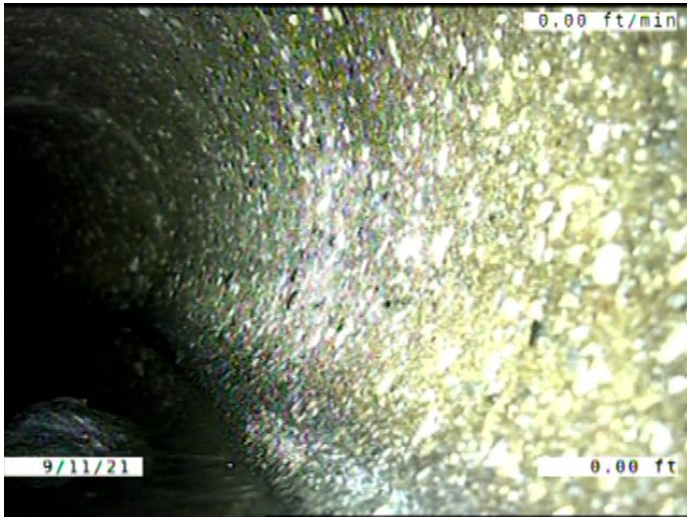
Code: **MWL**
 Description: **Miscellaneous Water Level**

Distance (ft): **.0**
 Structural Grade: **0**
 O&M Grade: **0**
 Clock Start/From:
 Clock To:
 1st Value:
 2nd Value:
 Value Percent: **5.000**
 Continuous Index:
 Within 8" of Joint: **NO**
 Remarks:

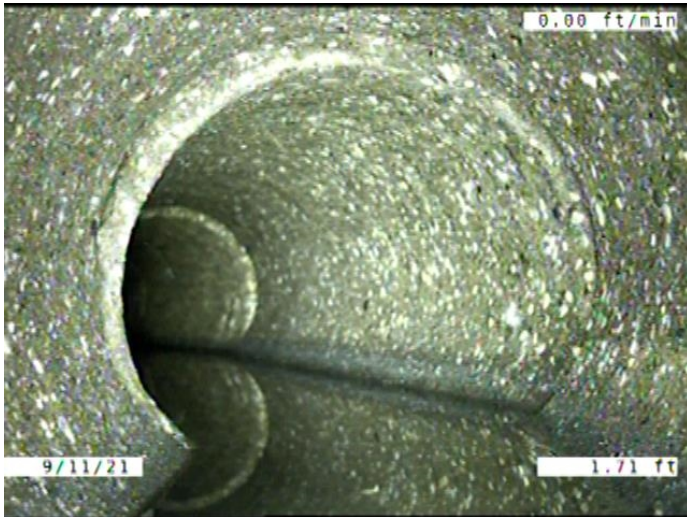
Code: **LL**
Description: **Line Left**

Distance (ft): **1.7**
Structural Grade: **0**
O&M Grade: **4**
Clock Start/From:
Clock To:
1st Value:
2nd Value:
Value Percent: **30.000**
Continuous Index:
Within 8" of Joint: **NO**
Remarks:

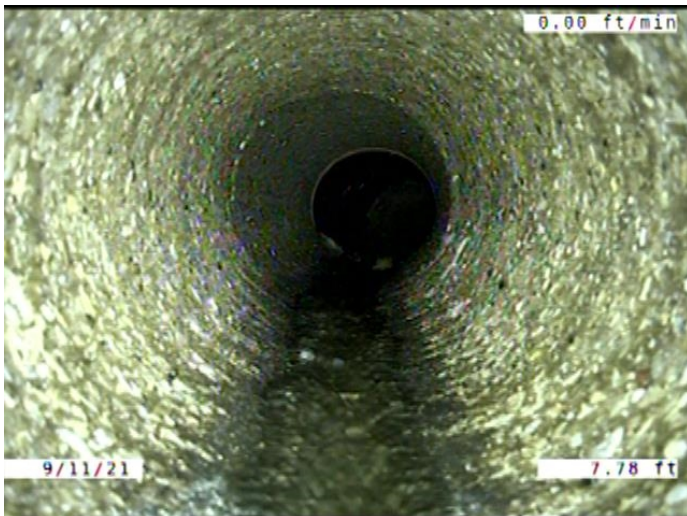
Code: **LU**
Description: **Line Up**

Distance (ft): **7.8**
Structural Grade: **0**
O&M Grade: **1**
Clock Start/From:
Clock To:
1st Value:
2nd Value:
Value Percent: **10.000**
Continuous Index:
Within 8" of Joint: **NO**
Remarks:

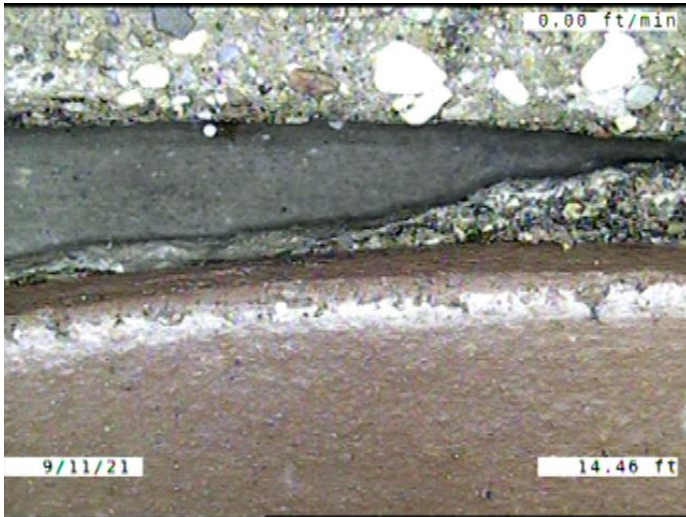
Code: **MMC**
 Description: **Miscellaneous Material Change**

Distance (ft): **14.5**
 Structural Grade: **0**
 O&M Grade: **0**
 Clock Start/From:
 Clock To:
 1st Value:
 2nd Value:
 Value Percent:
 Continuous Index:
 Within 8" of Joint: **NO**
 Remarks: **CONCRETE TO VCP**

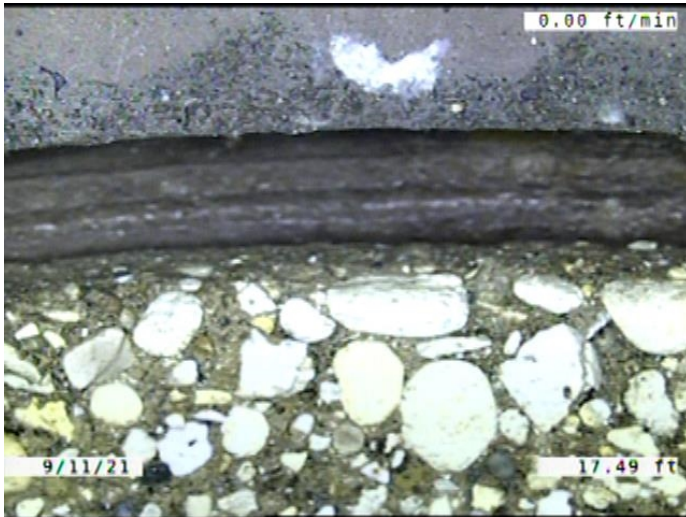
Code: **MMC**
 Description: **Miscellaneous Material Change**

Distance (ft): **17.5**
 Structural Grade: **0**
 O&M Grade: **0**
 Clock Start/From:
 Clock To:
 1st Value:
 2nd Value:
 Value Percent:
 Continuous Index:
 Within 8" of Joint: **NO**
 Remarks: **VCP TO CONCRETE**

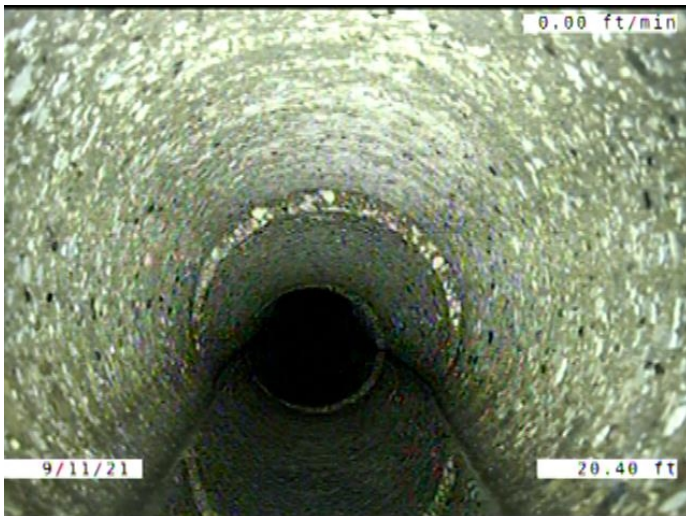
Code: **MWLS**
 Description: **Miscellaneous Water Level Sag**

Distance (ft): **20.4**
 Structural Grade: **2**
 O&M Grade: **0**
 Clock Start/From:
 Clock To:
 1st Value:
 2nd Value:
 Value Percent: **20.000**
 Continuous Index: **S02**
 Within 8" of Joint: **NO**
 Remarks:

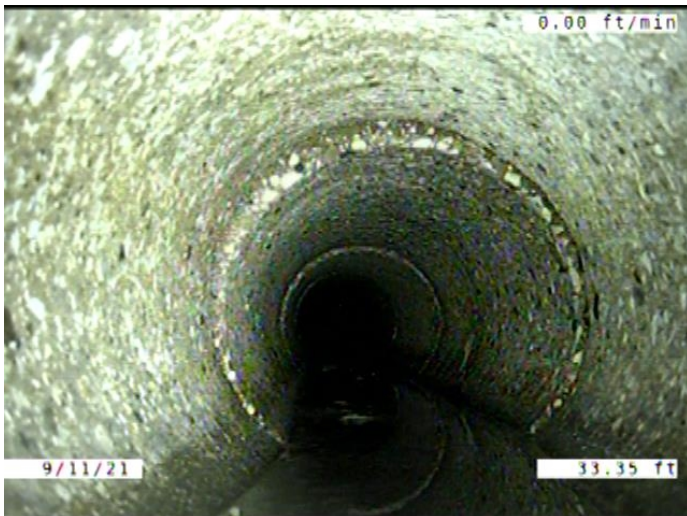
Code: **MWLS**
 Description: **Miscellaneous Water Level Sag**

Distance (ft): **33.3**
 Structural Grade: **2**
 O&M Grade: **0**
 Clock Start/From:
 Clock To:
 1st Value:
 2nd Value:
 Value Percent: **20.000**
 Continuous Index: **F02**
 Within 8" of Joint: **NO**
 Remarks:

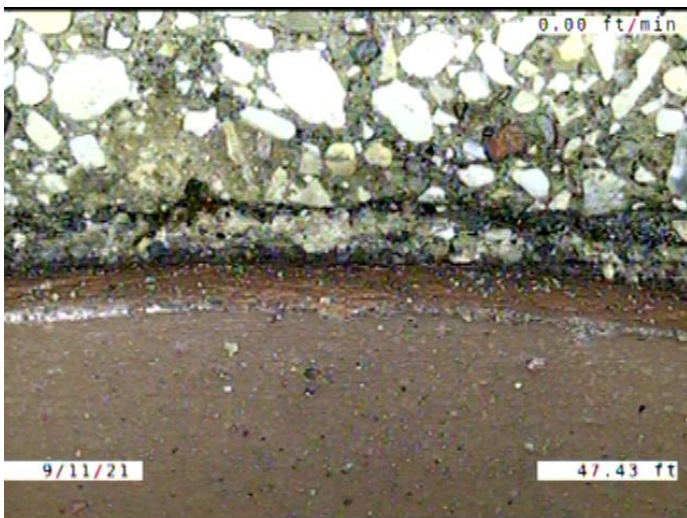
Code: **MMC**
 Description: **Miscellaneous Material Change**

Distance (ft): **47.4**
 Structural Grade: **0**
 O&M Grade: **0**
 Clock Start/From:
 Clock To:
 1st Value:
 2nd Value:
 Value Percent:
 Continuous Index:
 Within 8" of Joint: **NO**
 Remarks: **CONCRETE TO VCP**

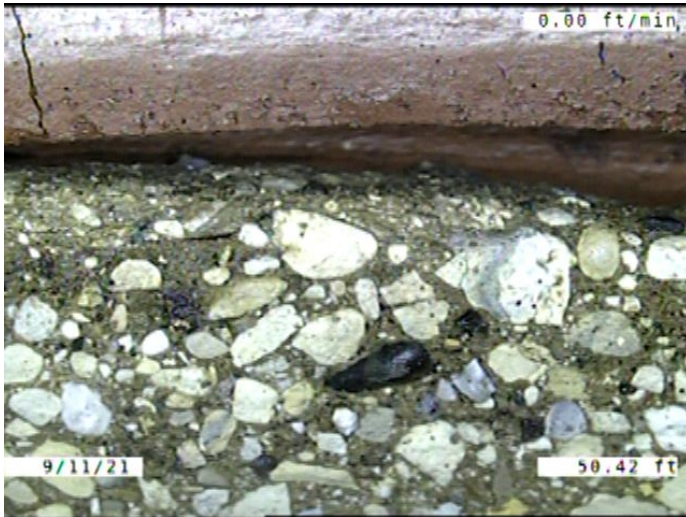
Code: **MMC**
 Description: **Miscellaneous Material Change**

Distance (ft): **50.4**
 Structural Grade: **0**
 O&M Grade: **0**
 Clock Start/From:
 Clock To:
 1st Value:
 2nd Value:
 Value Percent:
 Continuous Index:
 Within 8" of Joint: **NO**
 Remarks: **VCP TO CONCRETE**

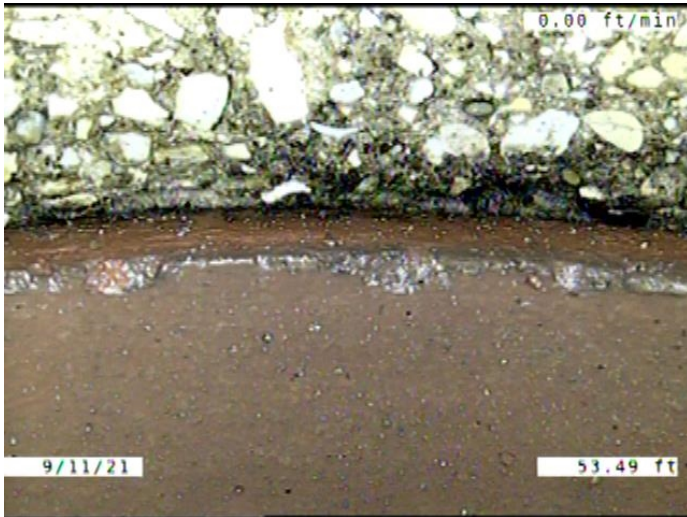
Code: **MMC**
 Description: **Miscellaneous Material Change**

Distance (ft): **53.5**
 Structural Grade: **0**
 O&M Grade: **0**
 Clock Start/From:
 Clock To:
 1st Value:
 2nd Value:
 Value Percent:
 Continuous Index:
 Within 8" of Joint: **NO**
 Remarks: **CONCRETE TO VCP**

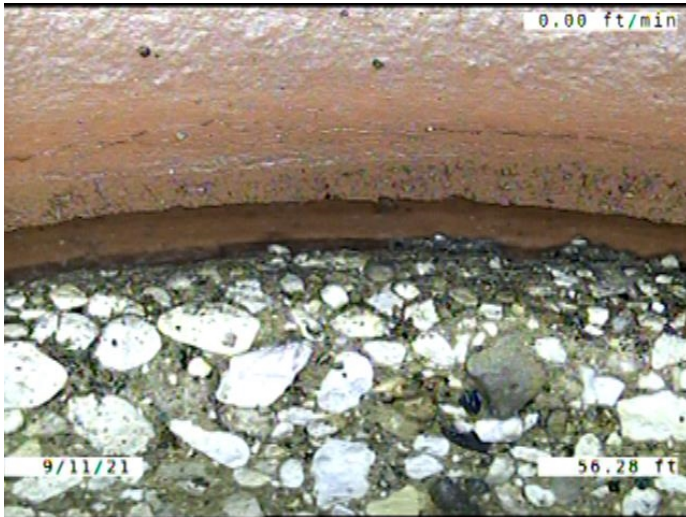
Code: **MMC**
 Description: **Miscellaneous Material Change**

Distance (ft): **56.3**
 Structural Grade: **0**
 O&M Grade: **0**
 Clock Start/From:
 Clock To:
 1st Value:
 2nd Value:
 Value Percent:
 Continuous Index:
 Within 8" of Joint: **NO**
 Remarks: **VCP TO CONCRETE**

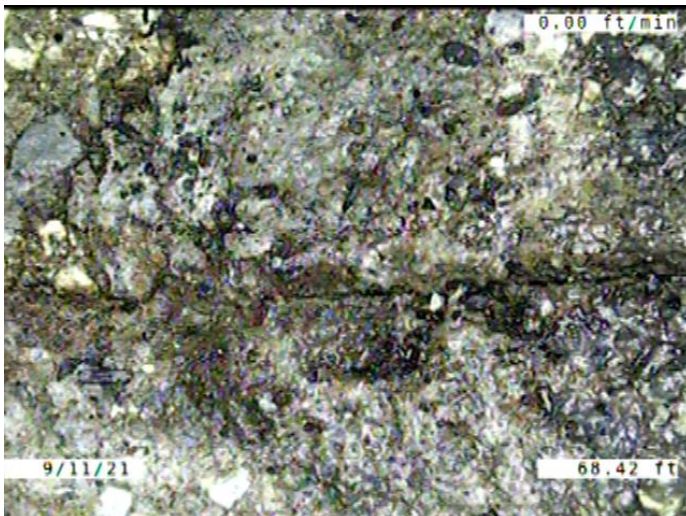
Code: **DAE**
 Description: **Deposits Attached Encrustation**

Distance (ft): **68.4**
 Structural Grade: **0**
 O&M Grade: **2**
 Clock Start/From: **8**
 Clock To: **10**
 1st Value:
 2nd Value:
 Value Percent: **5.000**
 Continuous Index:
 Within 8" of Joint: **YES**
 Remarks:

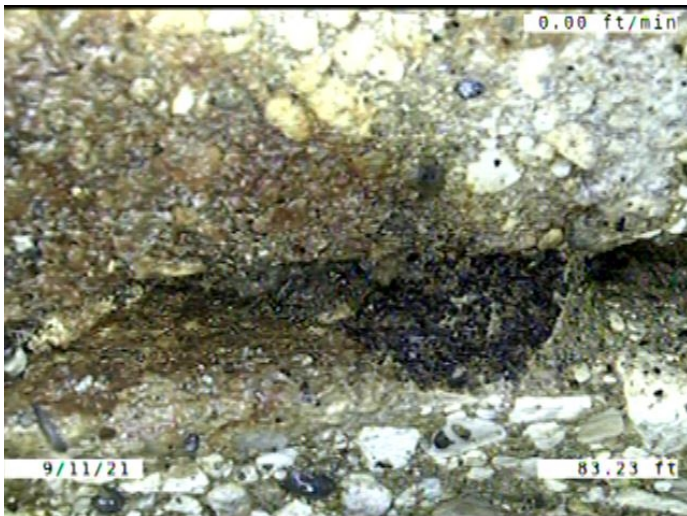
Code: **DAE**
 Description: **Deposits Attached Encrustation**

Distance (ft): **83.2**
 Structural Grade: **0**
 O&M Grade: **2**
 Clock Start/From: **3**
 Clock To: **9**
 1st Value:
 2nd Value:
 Value Percent: **5.000**
 Continuous Index:
 Within 8" of Joint: **YES**
 Remarks:

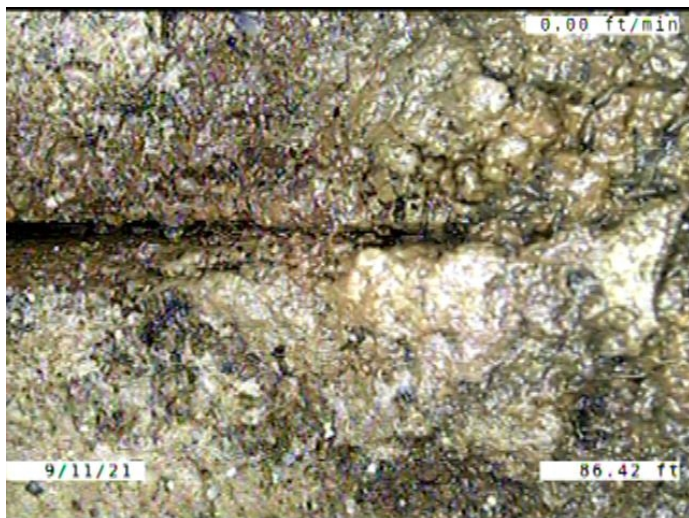
Code: **DAE**
 Description: **Deposits Attached Encrustation**

Distance (ft): **86.4**
 Structural Grade: **0**
 O&M Grade: **2**
 Clock Start/From: **2**
 Clock To: **10**
 1st Value:
 2nd Value:
 Value Percent: **5.000**
 Continuous Index:
 Within 8" of Joint: **YES**
 Remarks:

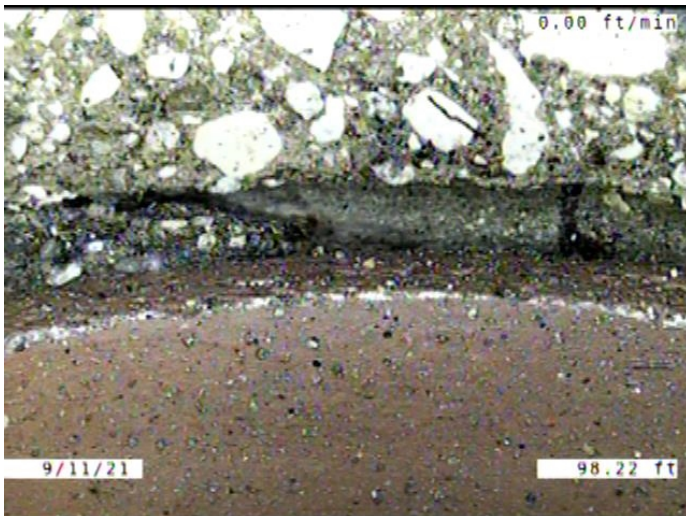
Code: **MMC**
 Description: **Miscellaneous Material Change**

Distance (ft): **98.2**
 Structural Grade: **0**
 O&M Grade: **0**
 Clock Start/From:
 Clock To:
 1st Value:
 2nd Value:
 Value Percent:
 Continuous Index:
 Within 8" of Joint: **NO**
 Remarks: **CONCRETE TO VCP**

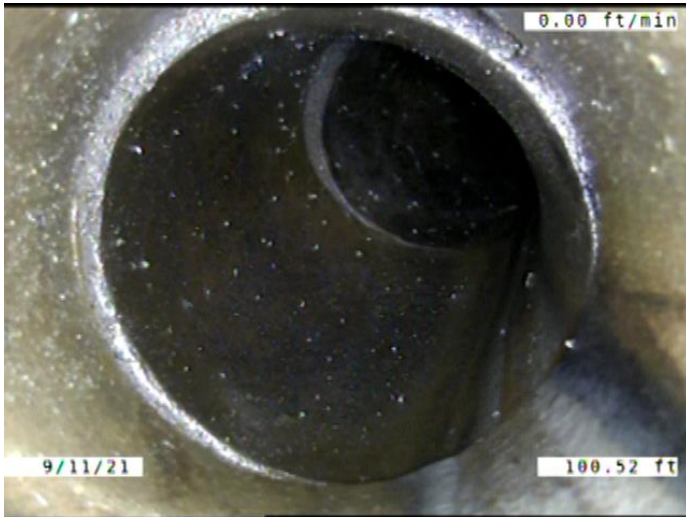
Code: **TF**
 Description: **Tap Factory**

Distance (ft): **100.5**
 Structural Grade: **0**
 O&M Grade: **0**
 Clock Start/From: **1**
 Clock To:
 1st Value: **4.000**
 2nd Value:
 Value Percent:
 Continuous Index:
 Within 8" of Joint: **YES**
 Remarks:

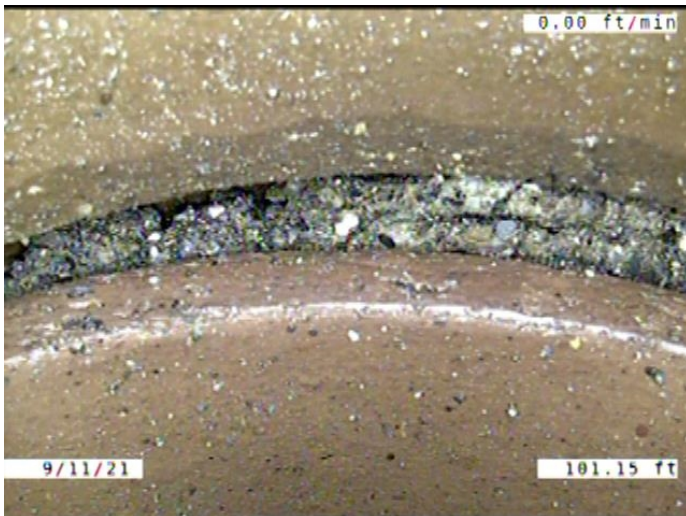
Code: **JOM**
 Description: **Joint Offset Medium**

Distance (ft): **101.1**
 Structural Grade: **3**
 O&M Grade: **0**
 Clock Start/From:
 Clock To:
 1st Value:
 2nd Value:
 Value Percent:
 Continuous Index:
 Within 8" of Joint: **NO**
 Remarks:

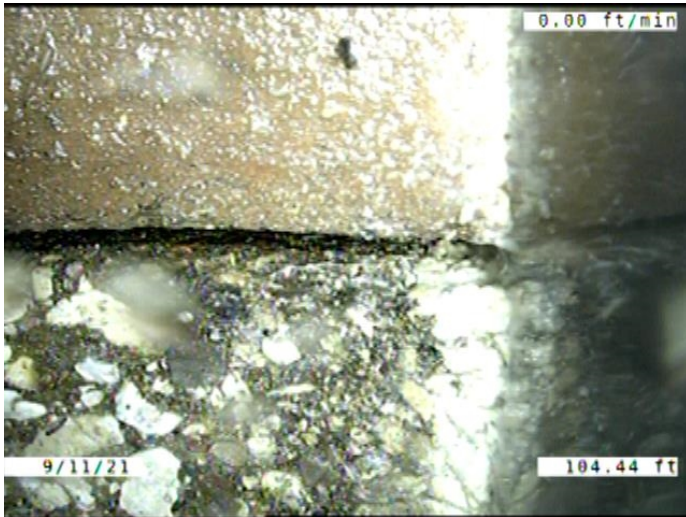
Code: **MMC**
 Description: **Miscellaneous Material Change**

Distance (ft): **104.4**
 Structural Grade: **0**
 O&M Grade: **0**
 Clock Start/From:
 Clock To:
 1st Value:
 2nd Value:
 Value Percent:
 Continuous Index:
 Within 8" of Joint: **NO**
 Remarks: **VCP TO CONCRETE**

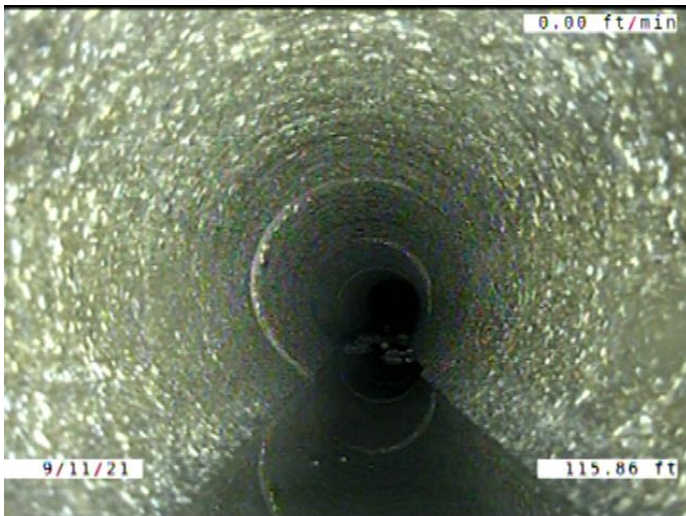
Code: **MWLS**
 Description: **Miscellaneous Water Level Sag**

Distance (ft): **115.9**
 Structural Grade: **2**
 O&M Grade: **0**
 Clock Start/From:
 Clock To:
 1st Value:
 2nd Value:
 Value Percent: **15.000**
 Continuous Index: **F04**
 Within 8" of Joint: **NO**
 Remarks:

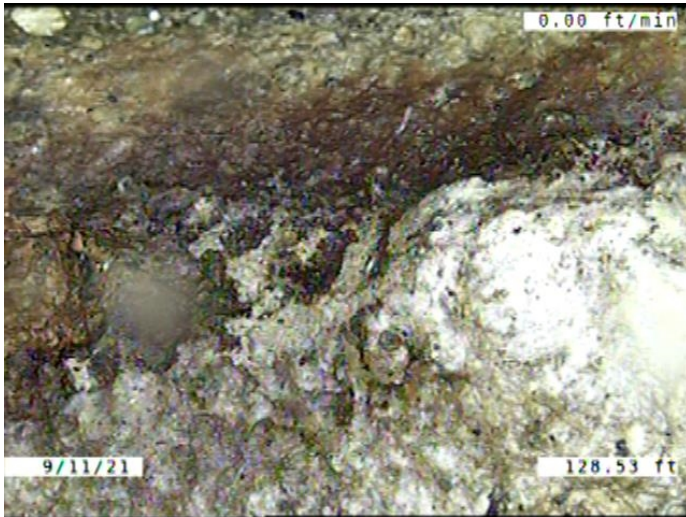
Code: **DAE**
Description: **Deposits Attached Encrustation**

Distance (ft): **128.5**
Structural Grade: **0**
O&M Grade: **2**
Clock Start/From: **8**
Clock To: **10**
1st Value:
2nd Value:
Value Percent: **5.000**
Continuous Index:
Within 8" of Joint: **YES**
Remarks:

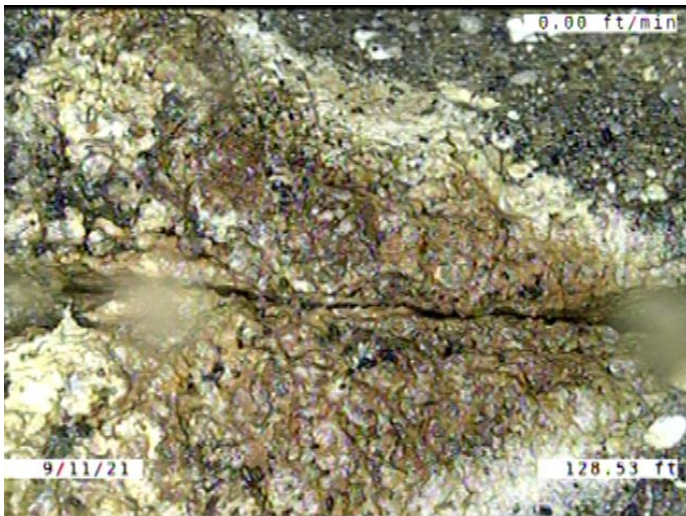
Code: **DAE**
Description: **Deposits Attached Encrustation**

Distance (ft): **128.5**
Structural Grade: **0**
O&M Grade: **2**
Clock Start/From: **2**
Clock To: **4**
1st Value:
2nd Value:
Value Percent: **5.000**
Continuous Index:
Within 8" of Joint: **YES**
Remarks:

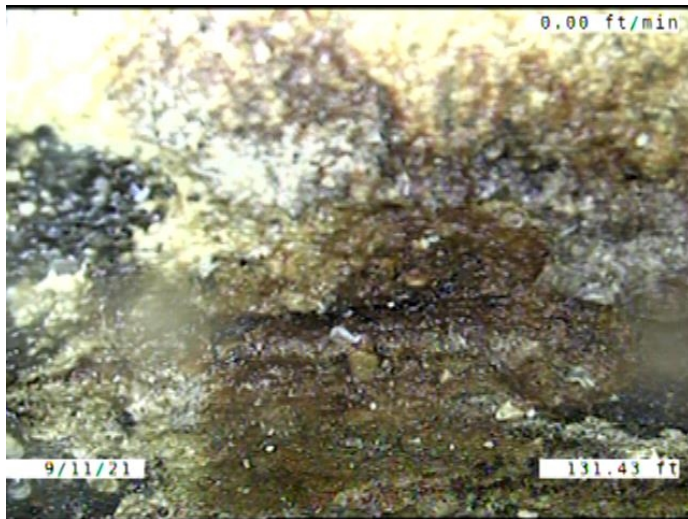
Code: **DAE**
 Description: **Deposits Attached Encrustation**

Distance (ft): **131.4**
 Structural Grade: **0**
 O&M Grade: **2**
 Clock Start/From: **8**
 Clock To: **11**
 1st Value:
 2nd Value:
 Value Percent: **5.000**
 Continuous Index:
 Within 8" of Joint: **YES**
 Remarks:

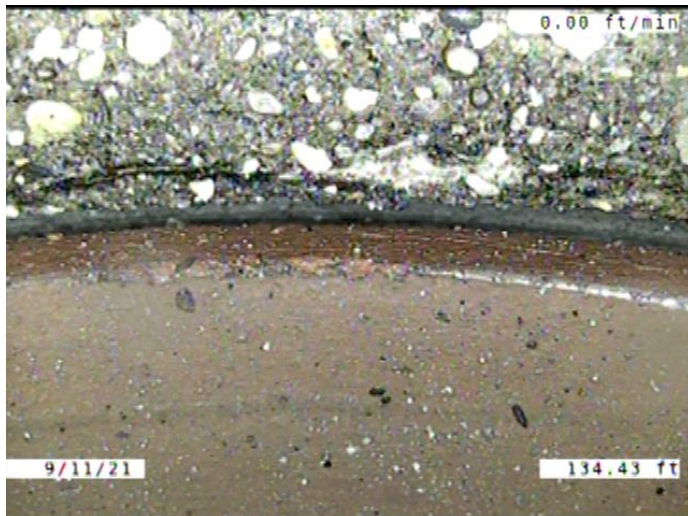
Code: **MMC**
 Description: **Miscellaneous Material Change**

Distance (ft): **134.4**
 Structural Grade: **0**
 O&M Grade: **0**
 Clock Start/From:
 Clock To:
 1st Value:
 2nd Value:
 Value Percent:
 Continuous Index:
 Within 8" of Joint: **NO**
 Remarks: **CONCRETE TO VCP**

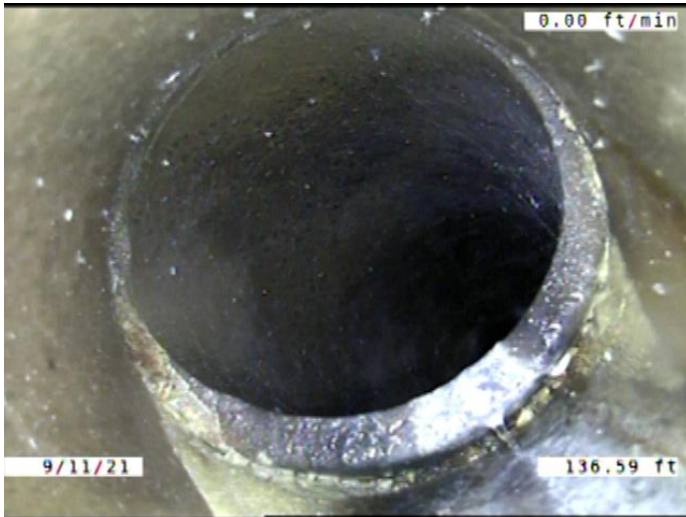
Code: **TF**
Description: **Tap Factory**

Distance (ft): **136.6**
Structural Grade: **0**
O&M Grade: **0**
Clock Start/From: **1**
Clock To:
1st Value: **4.000**
2nd Value:
Value Percent:
Continuous Index:
Within 8" of Joint: **YES**
Remarks:

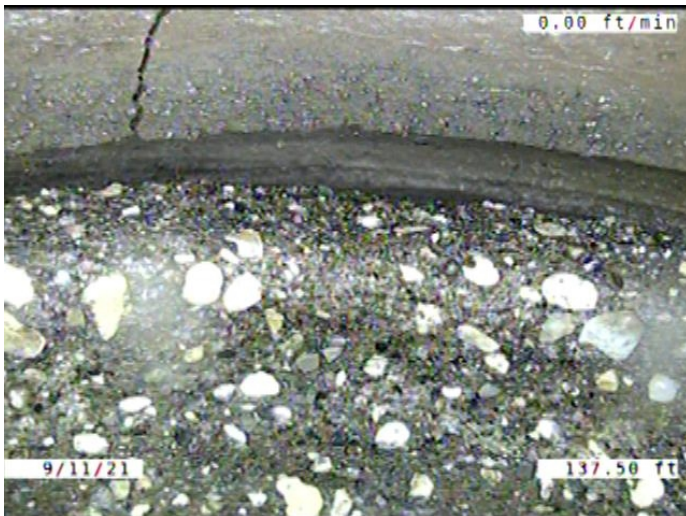
Code: **MMC**
Description: **Miscellaneous Material Change**

Distance (ft): **137.5**
Structural Grade: **0**
O&M Grade: **0**
Clock Start/From:
Clock To:
1st Value:
2nd Value:
Value Percent:
Continuous Index:
Within 8" of Joint: **NO**
Remarks: **VCP TO CONCRETE**

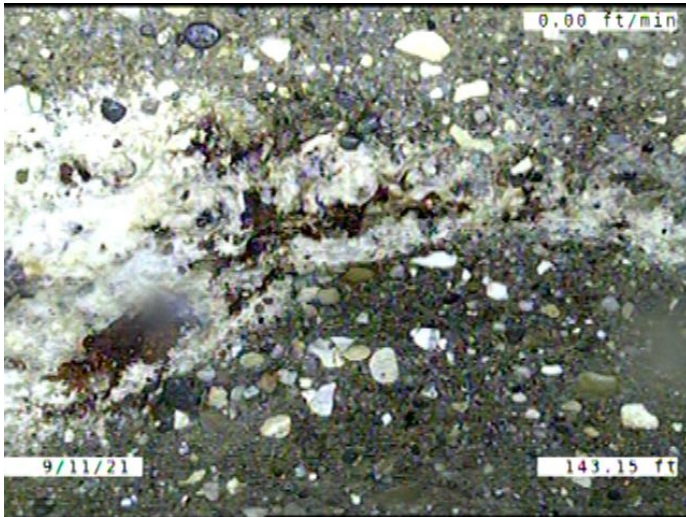
Code: **DAE**
 Description: **Deposits Attached Encrustation**

Distance (ft): **143.1**
 Structural Grade: **0**
 O&M Grade: **2**
 Clock Start/From: **7**
 Clock To: **5**
 1st Value:
 2nd Value:
 Value Percent: **5.000**
 Continuous Index:
 Within 8" of Joint: **NO**
 Remarks:

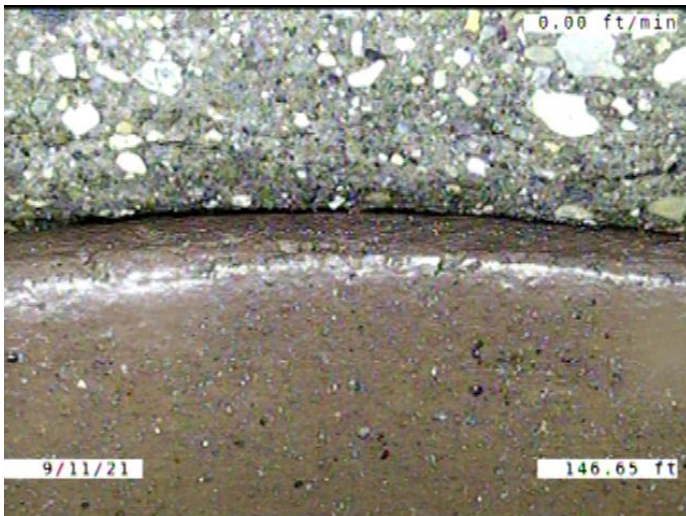
Code: **MMC**
 Description: **Miscellaneous Material Change**

Distance (ft): **146.6**
 Structural Grade: **0**
 O&M Grade: **0**
 Clock Start/From:
 Clock To:
 1st Value:
 2nd Value:
 Value Percent:
 Continuous Index:
 Within 8" of Joint: **NO**
 Remarks: **CONCRETE TO VCP**

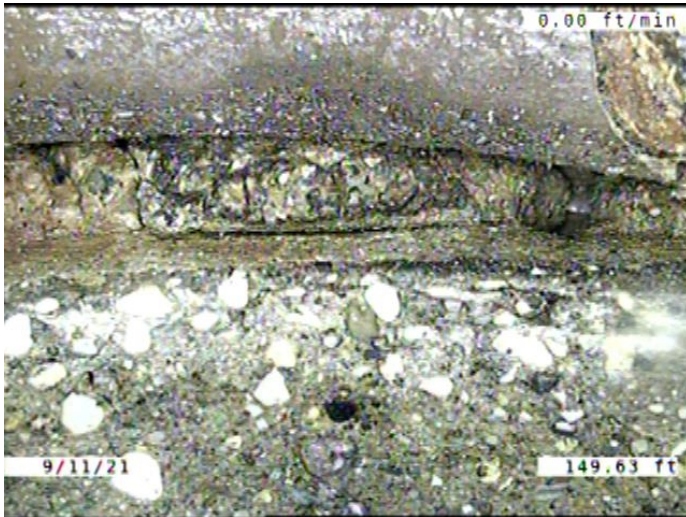
Code: **MMC**
 Description: **Miscellaneous Material Change**

Distance (ft): **149.6**
 Structural Grade: **0**
 O&M Grade: **0**
 Clock Start/From:
 Clock To:
 1st Value:
 2nd Value:
 Value Percent:
 Continuous Index:
 Within 8" of Joint: **NO**
 Remarks: **VCP TO CONCRETE**

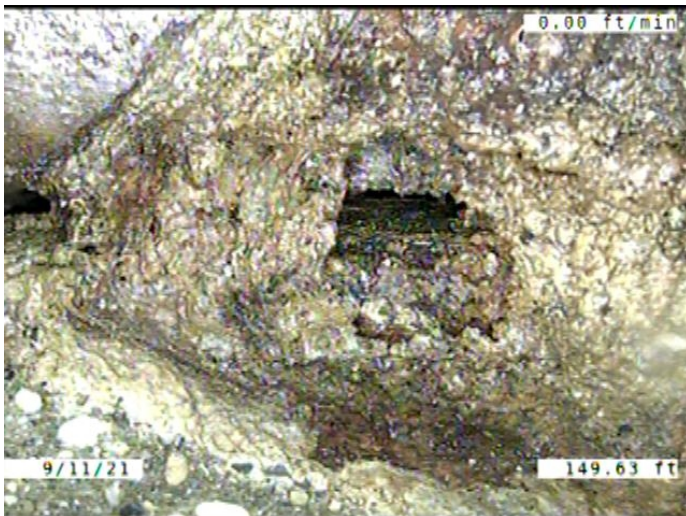
Code: **DAE**
 Description: **Deposits Attached Encrustation**

Distance (ft): **149.6**
 Structural Grade: **0**
 O&M Grade: **2**
 Clock Start/From: **9**
 Clock To: **5**
 1st Value:
 2nd Value:
 Value Percent: **5.000**
 Continuous Index:
 Within 8" of Joint: **YES**
 Remarks:

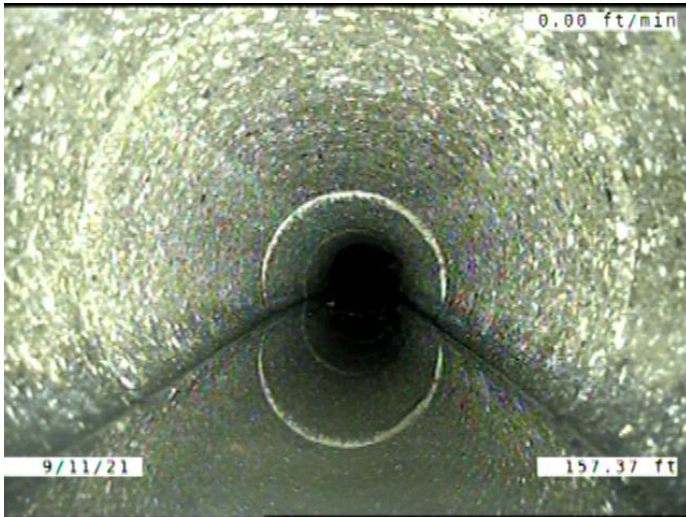
Code: **MWLS**
 Description: **Miscellaneous Water Level Sag**

Distance (ft): **157.4**
 Structural Grade: **2**
 O&M Grade: **0**
 Clock Start/From:
 Clock To:
 1st Value:
 2nd Value:
 Value Percent: **10.000**
 Continuous Index: **S05**
 Within 8" of Joint: **NO**
 Remarks:

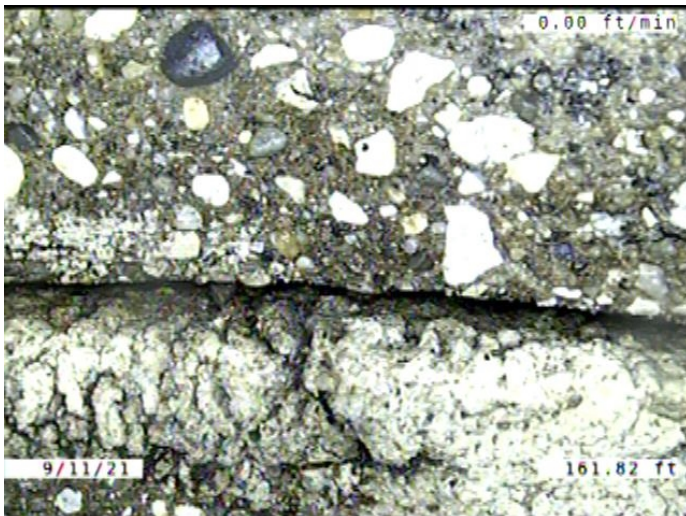
Code: **DAE**
 Description: **Deposits Attached Encrustation**

Distance (ft): **161.8**
 Structural Grade: **0**
 O&M Grade: **2**
 Clock Start/From: **9**
 Clock To: **3**
 1st Value:
 2nd Value:
 Value Percent: **5.000**
 Continuous Index:
 Within 8" of Joint: **YES**
 Remarks:

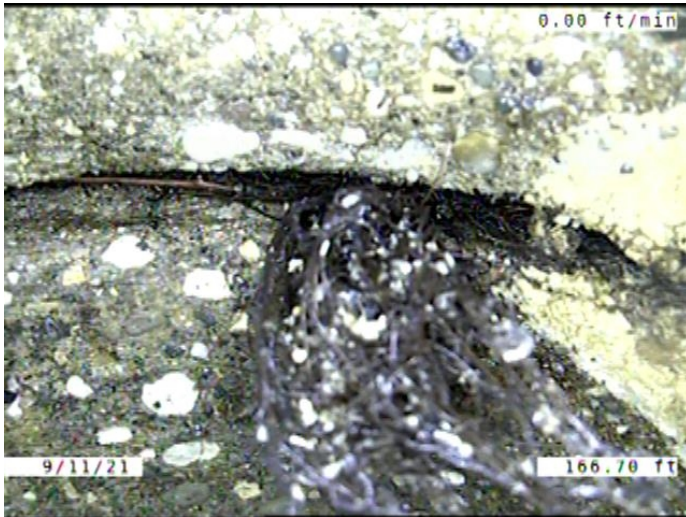
Code: **RFJ**
 Description: **Roots Fine Joint**

Distance (ft): **166.7**
 Structural Grade: **0**
 O&M Grade: **1**
 Clock Start/From: **1**
 Clock To: **4**
 1st Value:
 2nd Value:
 Value Percent:
 Continuous Index:
 Within 8" of Joint: **YES**
 Remarks:

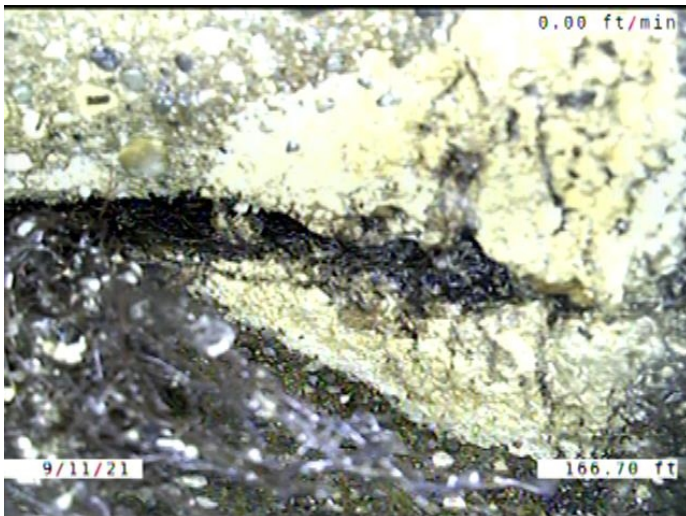
Code: **DAE**
 Description: **Deposits Attached Encrustation**

Distance (ft): **166.7**
 Structural Grade: **0**
 O&M Grade: **2**
 Clock Start/From: **2**
 Clock To: **3**
 1st Value:
 2nd Value:
 Value Percent: **5.000**
 Continuous Index:
 Within 8" of Joint: **YES**
 Remarks:

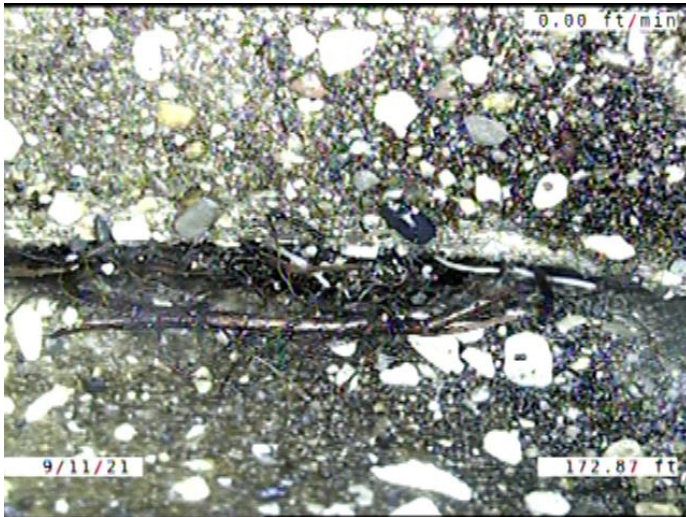
Code: **RFJ**
 Description: **Roots Fine Joint**

Distance (ft): **172.9**
 Structural Grade: **0**
 O&M Grade: **1**
 Clock Start/From: **2**
 Clock To: **3**
 1st Value:
 2nd Value:
 Value Percent:
 Continuous Index:
 Within 8" of Joint: **YES**
 Remarks:

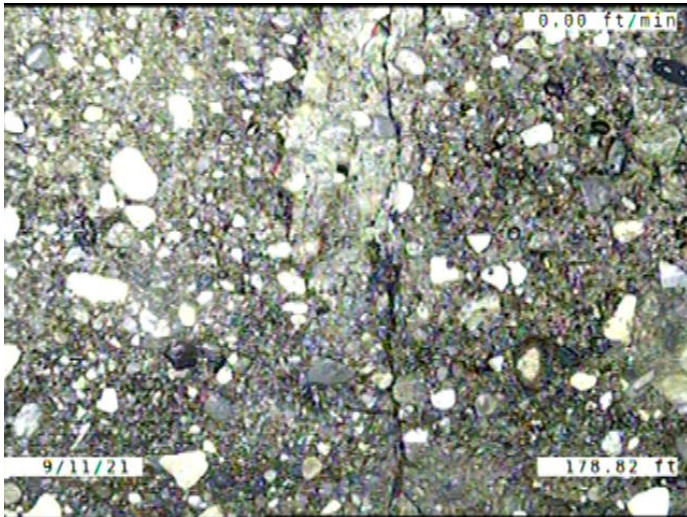
Code: **RFJ**
 Description: **Roots Fine Joint**

Distance (ft): **178.8**
 Structural Grade: **0**
 O&M Grade: **1**
 Clock Start/From: **8**
 Clock To: **10**
 1st Value:
 2nd Value:
 Value Percent:
 Continuous Index:
 Within 8" of Joint: **YES**
 Remarks:

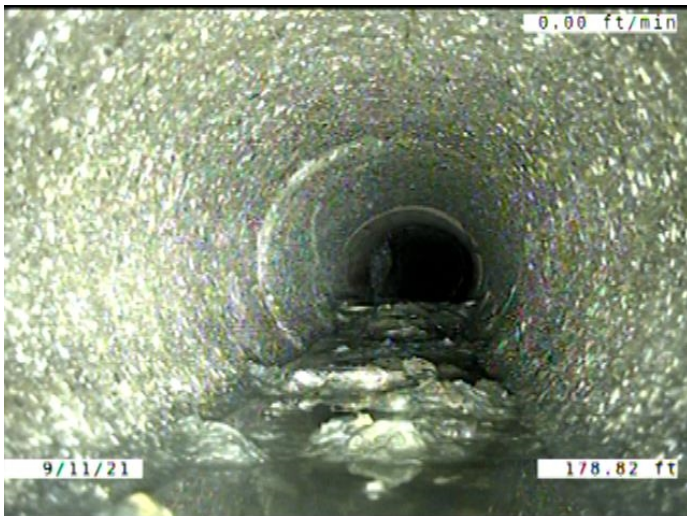
Code: **CM**
 Description: **Crack Multiple**

Distance (ft): **178.8**
 Structural Grade: **3**
 O&M Grade: **0**
 Clock Start/From: **9**
 Clock To: **10**
 1st Value:
 2nd Value:
 Value Percent:
 Continuous Index:
 Within 8" of Joint: **YES**
 Remarks:

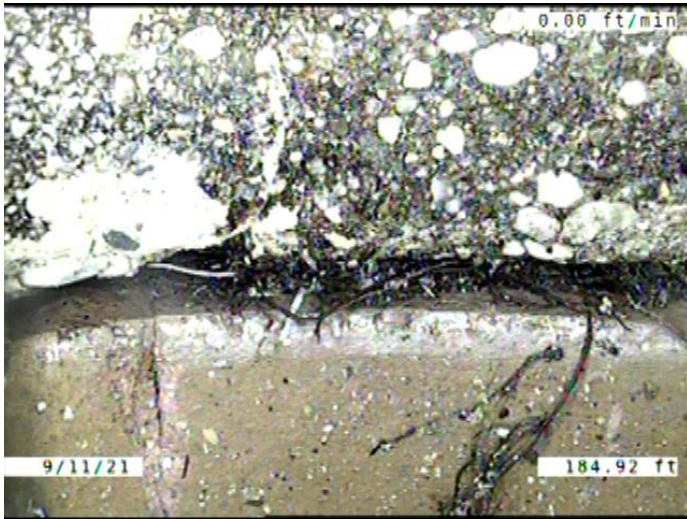
Code: **MMC**
 Description: **Miscellaneous Material Change**

Distance (ft): **184.9**
 Structural Grade: **0**
 O&M Grade: **0**
 Clock Start/From:
 Clock To:
 1st Value:
 2nd Value:
 Value Percent:
 Continuous Index:
 Within 8" of Joint: **NO**
 Remarks: **CONCRETE TO VCP**

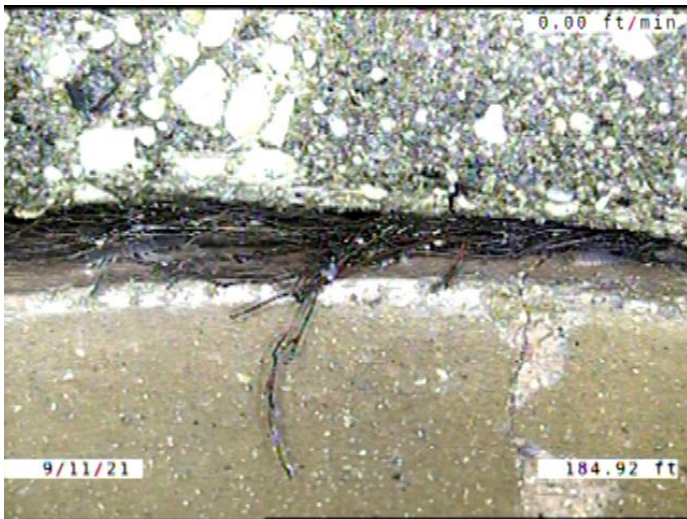
Code: **RFJ**
Description: **Roots Fine Joint**

Distance (ft): **184.9**
Structural Grade: **0**
O&M Grade: **1**
Clock Start/From: **9**
Clock To: **10**
1st Value:
2nd Value:
Value Percent:
Continuous Index:
Within 8" of Joint: **YES**
Remarks:

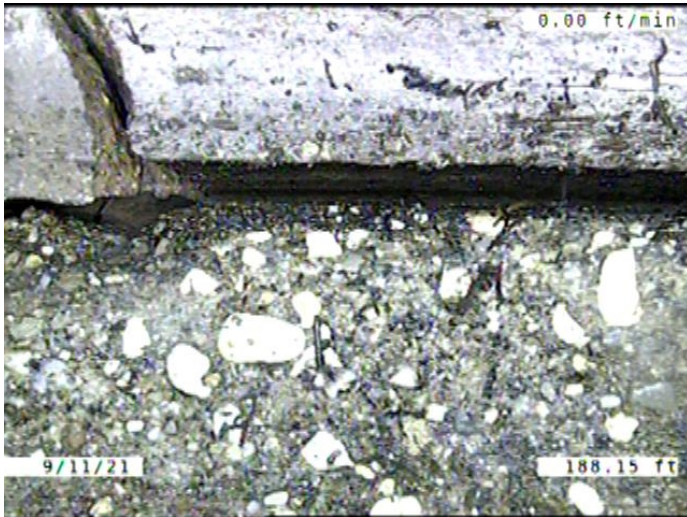
Code: **TFD**
 Description: **Tap Factory Defective**

Distance (ft): **187.4**
 Structural Grade: **0**
 O&M Grade: **3**
 Clock Start/From: **11**
 Clock To:
 1st Value: **4.000**
 2nd Value:
 Value Percent:
 Continuous Index:
 Within 8" of Joint: **YES**
 Remarks: **Defective**

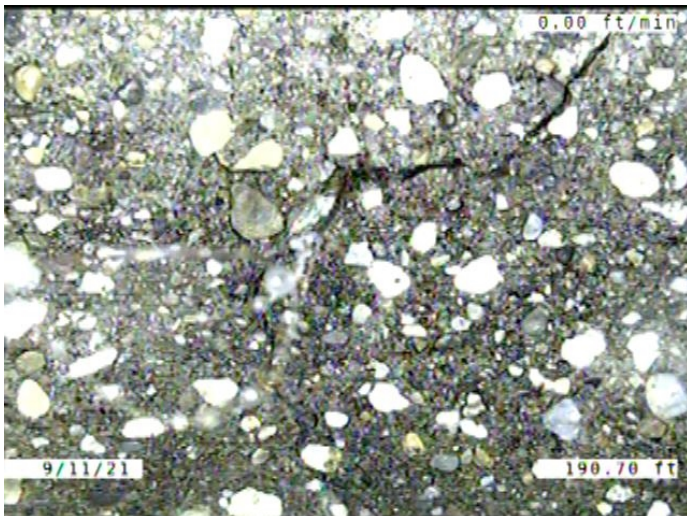
Code: **MMC**
 Description: **Miscellaneous Material Change**

Distance (ft): **188.2**
 Structural Grade: **0**
 O&M Grade: **0**
 Clock Start/From:
 Clock To:
 1st Value:
 2nd Value:
 Value Percent:
 Continuous Index:
 Within 8" of Joint: **NO**
 Remarks: **VCP TO CONCRETE**

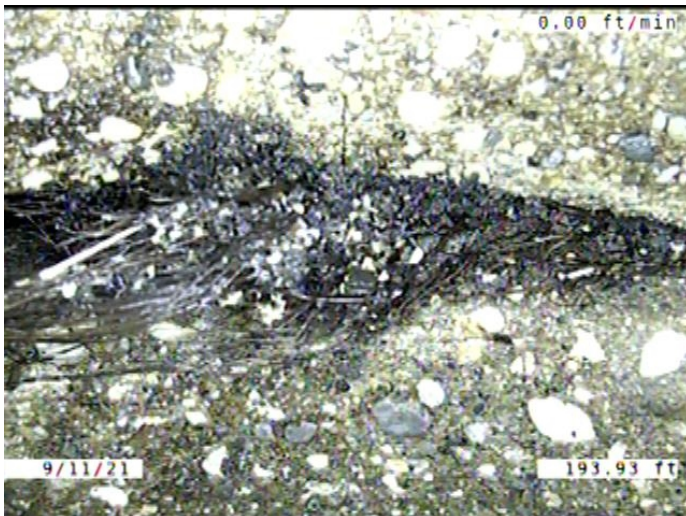
Code:	OBM
Description:	Obstruction Pipe Material in Invert
Distance (ft):	193.0
Structural Grade:	0
O&M Grade:	2
Clock Start/From:	5
Clock To:	7
1st Value:	
2nd Value:	
Value Percent:	10.000
Continuous Index:	
Within 8" of Joint:	YES
Remarks:

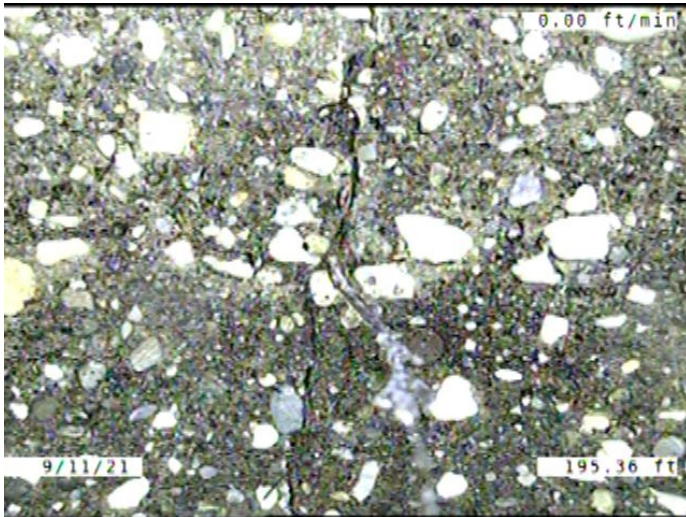
Code:	RFJ
Description:	Roots Fine Joint
Distance (ft):	193.9
Structural Grade:	0
O&M Grade:	1
Clock Start/From:	8
Clock To:	9
1st Value:	
2nd Value:	
Value Percent:	
Continuous Index:	
Within 8" of Joint:	YES
Remarks:

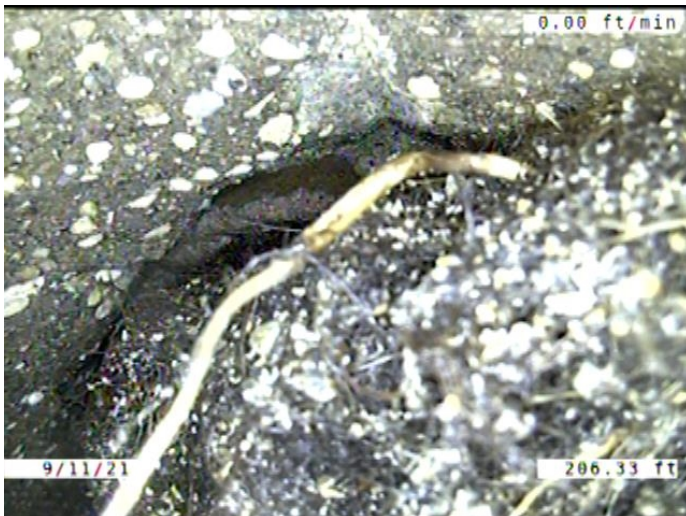
Code: **RFB**
Description: **Roots Fine Barrel**

Distance (ft): **195.4**
Structural Grade: **0**
O&M Grade: **2**
Clock Start/From: **12**
Clock To:
1st Value:
2nd Value:
Value Percent:
Continuous Index:
Within 8" of Joint: **NO**
Remarks:

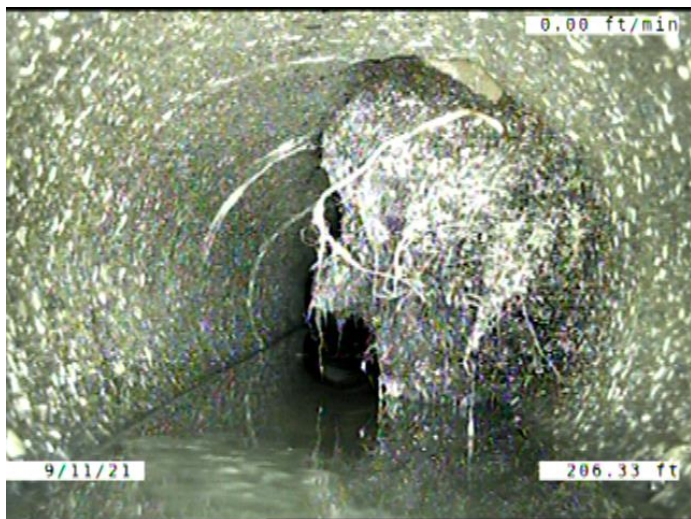
Code: **TBD**
Description: **Tap Break-in/Hammer Defective**

Distance (ft): **206.3**
Structural Grade: **0**
O&M Grade: **3**
Clock Start/From: **1**
Clock To:
1st Value: **4.000**
2nd Value:
Value Percent:
Continuous Index:
Within 8" of Joint: **YES**
Remarks: **100% PLUGGED WITH ROOTS**

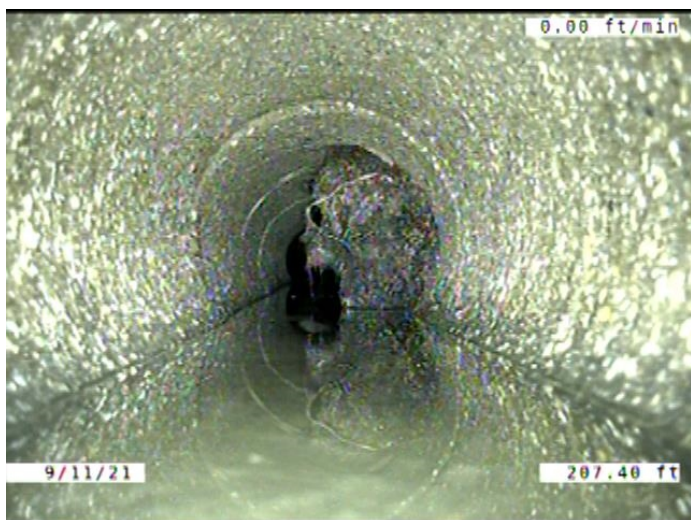
Code: **RML**
 Description: **Roots Medium Lateral**

Distance (ft): **206.3**
 Structural Grade: **0**
 O&M Grade: **3**
 Clock Start/From: **12**
 Clock To: **5**
 1st Value:
 2nd Value:
 Value Percent: **45.000**
 Continuous Index:
 Within 8" of Joint: **NO**
 Remarks:

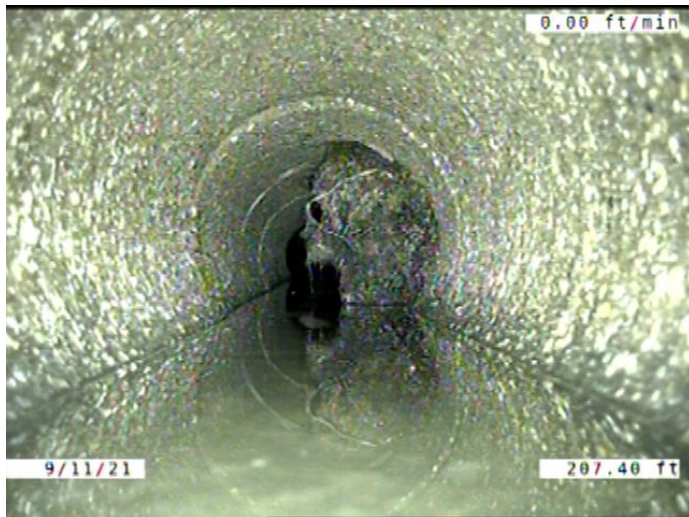
Code: **DSF**
 Description: **Deposits Settled Fine**

Distance (ft): **207.4**
 Structural Grade: **0**
 O&M Grade: **2**
 Clock Start/From: **5**
 Clock To: **7**
 1st Value:
 2nd Value:
 Value Percent: **5.000**
 Continuous Index: **F01**
 Within 8" of Joint: **YES**
 Remarks:

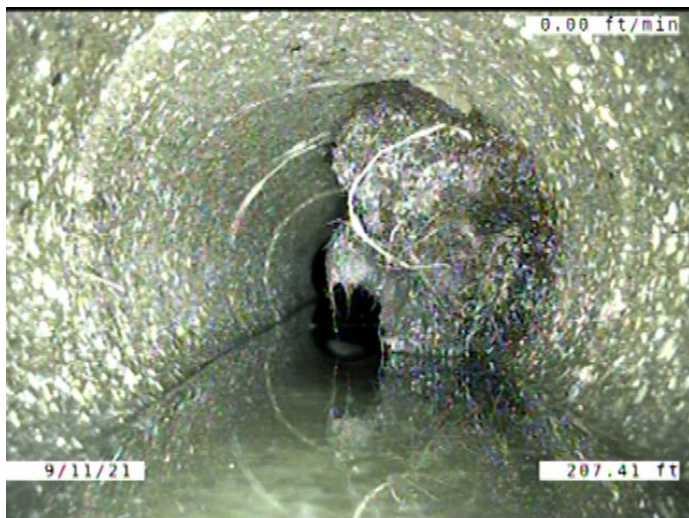
Code: **FM**
 Description: **Fracture Multiple**

Distance (ft): **207.4**
 Structural Grade: **4**
 O&M Grade: **0**
 Clock Start/From: **7**
 Clock To: **4**
 1st Value:
 2nd Value:
 Value Percent:
 Continuous Index: **F06**
 Within 8" of Joint: **YES**
 Remarks:
