# Profile/Photo Observation Report

Date:	<b>09/10/2021</b>	Weather:		Coding:	<b>PACP 7.0</b>
Pipe Length (ft):	<b>188.3</b>	Owner:	<b>City of Hobart</b>	Pre Clean:	<b>Heavy Cleaning</b>
P.O.#:	<b>YES502259</b>	Surveyor:	<b>S. Bucklin</b>	PSR:	<b>P-504-104-103</b>
Customer:	<b>City of Hobart</b>	Clean Date:	<b>08/27/2021</b>	Shape:	<b>C</b>

Street:	<b>North Colorado Street</b>	Flow Control:	<b>Not Controlled</b>
City:	<b>Hobart, IN</b>	Year Renewed:	
Location:	<b>Alley</b>	Tape/Media #:	
Purpose:	<b>Routine Assessment</b>	Dia/Height:	<b>12"</b>
Use:	<b>Sanitary Sewage Pipe</b>	Material:	<b>CP</b>
Drain Area:		Lining:	<b>None</b>
Category:	<b>NA</b>		
Comment:			
Location Details:		Direction of Survey:	<b>Downstream</b>
US MH:	<b>M-504-103</b>	DS MH:	<b>M-504-104</b>
		Total Length Surveyed (ft):	<b>188.3</b>

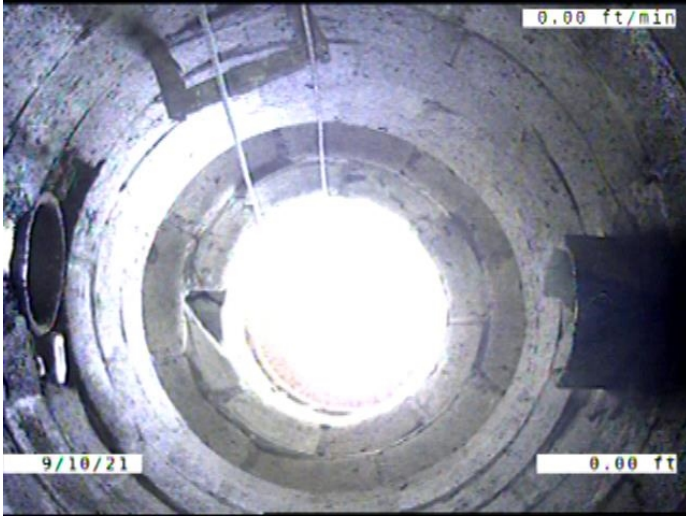
Code: **AMH**  
Description: **Manhole**

Distance (ft): **.0**  
Structural Grade: **0**  
O&M Grade: **0**  
Clock Start/From:  
Clock To:  
1st Value:  
2nd Value:  
Value Percent:  
Continuous Index:  
Within 8" of Joint: **NO**  
Remarks: **M-504-103**

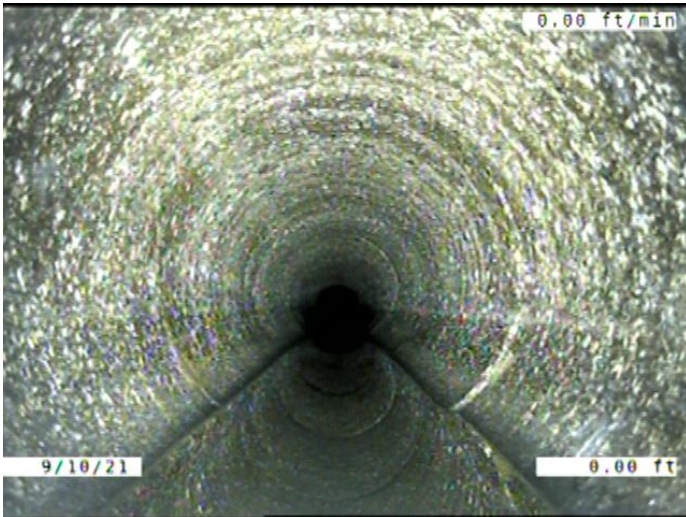
Code: **MWL**  
Description: **Miscellaneous Water Level**

Distance (ft): **.0**  
Structural Grade: **0**  
O&M Grade: **0**  
Clock Start/From:  
Clock To:  
1st Value:  
2nd Value:  
Value Percent: **5.000**  
Continuous Index:  
Within 8" of Joint: **NO**  
Remarks:

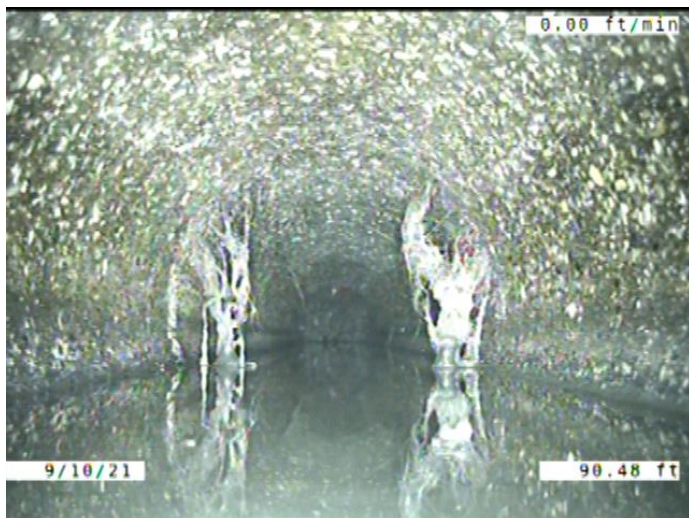
Code: **MWL**  
 Description: **Miscellaneous Water Level**

Distance (ft): **90.5**  
 Structural Grade: **0**  
 O&M Grade: **0**  
 Clock Start/From:  
 Clock To:  
 1st Value:  
 2nd Value:  
 Value Percent: **15.000**  
 Continuous Index:  
 Within 8" of Joint: **NO**  
 Remarks:

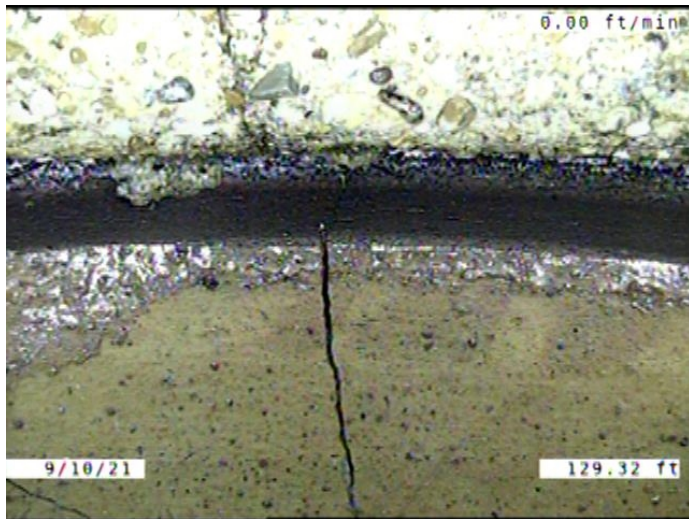
Code: **MMC**  
 Description: **Miscellaneous Material Change**

Distance (ft): **129.3**  
 Structural Grade: **0**  
 O&M Grade: **0**  
 Clock Start/From:  
 Clock To:  
 1st Value:  
 2nd Value:  
 Value Percent:  
 Continuous Index:  
 Within 8" of Joint: **NO**  
 Remarks: **CONCRETE TO VCP**

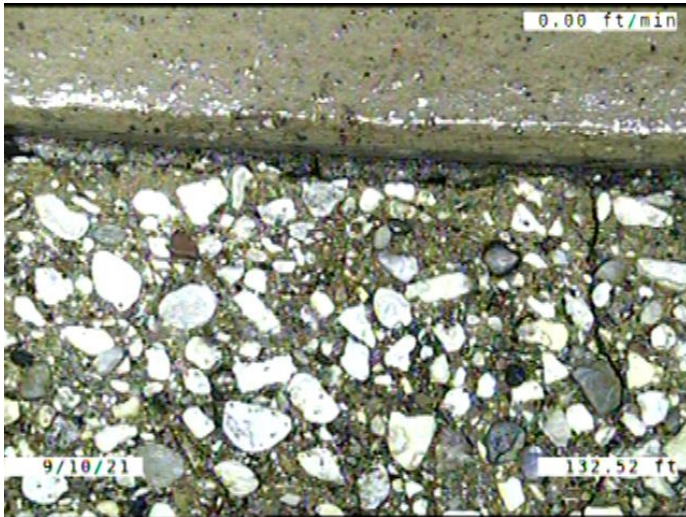
Code: **MMC**  
 Description: **Miscellaneous Material Change**

Distance (ft): **132.5**  
 Structural Grade: **0**  
 O&M Grade: **0**  
 Clock Start/From:  
 Clock To:  
 1st Value:  
 2nd Value:  
 Value Percent:  
 Continuous Index:  
 Within 8" of Joint: **NO**  
 Remarks: **VCP TO CONCRETE**
