# Profile/Photo Observation Report

Date:	<b>10/21/2021</b>	Weather:		Coding:	<b>PACP 7.0</b>
Pipe Length (ft):	<b>241.0</b>	Owner:	<b>City of Hobart</b>	Pre Clean:	<b>Light Cleaning</b>
P.O.#:	<b>YES502259</b>	Surveyor:	<b>S. Bucklin</b>	PSR:	<b>P-504-107-106</b>
Customer:	<b>City of Hobart</b>	Clean Date:	<b>08/30/2021</b>	Shape:	<b>C</b>

Street:	<b>42nd Avenue</b>	Flow Control:	<b>Not Controlled</b>
City:	<b>Hobart, IN</b>	Year Renewed:	
Location:	<b>Alley</b>	Tape/Media #:	
Purpose:	<b>Routine Assessment</b>	Dia/Height:	<b>8"</b>
Use:	<b>Sanitary Sewage Pipe</b>	Material:	<b>CP</b>
Drain Area:		Lining:	
Category:	<b>NA</b>		
Comment:			
Location Details:		Direction of Survey:	<b>Downstream</b>
US MH:	<b>M-504-106</b>	DS MH:	<b>M-504-107</b>
		Total Length Surveyed (ft):	<b>97.0</b>

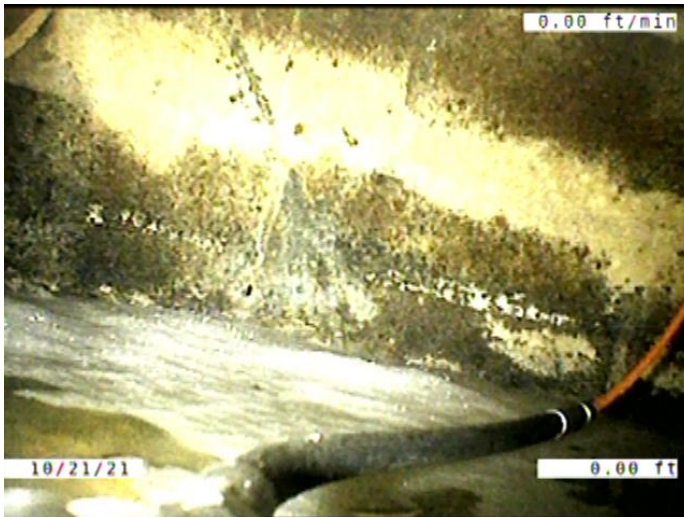
Code: **AMH**  
Description: **Manhole**

Distance (ft): **.0**  
Structural Grade: **0**  
O&M Grade: **0**  
Clock Start/From:  
Clock To:  
1st Value:  
2nd Value:  
Value Percent:  
Continuous Index:  
Within 8" of Joint: **NO**  
Remarks: **M-504-106**
