Profile/Photo Observation Report

Date:	10/22/2021	Weather:		Coding:	PACP 7.0
Pipe Length (ft):	241.0	Owner:	City of Hobart	Pre Clean:	Light Cleaning
P.O.#:	YES502259	Surveyor:	S. Bucklin	PSR:	P-504-107-106
Customer:	City of Hobart	Clean Date:	08/30/2021	Shape:	C

Street:	42nd Avenue	Flow Control:	Not Controlled
City:	Hobart, IN	Year Renewed:	
Location:	Alley	Tape/Media #:	
Purpose:	Routine Assessment	Dia/Height:	8"
Use:	Sanitary Sewage Pipe	Material:	CP
Drain Area:		Lining:	
Category:	NA		
Comment:			
Location Details:		Direction of Survey:	Upstream
US MH:	M-504-106	DS MH:	M-504-107
		Total Length Surveyed (ft):	105.6

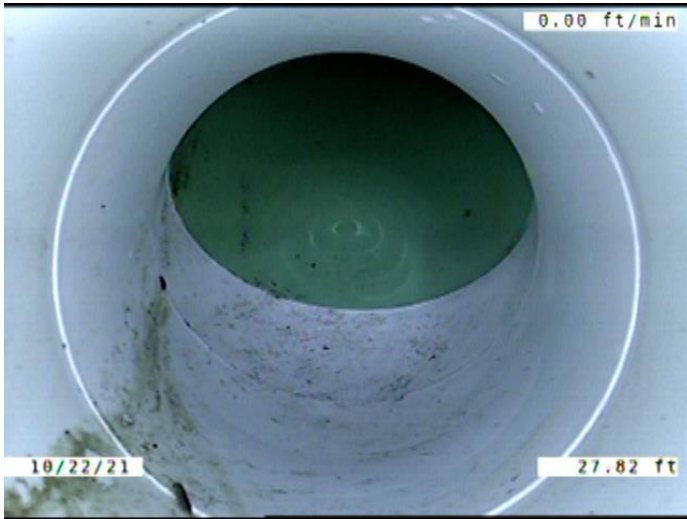
Code: **TF**
Description: **Tap Factory**

Distance (ft): **27.8**
Structural Grade: **0**
O&M Grade: **0**
Clock Start/From: **10**
Clock To:
1st Value: **4.000**
2nd Value:
Value Percent:
Continuous Index:
Within 8" of Joint: **YES**
Remarks:

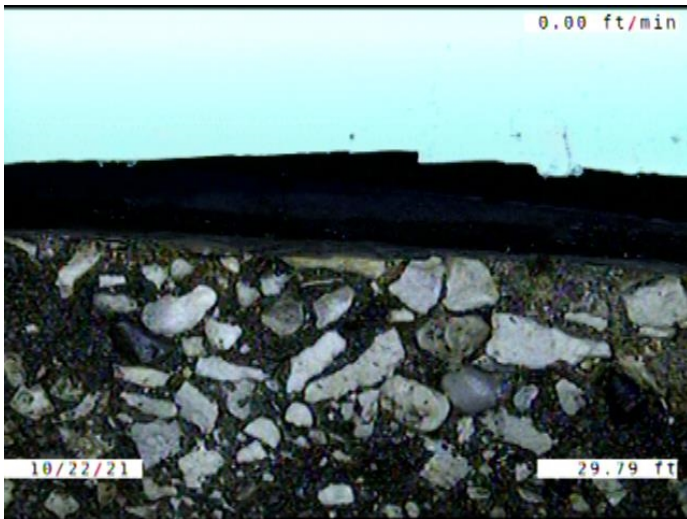
Code: **MMC**
Description: **Miscellaneous Material Change**

Distance (ft): **29.8**
Structural Grade: **0**
O&M Grade: **0**
Clock Start/From:
Clock To:
1st Value:
2nd Value:
Value Percent:
Continuous Index:
Within 8" of Joint: **NO**
Remarks: **PVC TO CONCRETE**

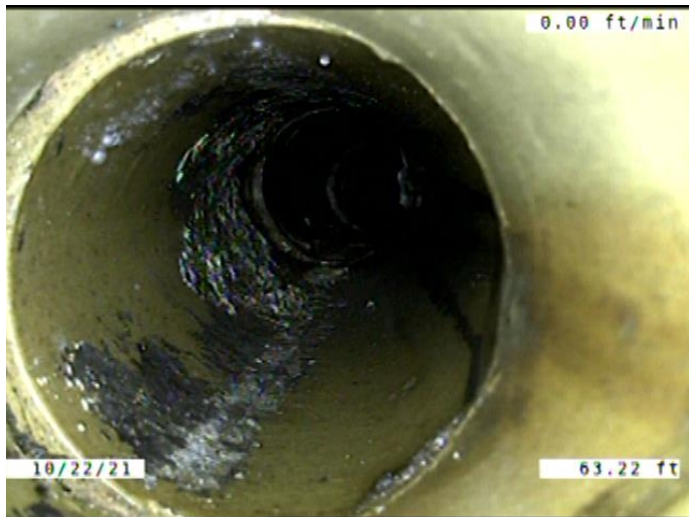
Code: **TF**
 Description: **Tap Factory**

Distance (ft): **63.2**
 Structural Grade: **0**
 O&M Grade: **0**
 Clock Start/From: **3**
 Clock To:
 1st Value: **4.000**
 2nd Value:
 Value Percent:
 Continuous Index:
 Within 8" of Joint: **YES**
 Remarks:

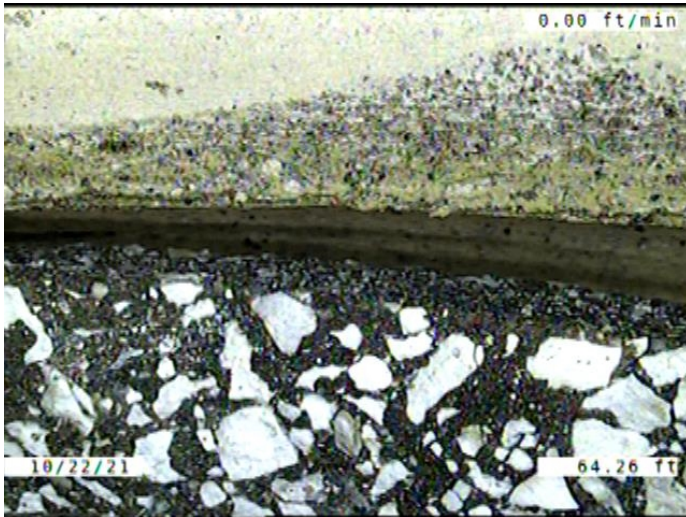
Code: **MMC**
Description: **Miscellaneous Material Change**

Distance (ft): **64.3**
Structural Grade: **0**
O&M Grade: **0**
Clock Start/From:
Clock To:
1st Value:
2nd Value:
Value Percent:
Continuous Index:
Within 8" of Joint: **NO**
Remarks: **VCP TO CONCRETE**

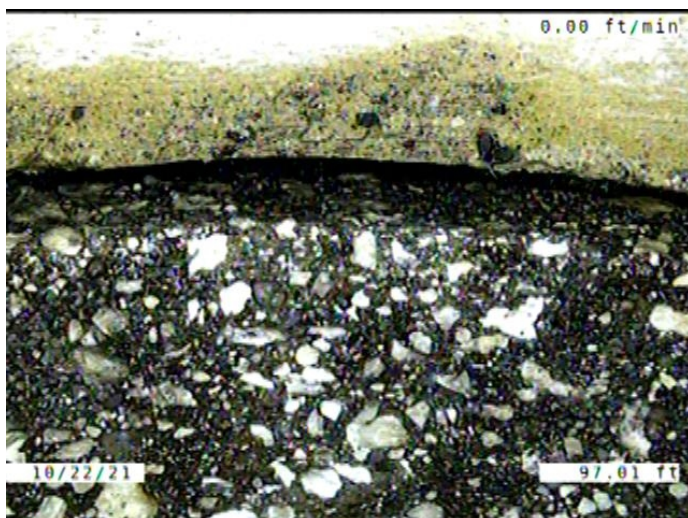
Code:	MMC
Description:	Miscellaneous Material Change
Distance (ft):	97.0
Structural Grade:	0
O&M Grade:	0
Clock Start/From:	
Clock To:	
1st Value:	
2nd Value:	
Value Percent:	
Continuous Index:	
Within 8" of Joint:	NO
Remarks:	VCP TO CONCRETE

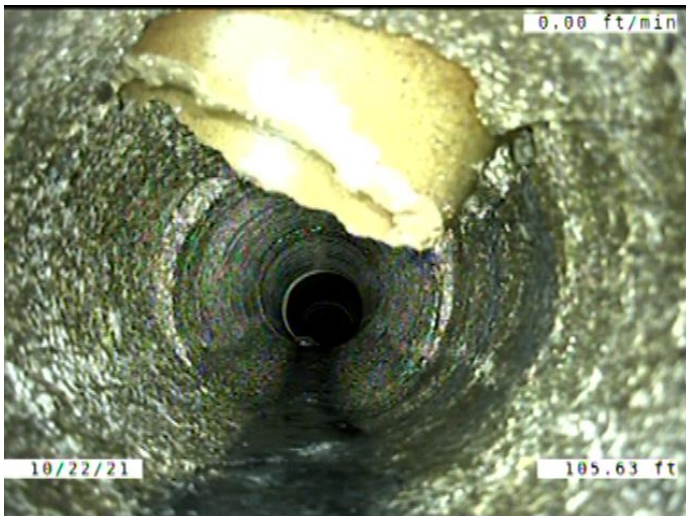
Code: **MSA**
 Description: **Miscellaneous Survey Abandoned**

Distance (ft): **105.6**
 Structural Grade: **0**
 O&M Grade: **0**
 Clock Start/From:
 Clock To:
 1st Value:
 2nd Value:
 Value Percent:
 Continuous Index:
 Within 8" of Joint: **NO**
 Remarks: **MADE IT TO THE POINT OF OVERLAP.
 REVERSAL COMPLETE**
