Profile/Photo Observation Report

Date:	10/22/2021	Weather:		Coding:	PACP 7.0
Pipe Length (ft):	241.0	Owner:	City of Hobart	Pre Clean:	Light Cleaning
P.O.#:	YES502259	Surveyor:	S. Bucklin	PSR:	P-504-107-106
Customer:	City of Hobart	Clean Date:	08/30/2021	Shape:	C

Street:	42nd Avenue	Flow Control:	Not Controlled
City:	Hobart, IN	Year Renewed:	
Location:	Alley	Tape/Media #:	
Purpose:	Routine Assessment	Dia/Height:	8"
Use:	Sanitary Sewage Pipe	Material:	CP
Drain Area:		Lining:	
Category:	NA		
Comment:			
Location Details:		Direction of Survey:	Upstream
US MH:	M-504-106	DS MH:	M-504-107
		Total Length Surveyed (ft):	105.6

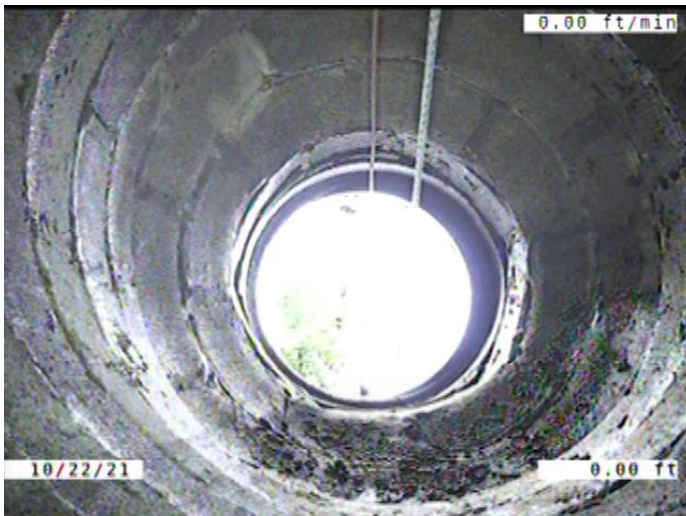
Code: **AMH**
Description: **Manhole**

Distance (ft): **.0**
Structural Grade: **0**
O&M Grade: **0**
Clock Start/From:
Clock To:
1st Value:
2nd Value:
Value Percent:
Continuous Index:
Within 8" of Joint: **NO**
Remarks: **M-504-107**

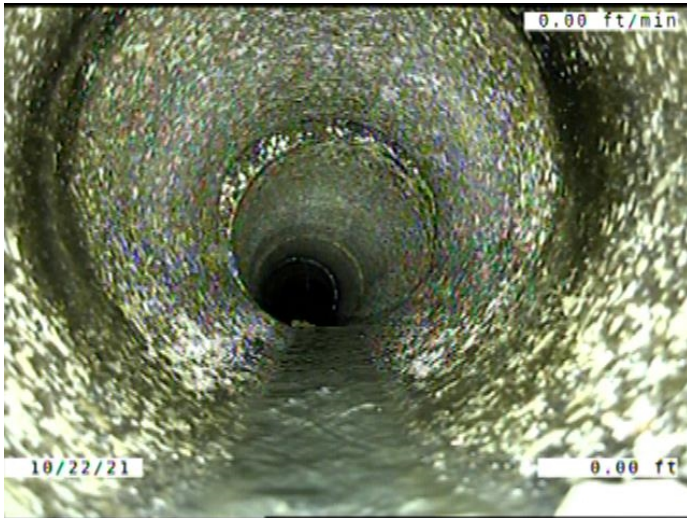
Code:	MWL
Description:	Miscellaneous Water Level
Distance (ft):	.0
Structural Grade:	0
O&M Grade:	0
Clock Start/From:	
Clock To:	
1st Value:	
2nd Value:	
Value Percent:	5.000
Continuous Index:	
Within 8" of Joint:	NO
Remarks:

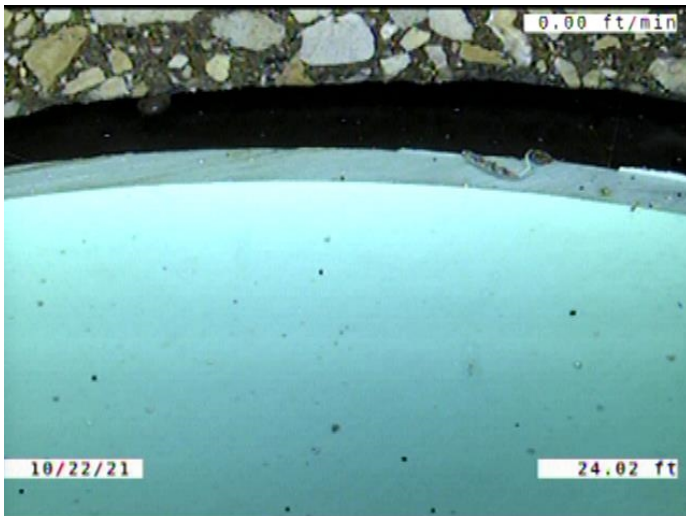
Code: **MMC**
 Description: **Miscellaneous Material Change**

Distance (ft): **24.0**
 Structural Grade: **0**
 O&M Grade: **0**
 Clock Start/From:
 Clock To:
 1st Value:
 2nd Value:
 Value Percent:
 Continuous Index:
 Within 8" of Joint: **NO**
 Remarks: **CONCRETE TO PVC.**

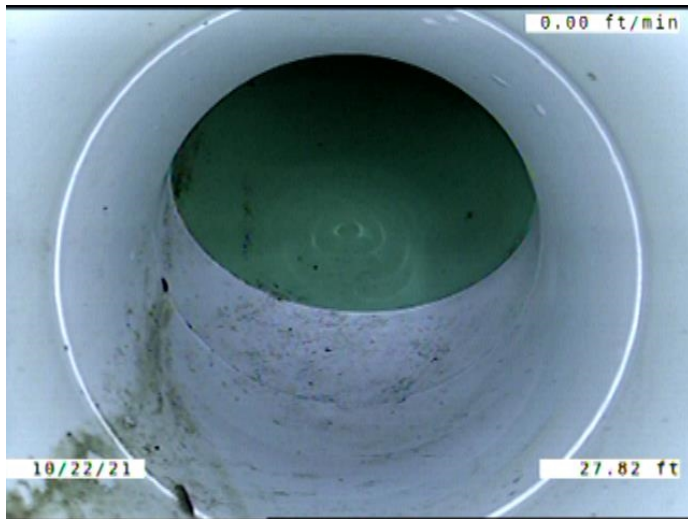
Code: **TF**
 Description: **Tap Factory**

Distance (ft): **27.8**
 Structural Grade: **0**
 O&M Grade: **0**
 Clock Start/From: **10**
 Clock To:
 1st Value: **4.000**
 2nd Value:
 Value Percent:
 Continuous Index:
 Within 8" of Joint: **YES**
 Remarks:

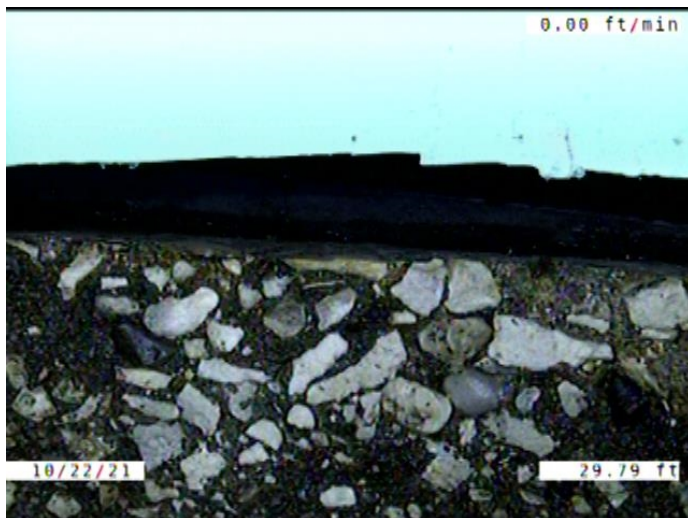
Code: **MMC**
 Description: **Miscellaneous Material Change**

Distance (ft): **29.8**
 Structural Grade: **0**
 O&M Grade: **0**
 Clock Start/From:
 Clock To:
 1st Value:
 2nd Value:
 Value Percent:
 Continuous Index:
 Within 8" of Joint: **NO**
 Remarks: **PVC TO CONCRETE**

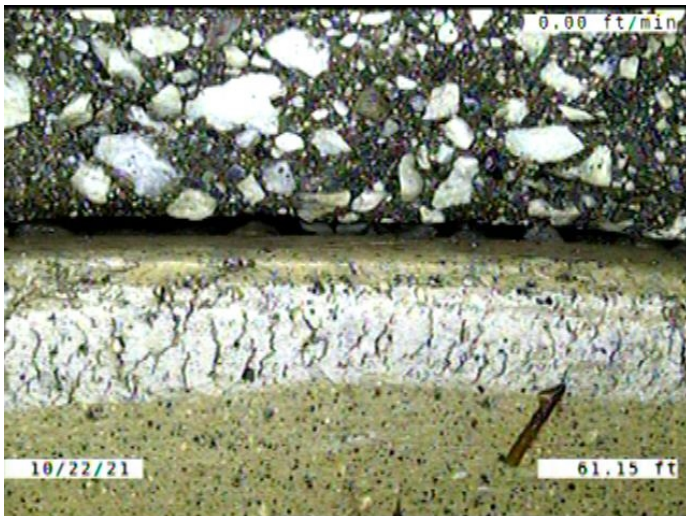
Code: **MMC**
Description: **Miscellaneous Material Change**

Distance (ft): **61.1**
Structural Grade: **0**
O&M Grade: **0**
Clock Start/From:
Clock To:
1st Value:
2nd Value:
Value Percent:
Continuous Index:
Within 8" of Joint: **NO**
Remarks: **CONCRETE TO VCP**

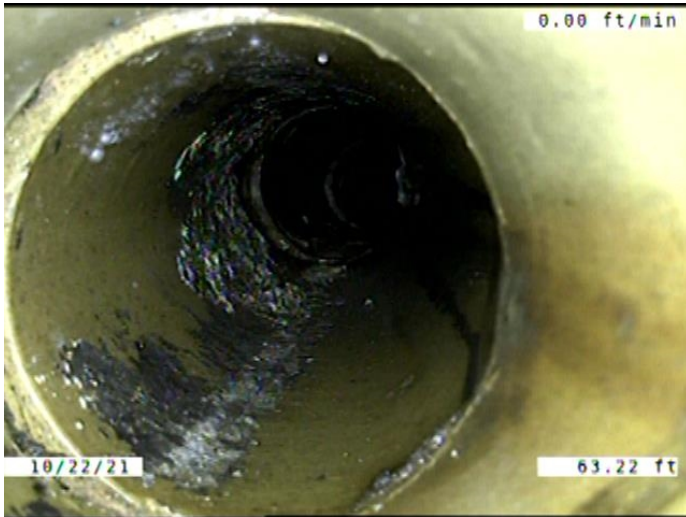
Code: **TF**
 Description: **Tap Factory**

Distance (ft): **63.2**
 Structural Grade: **0**
 O&M Grade: **0**
 Clock Start/From: **3**
 Clock To:
 1st Value: **4.000**
 2nd Value:
 Value Percent:
 Continuous Index:
 Within 8" of Joint: **YES**
 Remarks:

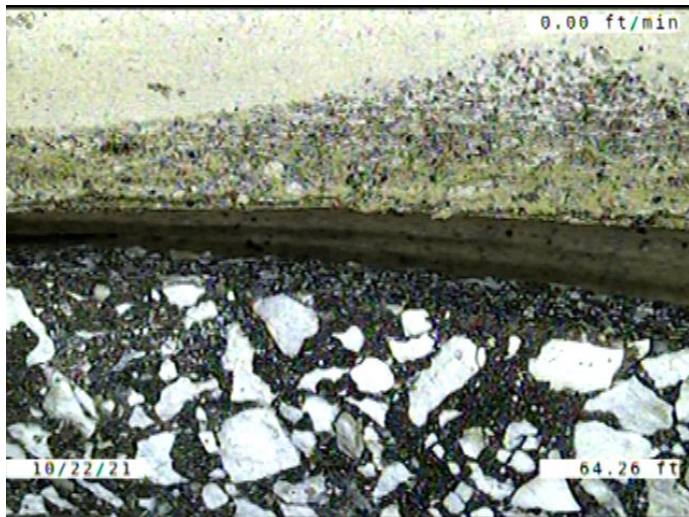
Code: **MMC**
 Description: **Miscellaneous Material Change**

Distance (ft): **64.3**
 Structural Grade: **0**
 O&M Grade: **0**
 Clock Start/From:
 Clock To:
 1st Value:
 2nd Value:
 Value Percent:
 Continuous Index:
 Within 8" of Joint: **NO**
 Remarks: **VCP TO CONCRETE**

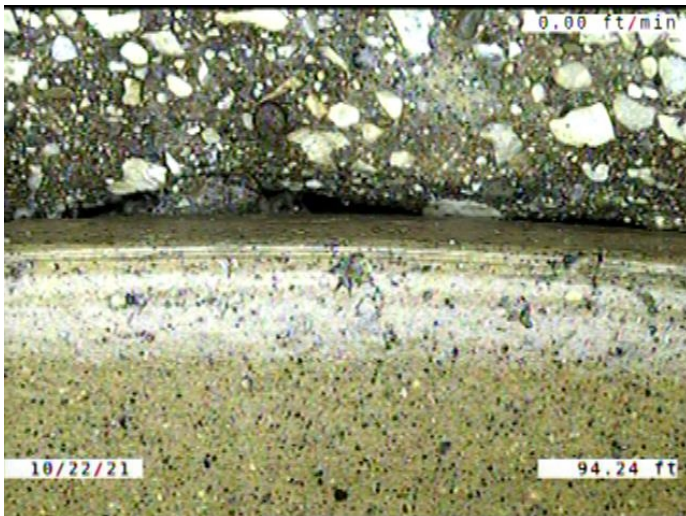
Code: **MMC**
Description: **Miscellaneous Material Change**

Distance (ft): **94.2**
Structural Grade: **0**
O&M Grade: **0**
Clock Start/From:
Clock To:
1st Value:
2nd Value:
Value Percent:
Continuous Index:
Within 8" of Joint: **NO**
Remarks: **CONCRETE TO VCP**

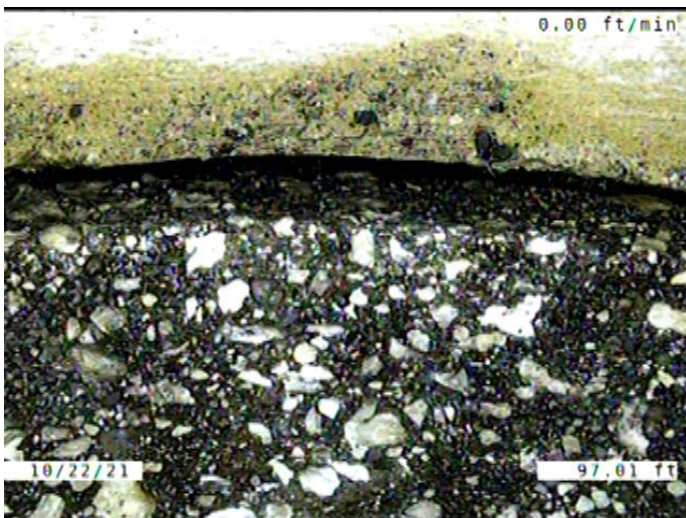
Code:	MMC
Description:	Miscellaneous Material Change
Distance (ft):	97.0
Structural Grade:	0
O&M Grade:	0
Clock Start/From:	
Clock To:	
1st Value:	
2nd Value:	
Value Percent:	
Continuous Index:	
Within 8" of Joint:	NO
Remarks:	VCP TO CONCRETE

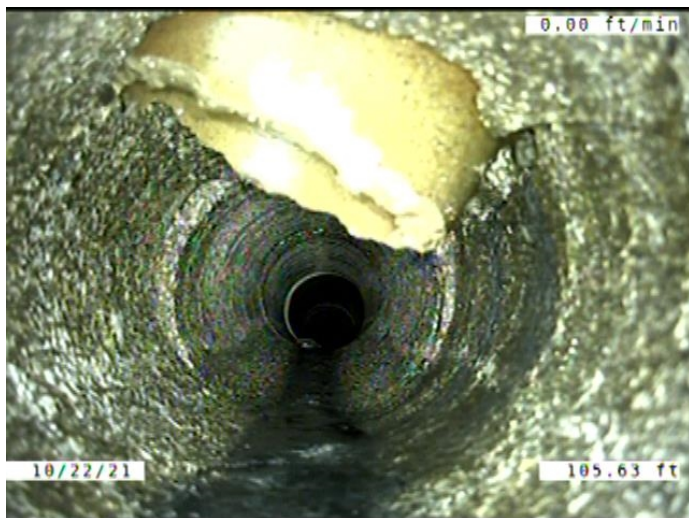
Code: **MSA**
 Description: **Miscellaneous Survey Abandoned**

Distance (ft): **105.6**
 Structural Grade: **0**
 O&M Grade: **0**
 Clock Start/From:
 Clock To:
 1st Value:
 2nd Value:
 Value Percent:
 Continuous Index:
 Within 8" of Joint: **NO**
 Remarks: **MADE IT TO THE POINT OF OVERLAP.
 REVERSAL COMPLETE**
