RedZone
ROBOTICS

Street:	North Virginia Street		Flow Control:	Not Controlled	
City:	Hobart, IN		Year Renewed:		
Location:	Alley		Tape/Media #:		
Purpose:	Routine Assessment		Dia/Height:	12"	
Use:	Sanitary Sewage Pipe		Material:	CP	
Drain Area:			Lining:		
Category:	NA				
Comment:					
Location Details:			Direction of Survey:	Upstream	
US MH:	M-504-106	DS MH:	M-504-108	Total Length Surveyed (ft):	202.7

Wednesday, October 13, 2021

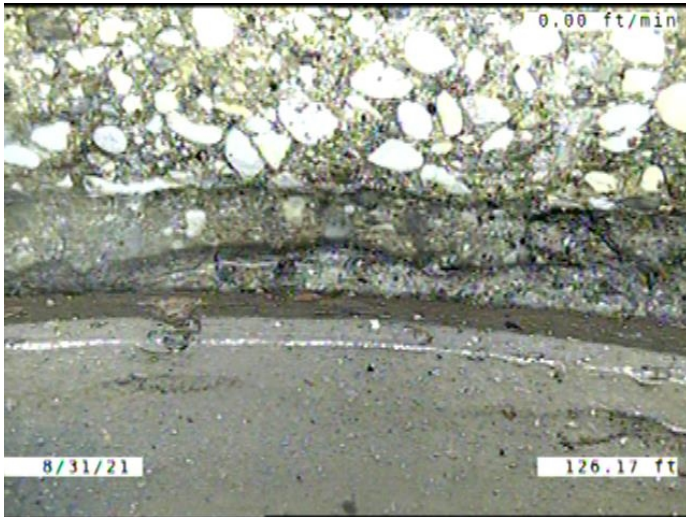
Code: **MWLS**
 Description: **Miscellaneous Water Level Sag**

Distance (ft): **123.4**
 Structural Grade: **2**
 O&M Grade: **0**
 Clock Start/From:
 Clock To:
 1st Value:
 2nd Value:
 Value Percent: **5.000**
 Continuous Index: **S04**
 Within 8" of Joint: **NO**
 Remarks:

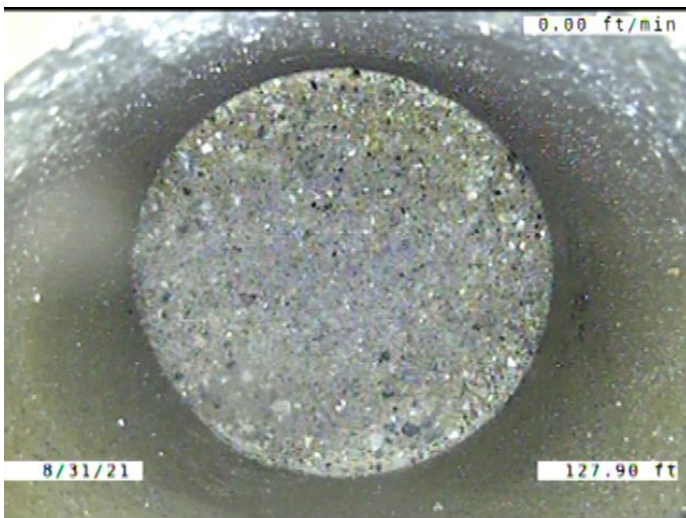
Code: **MMC**
 Description: **Miscellaneous Material Change**

Distance (ft): **126.2**
 Structural Grade: **0**
 O&M Grade: **0**
 Clock Start/From:
 Clock To:
 1st Value:
 2nd Value:
 Value Percent:
 Continuous Index:
 Within 8" of Joint: **NO**
 Remarks: **CONCRETE TO VCP**

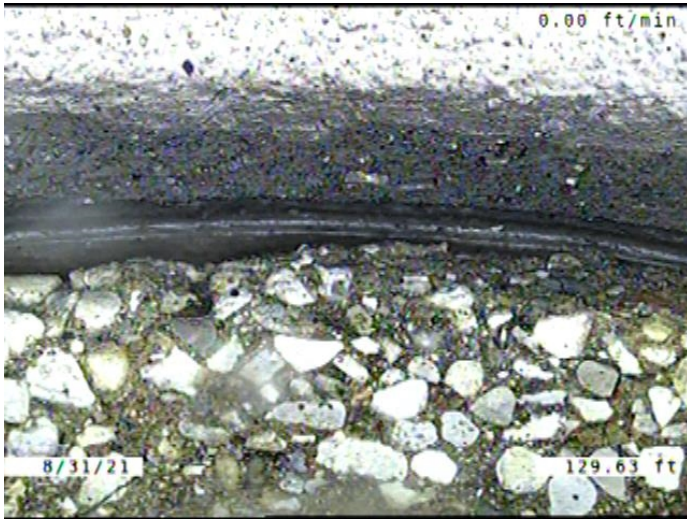
Code: **TFC**
 Description: **Tap Factory Capped**

Distance (ft): **127.9**
 Structural Grade: **0**
 O&M Grade: **0**
 Clock Start/From: **11**
 Clock To:
 1st Value: **4.000**
 2nd Value:
 Value Percent:
 Continuous Index:
 Within 8" of Joint: **YES**
 Remarks:

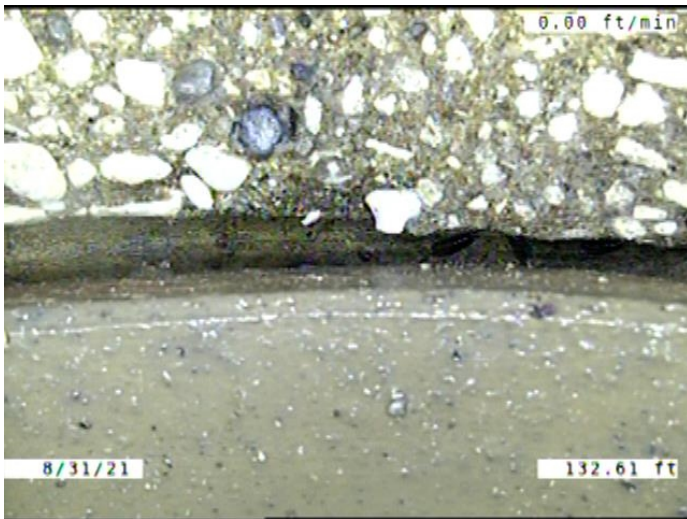
Code: **MMC**
 Description: **Miscellaneous Material Change**

Distance (ft): **129.6**
 Structural Grade: **0**
 O&M Grade: **0**
 Clock Start/From:
 Clock To:
 1st Value:
 2nd Value:
 Value Percent:
 Continuous Index:
 Within 8" of Joint: **NO**
 Remarks: **VCP TO CONCRETE**
