Profile/Photo Observation Report

Date:	04/09/2018	Weather:		Coding:	PACP 6.0
Pipe Length (ft):	394.1	Owner:	NA	Pre Clean:	Not Known
P.O.#:		Surveyor:	Byrd Fitzgerald	PSR:	P-504-110-112
Customer:		Clean Date:	01/01/1900	Shape:	C

Street:	OFF W 41ST AVE	Flow Control:	Not Controlled
City:	Hobart, IN	Year Renewed:	
Location:	Other	Tape/Media #:	
Purpose:	Not Known	Dia/Height:	10"
Use:	Sanitary	Material:	CP
Drain Area:	NA	Lining:	
Category:	NA		
Comment:

Location Details:		Direction of Survey:	Upstream
US MH:	M-504-112	DS MH:	M-504-110
		Total Length Surveyed (ft):	52.2

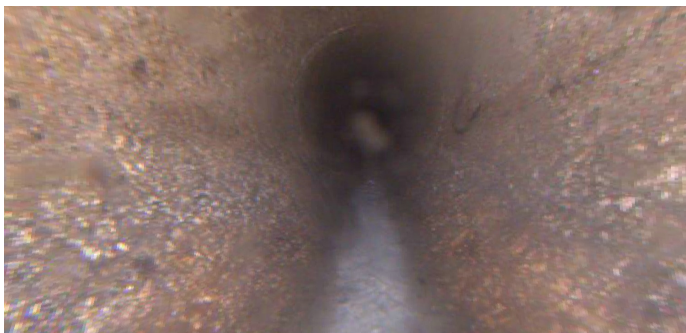
Code: **AMH**
Description: **Manhole**

Distance (ft): **.0**
Structural Grade: **0**
O&M Grade: **0**
Clock Start/From:
Clock To:
1st Value:
2nd Value:
Value Percent:
Continuous Index:
Within 8" of Joint: **NO**
Remarks: **M-504-110**

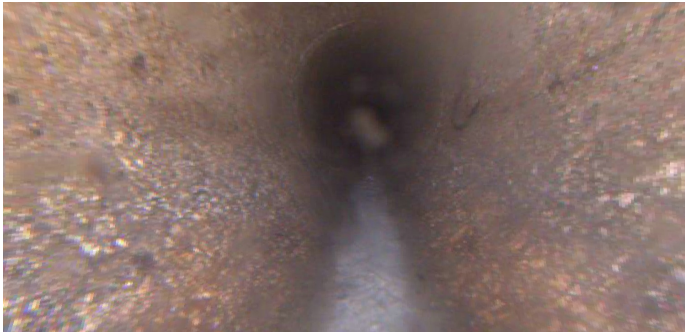
Code:	MWL
Description:	Water Level

Distance (ft):	.0
Structural Grade:	0
O&M Grade:	0
Clock Start/From:	
Clock To:	
1st Value:	
2nd Value:	
Value Percent:	5.000
Continuous Index:	
Within 8" of Joint:	NO
Remarks:

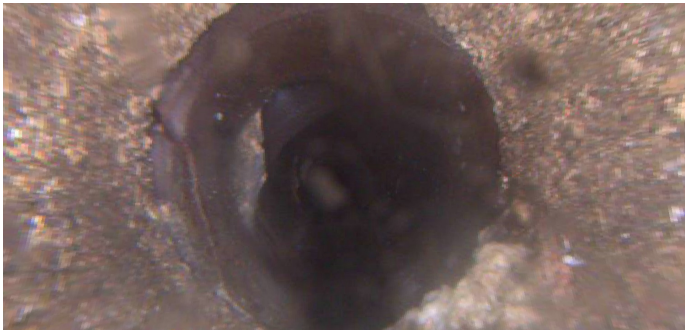
Code: **MMC**
Description: **Material Change**

Distance (ft): **35.0**
Structural Grade: **0**
O&M Grade: **0**
Clock Start/From:
Clock To:
1st Value:
2nd Value:
Value Percent:
Continuous Index:
Within 8" of Joint: **NO**
Remarks: **vcp**

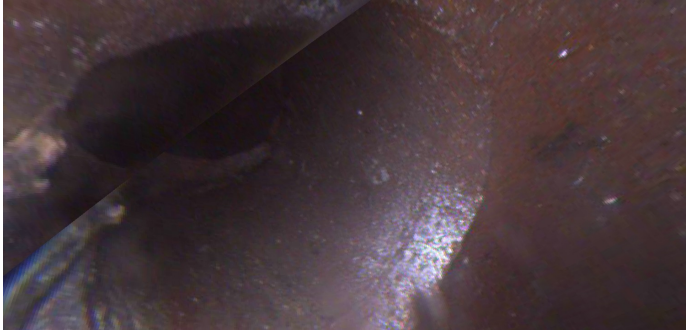
Code: **TF**
Description: **Tap Factory**

Distance (ft): **36.2**
Structural Grade: **0**
O&M Grade: **0**
Clock Start/From: **10**
Clock To:
1st Value: **4.000**
2nd Value:
Value Percent:
Continuous Index:
Within 8" of Joint: **YES**
Remarks:

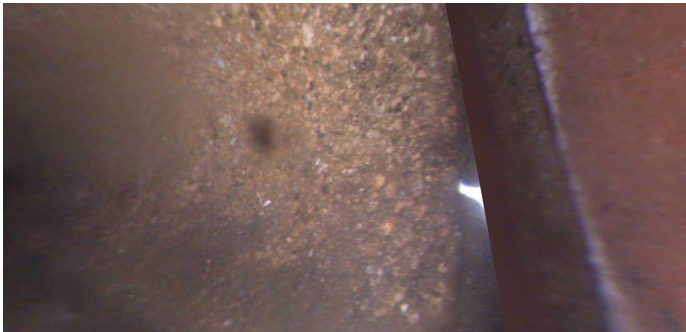
Code: **MMC**
Description: **Material Change**

Distance (ft): **38.6**
Structural Grade: **0**
O&M Grade: **0**
Clock Start/From:
Clock To:
1st Value:
2nd Value:
Value Percent:
Continuous Index:
Within 8" of Joint: **NO**
Remarks: **cp**

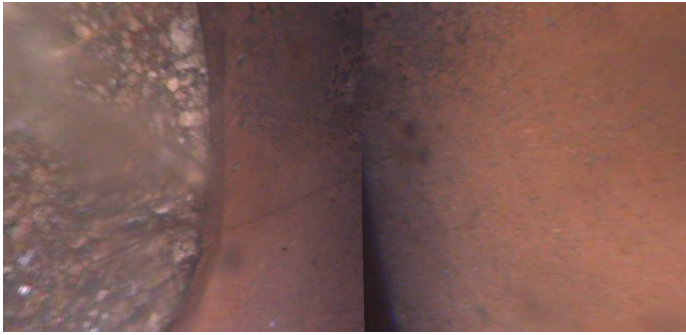
Code: **MMC**
Description: **Material Change**

Distance (ft): **41.9**
Structural Grade: **0**
O&M Grade: **0**
Clock Start/From:
Clock To:
1st Value:
2nd Value:
Value Percent:
Continuous Index:
Within 8" of Joint: **NO**
Remarks: **vcp**

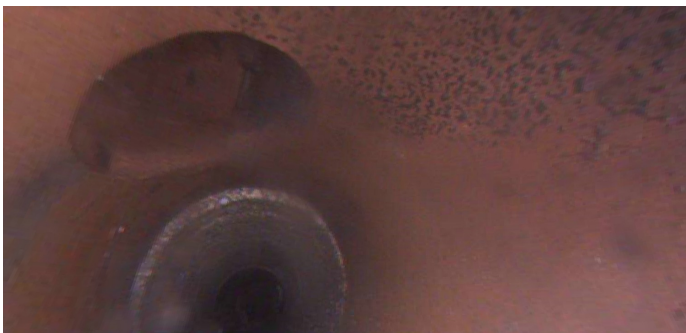
Code: **TFC**
Description: **Tap Factory Capped**

Distance (ft): **43.0**
Structural Grade: **0**
O&M Grade: **0**
Clock Start/From: **1**
Clock To:
1st Value: **4.000**
2nd Value:
Value Percent:
Continuous Index:
Within 8" of Joint: **YES**
Remarks:
