Profile/Photo Observation Report

Date:	09/07/2021	Weather:		Coding:	PACP 7.0
Pipe Length (ft):	194.7	Owner:	City of Hobart	Pre Clean:	Light Cleaning
P.O.#:	YES502259	Surveyor:	S. Bucklin	PSR:	P-504-110-112
Customer:	City of Hobart	Clean Date:	08/26/2021	Shape:	C

Street:	41st Avenue	Flow Control:	Not Controlled
City:	Hobart, IN	Year Renewed:	
Location:	Alley	Tape/Media #:	
Purpose:	Routine Assessment	Dia/Height:	10"
Use:	Sanitary Sewage Pipe	Material:	CP
Drain Area:		Lining:	None
Category:	NA		
Comment:			
Location Details:		Direction of Survey:	Upstream
US MH:	M-504-112	DS MH:	M-504-110
		Total Length Surveyed (ft):	194.7

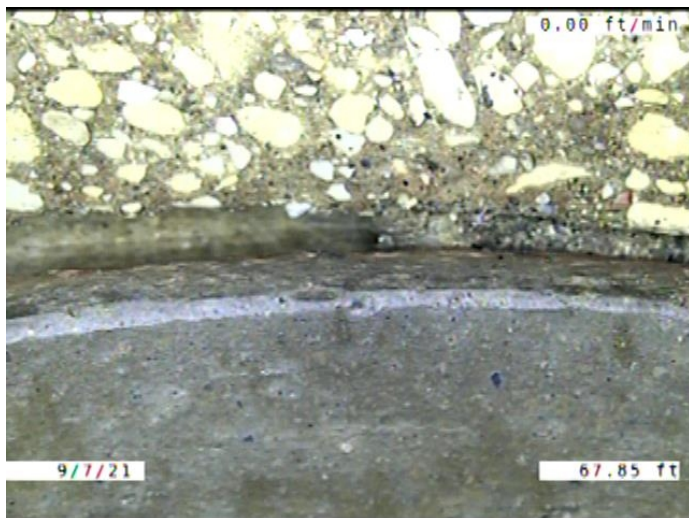
Code: **MMC**
 Description: **Miscellaneous Material Change**

Distance (ft): **67.8**
 Structural Grade: **0**
 O&M Grade: **0**
 Clock Start/From:
 Clock To:
 1st Value:
 2nd Value:
 Value Percent:
 Continuous Index:
 Within 8" of Joint: **NO**
 Remarks: **CONCRETE TO VCP**

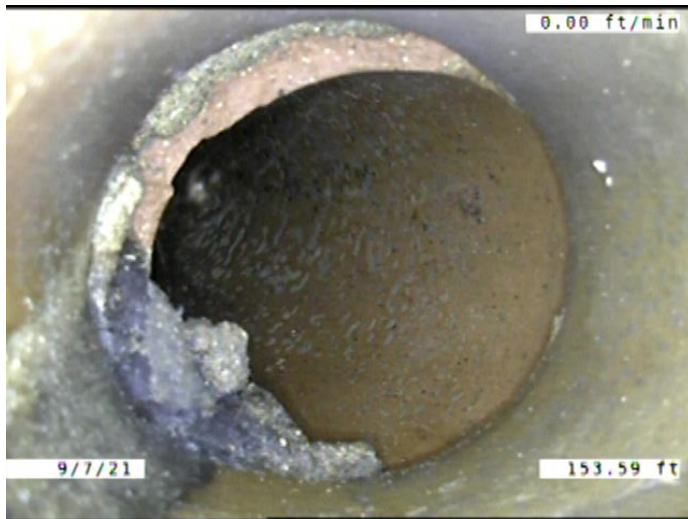
Code: **TF**
 Description: **Tap Factory**

Distance (ft): **153.6**
 Structural Grade: **0**
 O&M Grade: **0**
 Clock Start/From: **11**
 Clock To:
 1st Value: **4.000**
 2nd Value:
 Value Percent:
 Continuous Index:
 Within 8" of Joint: **YES**
 Remarks:
