# Profile/Photo Observation Report

Date:	09/07/2021	Weather:		Coding:	PACP 7.0
Pipe Length (ft):	194.7	Owner:	City of Hobart	Pre Clean:	Light Cleaning
P.O.#:	YES502259	Surveyor:	S. Bucklin	PSR:	P-504-110-112
Customer:	City of Hobart	Clean Date:	08/26/2021	Shape:	C

Street:	41st Avenue	Flow Control:	Not Controlled
City:	Hobart, IN	Year Renewed:	
Location:	Alley	Tape/Media #:	
Purpose:	Routine Assessment	Dia/Height:	10"
Use:	Sanitary Sewage Pipe	Material:	CP
Drain Area:		Lining:	None
Category:	NA		
Comment:			
Location Details:		Direction of Survey:	Upstream
US MH:	M-504-112	DS MH:	M-504-110
		Total Length Surveyed (ft):	194.7

O&M Index:	1.87	O&M Quick:	312I	O&M Rating:	116.00
Structural Index:	3.58	Structural Quick:	514A	Structural Rating:	68.00
Overall Index:	2.27	Overall Quick:	514A	Overall Rating:	184.00

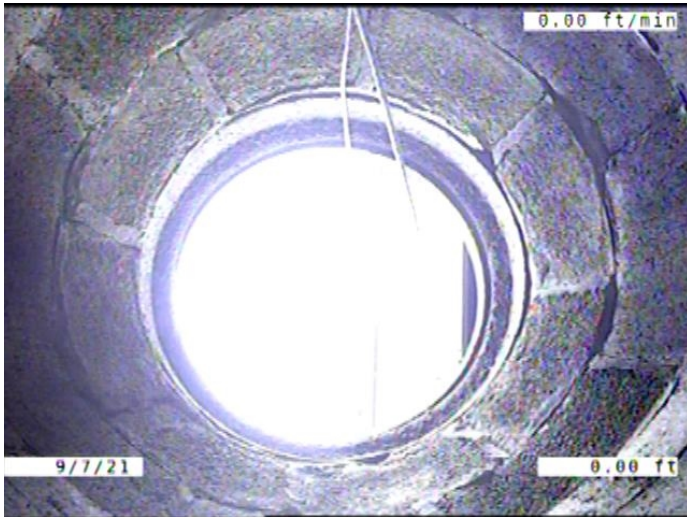
Code: **AMH**  
Description: **Manhole**

Distance (ft): **.0**  
Structural Grade: **0**  
O&M Grade: **0**  
Clock Start/From:  
Clock To:  
1st Value:  
2nd Value:  
Value Percent:  
Continuous Index:  
Within 8" of Joint: **NO**  
Remarks: **M-504-110**

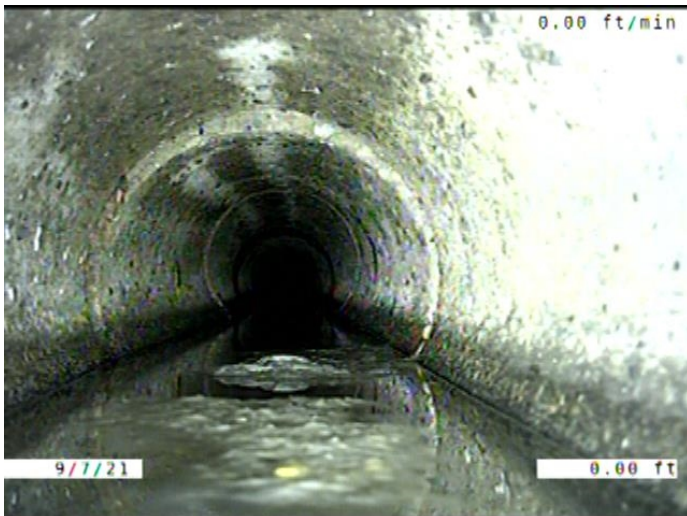
Code: **MWL**  
Description: **Miscellaneous Water Level**

Distance (ft): **.0**  
Structural Grade: **0**  
O&M Grade: **0**  
Clock Start/From:  
Clock To:  
1st Value:  
2nd Value:  
Value Percent: **10.000**  
Continuous Index:  
Within 8" of Joint: **NO**  
Remarks:

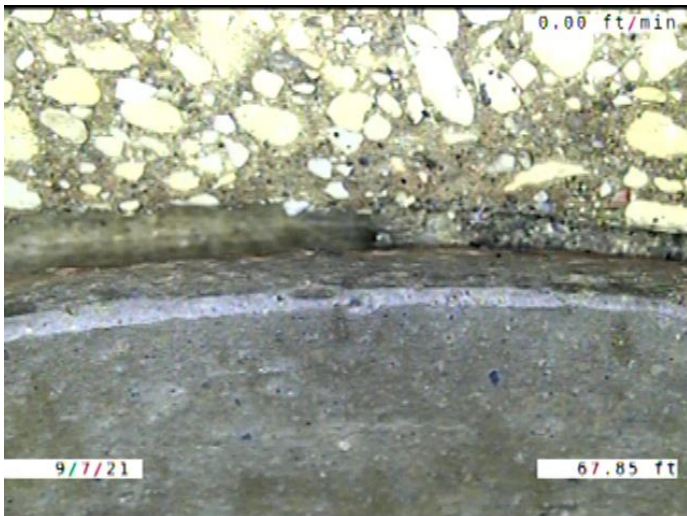
Code: **MMC**  
 Description: **Miscellaneous Material Change**

Distance (ft): **67.8**  
 Structural Grade: **0**  
 O&M Grade: **0**  
 Clock Start/From:  
 Clock To:  
 1st Value:  
 2nd Value:  
 Value Percent:  
 Continuous Index:  
 Within 8" of Joint: **NO**  
 Remarks: **CONCRETE TO VCP**

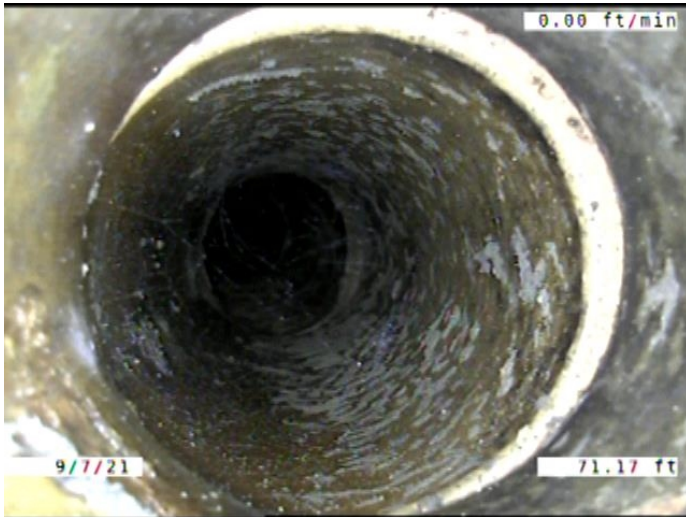
Code: **TF**  
 Description: **Tap Factory**

Distance (ft): **71.2**  
 Structural Grade: **0**  
 O&M Grade: **0**  
 Clock Start/From: **10**  
 Clock To:  
 1st Value: **4.000**  
 2nd Value:  
 Value Percent:  
 Continuous Index:  
 Within 8" of Joint: **YES**  
 Remarks:

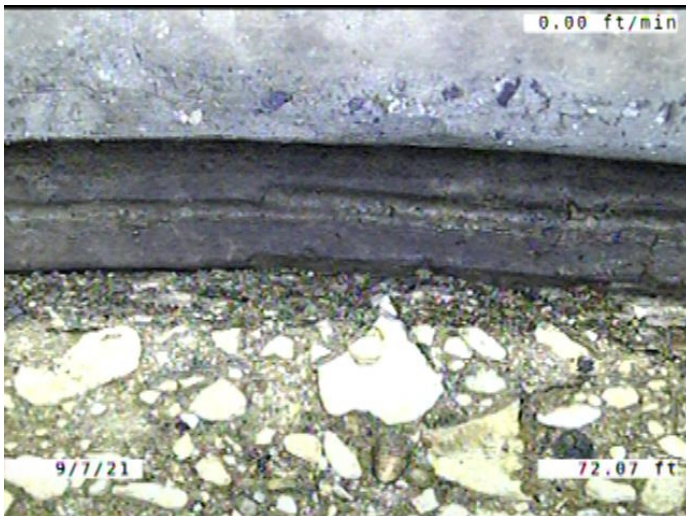
Code: **MMC**  
 Description: **Miscellaneous Material Change**

Distance (ft): **72.1**  
 Structural Grade: **0**  
 O&M Grade: **0**  
 Clock Start/From:  
 Clock To:  
 1st Value:  
 2nd Value:  
 Value Percent:  
 Continuous Index:  
 Within 8" of Joint: **NO**  
 Remarks: **VCP TO CONCRETE**

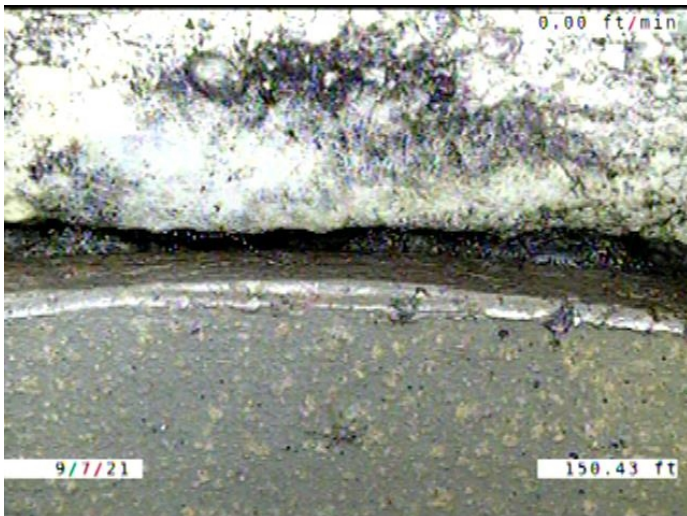
Code: **MMC**  
 Description: **Miscellaneous Material Change**

Distance (ft): **150.4**  
 Structural Grade: **0**  
 O&M Grade: **0**  
 Clock Start/From:  
 Clock To:  
 1st Value:  
 2nd Value:  
 Value Percent:  
 Continuous Index:  
 Within 8" of Joint: **NO**  
 Remarks: **CONCRETE TO VCP**

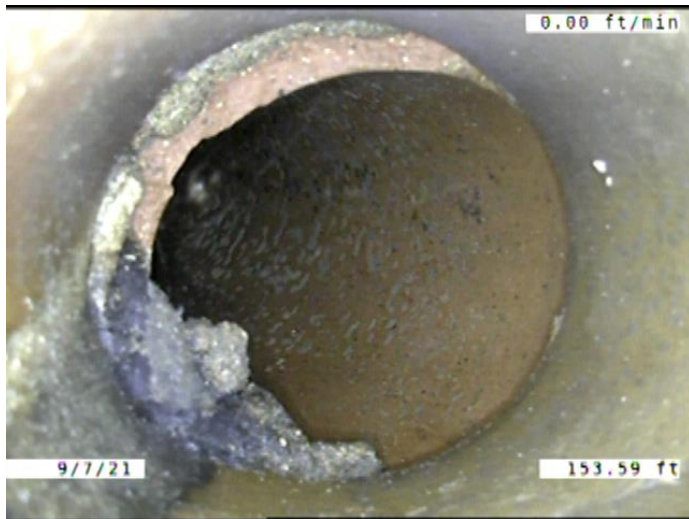
Code: **TF**  
Description: **Tap Factory**

Distance (ft): **153.6**  
Structural Grade: **0**  
O&M Grade: **0**  
Clock Start/From: **11**  
Clock To:  
1st Value: **4.000**  
2nd Value:  
Value Percent:  
Continuous Index:  
Within 8" of Joint: **YES**  
Remarks:

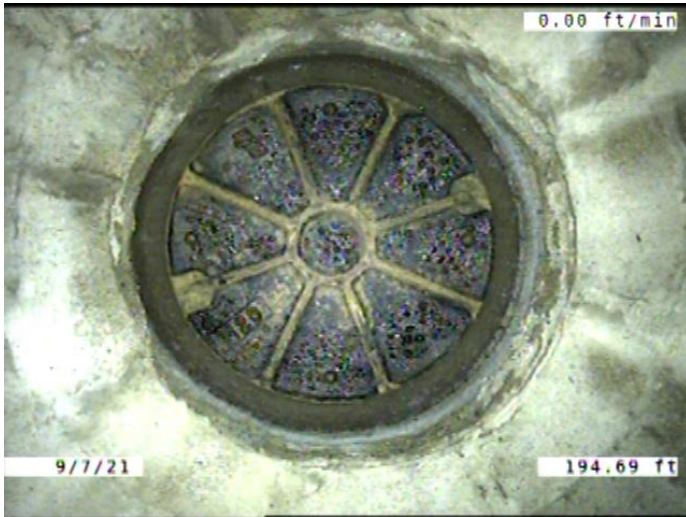
Code:	<b>AMH</b>
Description:	<b>Manhole</b>
Distance (ft):	<b>194.7</b>
Structural Grade:	<b>0</b>
O&M Grade:	<b>0</b>
Clock Start/From:	
Clock To:	
1st Value:	
2nd Value:	
Value Percent:	
Continuous Index:	
Within 8" of Joint:	<b>NO</b>
Remarks:	<b>M-504-112</b>
