Profile/Photo Observation Report

Date:	09/06/2021	Weather:		Coding:	PACP 7.0
Pipe Length (ft):	158.8	Owner:	City of Hobart	Pre Clean:	Heavy Cleaning
P.O.#:	YES502259	Surveyor:	S. Bucklin	PSR:	P-504-112-111
Customer:	City of Hobart	Clean Date:	08/26/2021	Shape:	C

Street:	North Colorado Street	Flow Control:	Not Controlled
City:	Hobart, IN	Year Renewed:	
Location:	Alley	Tape/Media #:	
Purpose:	Routine Assessment	Dia/Height:	12"
Use:	Sanitary Sewage Pipe	Material:	VCP
Drain Area:		Lining:	None
Category:	NA		
Comment:

Location Details:		Direction of Survey:	Downstream
US MH:	M-504-112	DS MH:	M-504-111.1
		Total Length Surveyed (ft):	158.8

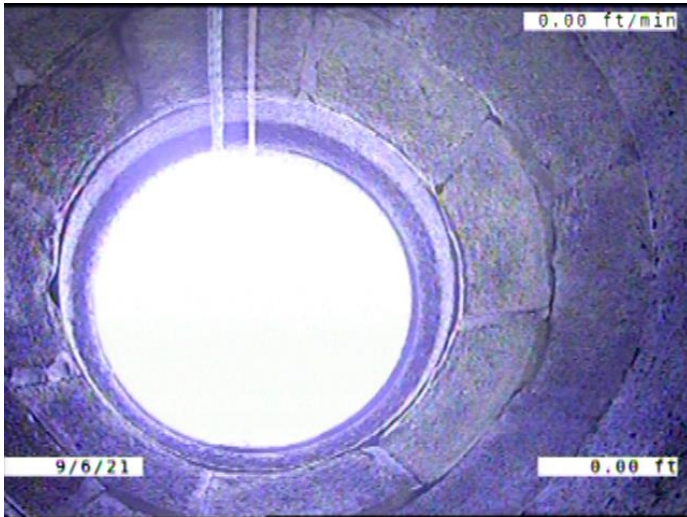
Code: **AMH**
 Description: **Manhole**

Distance (ft): **.0**
 Structural Grade: **0**
 O&M Grade: **0**
 Clock Start/From:
 Clock To:
 1st Value:
 2nd Value:
 Value Percent:
 Continuous Index:
 Within 8" of Joint: **NO**
 Remarks: **M-504-112**

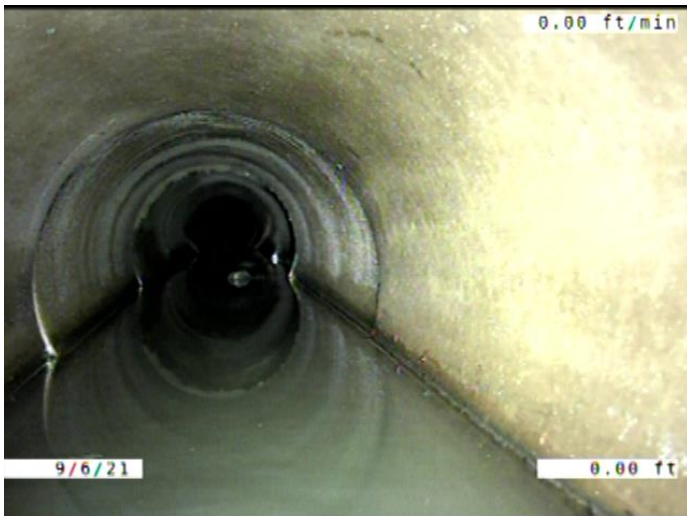
Code: **MWL**
 Description: **Miscellaneous Water Level**

Distance (ft): **.0**
 Structural Grade: **0**
 O&M Grade: **0**
 Clock Start/From:
 Clock To:
 1st Value:
 2nd Value:
 Value Percent: **10.000**
 Continuous Index:
 Within 8" of Joint: **NO**
 Remarks:

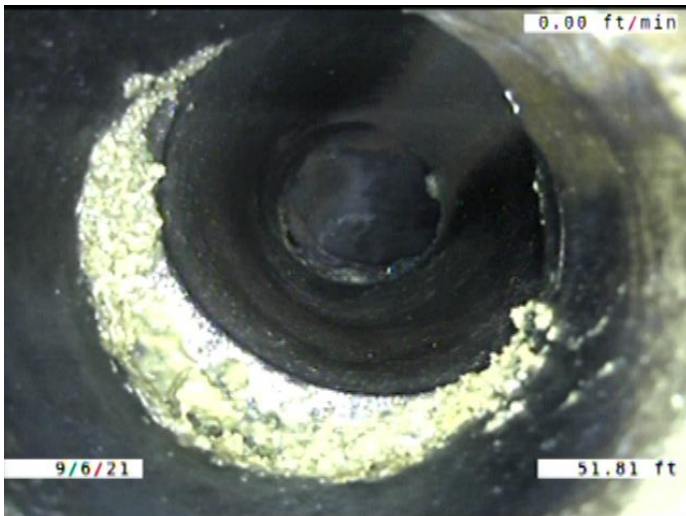
Code: **TFA**
 Description: **Tap Factory Activity**

Distance (ft): **51.8**
 Structural Grade: **0**
 O&M Grade: **0**
 Clock Start/From: **1**
 Clock To:
 1st Value: **4.000**
 2nd Value:
 Value Percent:
 Continuous Index:
 Within 8" of Joint: **YES**
 Remarks:

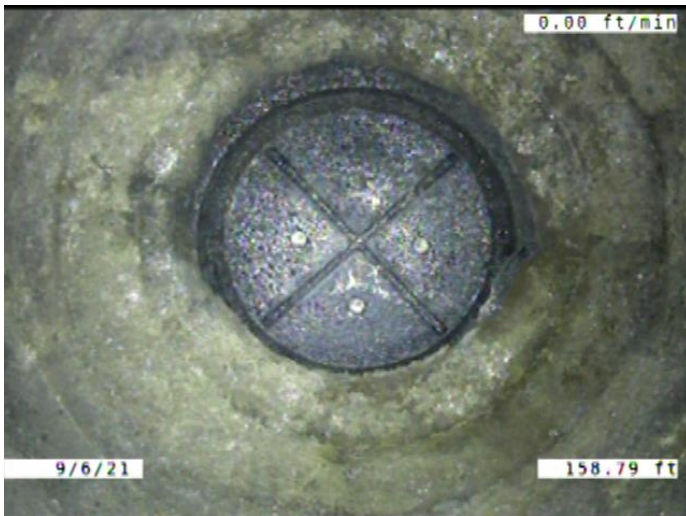
Code: **AMH**
 Description: **Manhole**

Distance (ft): **158.8**
 Structural Grade: **0**
 O&M Grade: **0**
 Clock Start/From:
 Clock To:
 1st Value:
 2nd Value:
 Value Percent:
 Continuous Index:
 Within 8" of Joint: **NO**
 Remarks: **M-504-111.1**
