Profile/Photo Observation Report

Date:	09/06/2021	Weather:		Coding:	PACP 7.0
Pipe Length (ft):	211.9	Owner:	City of Hobart	Pre Clean:	Heavy Cleaning
P.O.#:	YES502259	Surveyor:	S. Bucklin	PSR:	M-504-111.1_M-504-111
Customer:	City of Hobart	Clean Date:	08/26/2021	Shape:	C

Street:	North Colorado Street	Flow Control:	Not Controlled
City:	Hobart, IN	Year Renewed:	
Location:	Alley	Tape/Media #:	
Purpose:	Routine Assessment	Dia/Height:	12"
Use:	Sanitary Sewage Pipe	Material:	VCP
Drain Area:		Lining:	None
Category:	NA		
Comment:

Location Details:		Direction of Survey:	Downstream
US MH:	M-504-111.1	DS MH:	M-504-111
		Total Length Surveyed (ft):	211.9

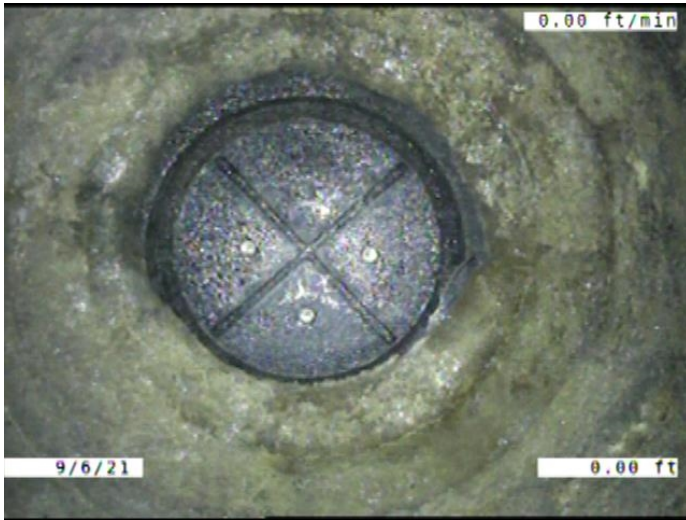
Code: **AMH**
Description: **Manhole**

Distance (ft): **.0**
Structural Grade: **0**
O&M Grade: **0**
Clock Start/From:
Clock To:
1st Value:
2nd Value:
Value Percent:
Continuous Index:
Within 8" of Joint: **NO**
Remarks: **M-504-111.1**

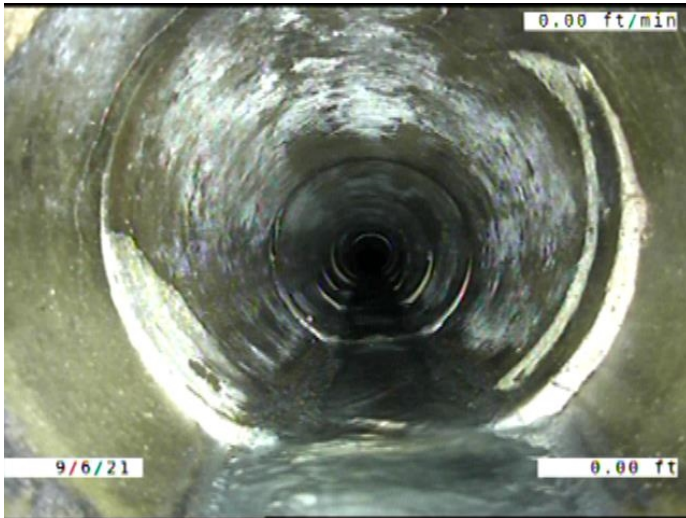
Code: **MWL**
Description: **Miscellaneous Water Level**

Distance (ft): **.0**
Structural Grade: **0**
O&M Grade: **0**
Clock Start/From:
Clock To:
1st Value:
2nd Value:
Value Percent: **5.000**
Continuous Index:
Within 8" of Joint: **NO**
Remarks:

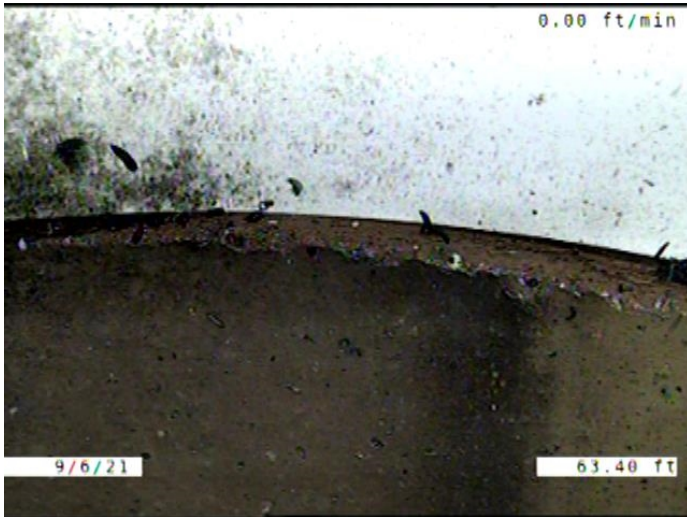
Code: **MMC**
 Description: **Miscellaneous Material Change**

Distance (ft): **63.4**
 Structural Grade: **0**
 O&M Grade: **0**
 Clock Start/From:
 Clock To:
 1st Value:
 2nd Value:
 Value Percent:
 Continuous Index:
 Within 8" of Joint: **NO**
 Remarks: **PVC TO VCP**

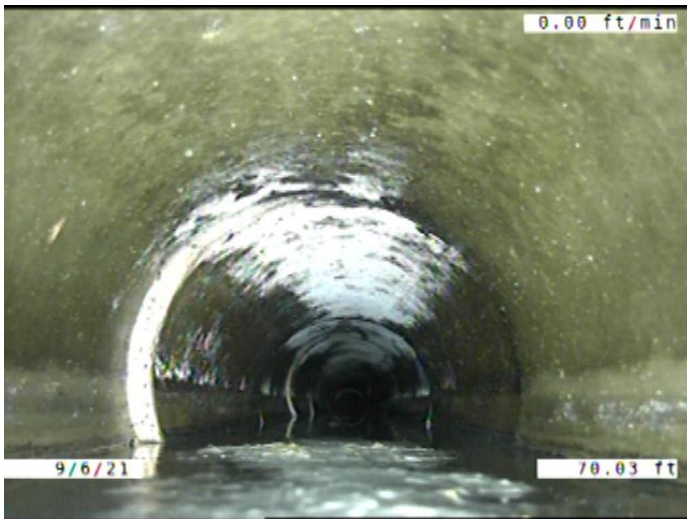
Code: **MWL**
 Description: **Miscellaneous Water Level**

Distance (ft): **70.0**
 Structural Grade: **0**
 O&M Grade: **0**
 Clock Start/From:
 Clock To:
 1st Value:
 2nd Value:
 Value Percent: **15.000**
 Continuous Index:
 Within 8" of Joint: **NO**
 Remarks:

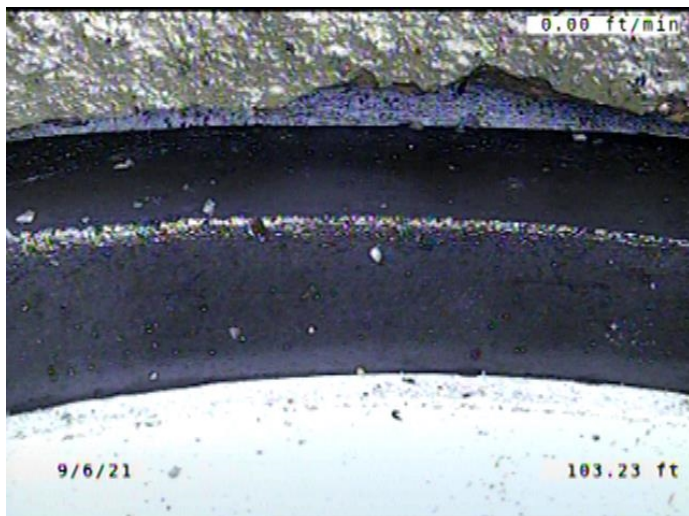
Code: **MMC**
 Description: **Miscellaneous Material Change**

Distance (ft): **103.2**
 Structural Grade: **0**
 O&M Grade: **0**
 Clock Start/From:
 Clock To:
 1st Value:
 2nd Value:
 Value Percent:
 Continuous Index:
 Within 8" of Joint: **NO**
 Remarks: **VCP TO PVC**

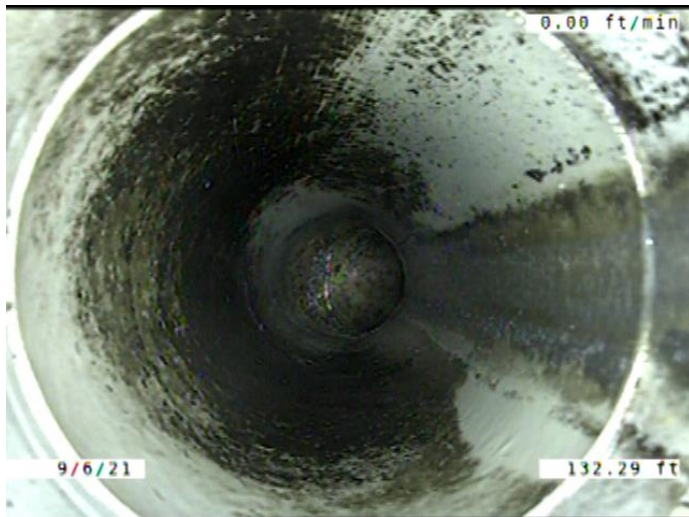
Code: **TF**
 Description: **Tap Factory**

Distance (ft): **132.3**
 Structural Grade: **0**
 O&M Grade: **0**
 Clock Start/From: **1**
 Clock To:
 1st Value: **4.000**
 2nd Value:
 Value Percent:
 Continuous Index:
 Within 8" of Joint: **YES**
 Remarks:

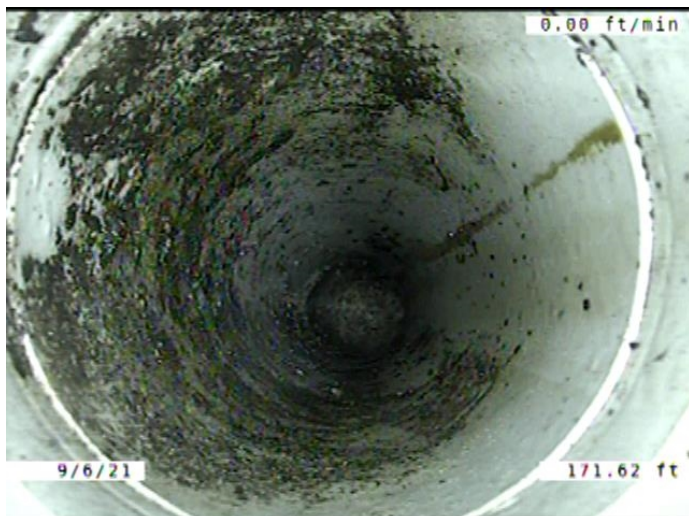
Code: **TF**
 Description: **Tap Factory**

Distance (ft): **171.6**
 Structural Grade: **0**
 O&M Grade: **0**
 Clock Start/From: **1**
 Clock To:
 1st Value: **4.000**
 2nd Value:
 Value Percent:
 Continuous Index:
 Within 8" of Joint: **YES**
 Remarks:

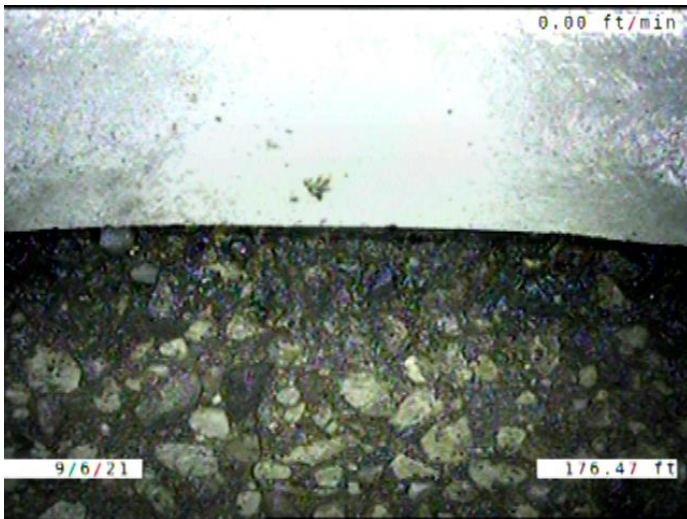
Code: **MMC**
 Description: **Miscellaneous Material Change**

Distance (ft): **176.5**
 Structural Grade: **0**
 O&M Grade: **0**
 Clock Start/From:
 Clock To:
 1st Value:
 2nd Value:
 Value Percent:
 Continuous Index:
 Within 8" of Joint: **NO**
 Remarks: **PVC TO CONCRETE**
