Profile/Photo Observation Report

Date:	09/11/2021	Weather:		Coding:	PACP 7.0
Pipe Length (ft):	260.0	Owner:	City of Hobart	Pre Clean:	Heavy Cleaning
P.O.#:	YES502259	Surveyor:	S. Bucklin	PSR:	P-504-111-104
Customer:	City of Hobart	Clean Date:	09/11/2021	Shape:	C

Street:	North Colorado Street	Flow Control:	Not Controlled
City:	Hobart, IN	Year Renewed:	
Location:	Alley	Tape/Media #:	
Purpose:	Routine Assessment	Dia/Height:	12"
Use:	Sanitary Sewage Pipe	Material:	CP
Drain Area:		Lining:	None
Category:	NA		
Comment:

Location Details:		Direction of Survey:	Downstream
US MH:	M-504-104	DS MH:	M-504-111
		Total Length Surveyed (ft):	65.9

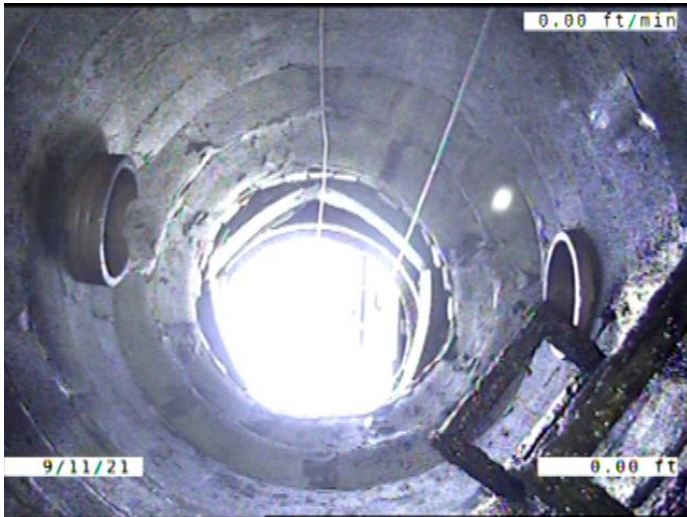
Code: **AMH**
 Description: **Manhole**

Distance (ft): **.0**
 Structural Grade: **0**
 O&M Grade: **0**
 Clock Start/From:
 Clock To:
 1st Value:
 2nd Value:
 Value Percent:
 Continuous Index:
 Within 8" of Joint: **NO**
 Remarks: **M-504-104**

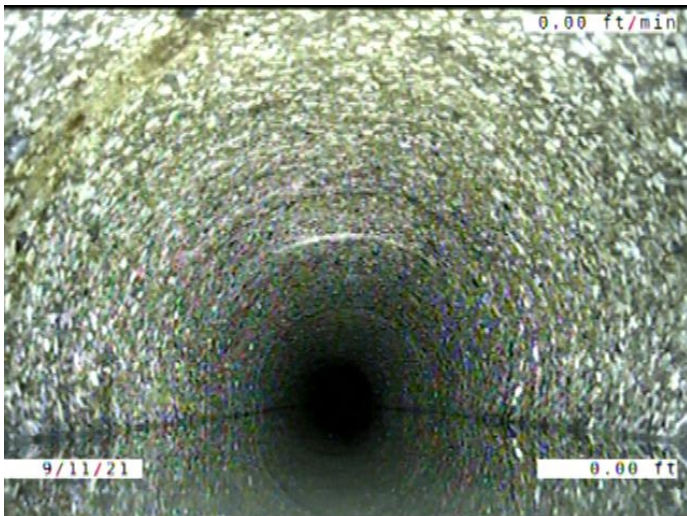
Code: **MWL**
 Description: **Miscellaneous Water Level**

Distance (ft): **.0**
 Structural Grade: **0**
 O&M Grade: **0**
 Clock Start/From:
 Clock To:
 1st Value:
 2nd Value:
 Value Percent: **15.000**
 Continuous Index:
 Within 8" of Joint: **NO**
 Remarks:
