RedZone
ROBOTICS

Street:	41st Avenue	Flow Control:	Not Controlled
City:	Hobart, IN	Year Renewed:	
Location:	Alley	Tape/Media #:	
Purpose:	Routine Assessment	Dia/Height:	10"
Use:	Sanitary Sewage Pipe	Material:	CP
Drain Area:		Lining:	None
Category:	NA		
Comment:			
Location Details:		Direction of Survey:	Upstream
US MH:	M-503-032	DS MH:	M-504-112
		Total Length Surveyed (ft):	160.2

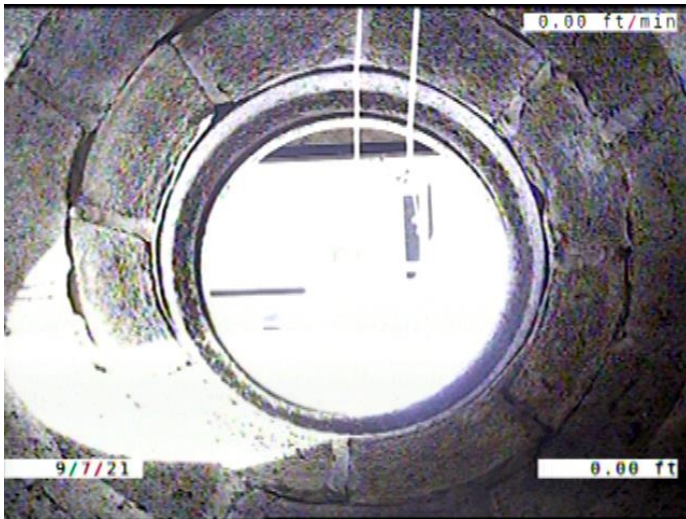
Code: **AMH**
Description: **Manhole**

Distance (ft): **.0**
Structural Grade: **0**
O&M Grade: **0**
Clock Start/From:
Clock To:
1st Value:
2nd Value:
Value Percent:
Continuous Index:
Within 8" of Joint: **NO**
Remarks: **M-504-112**

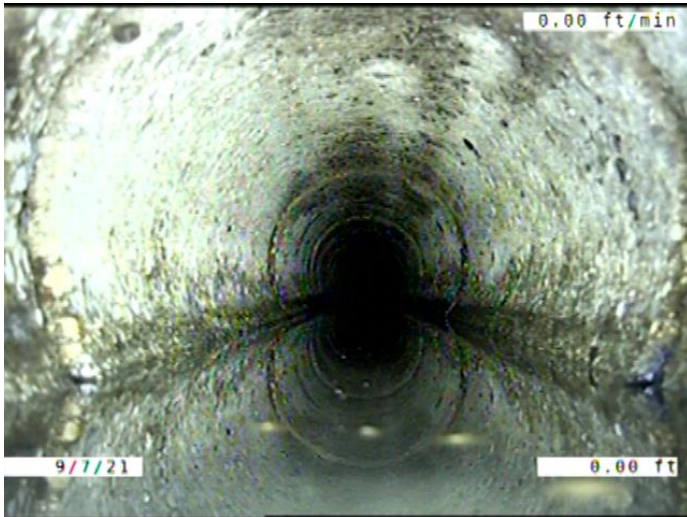
Code: **MWL**
 Description: **Miscellaneous Water Level**

Distance (ft): **.0**
 Structural Grade: **0**
 O&M Grade: **0**
 Clock Start/From:
 Clock To:
 1st Value:
 2nd Value:
 Value Percent: **10.000**
 Continuous Index:
 Within 8" of Joint: **NO**
 Remarks:

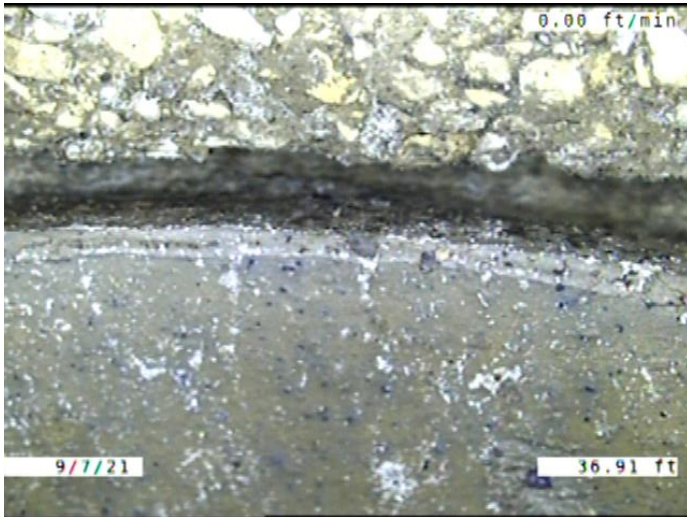
Code: **MMC**
 Description: **Miscellaneous Material Change**

Distance (ft): **36.9**
 Structural Grade: **0**
 O&M Grade: **0**
 Clock Start/From:
 Clock To:
 1st Value:
 2nd Value:
 Value Percent:
 Continuous Index:
 Within 8" of Joint: **NO**
 Remarks: **CONCRETE TO VCP**

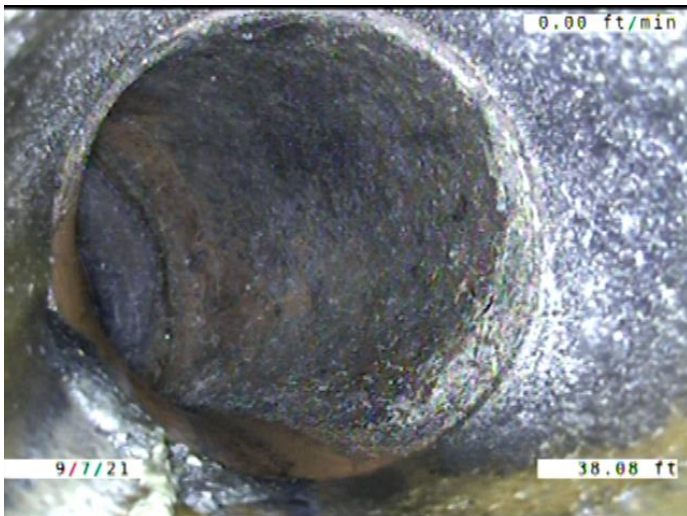
Code: **TF**
 Description: **Tap Factory**

Distance (ft): **38.1**
 Structural Grade: **0**
 O&M Grade: **0**
 Clock Start/From: **11**
 Clock To:
 1st Value: **4.000**
 2nd Value:
 Value Percent:
 Continuous Index:
 Within 8" of Joint: **YES**
 Remarks:

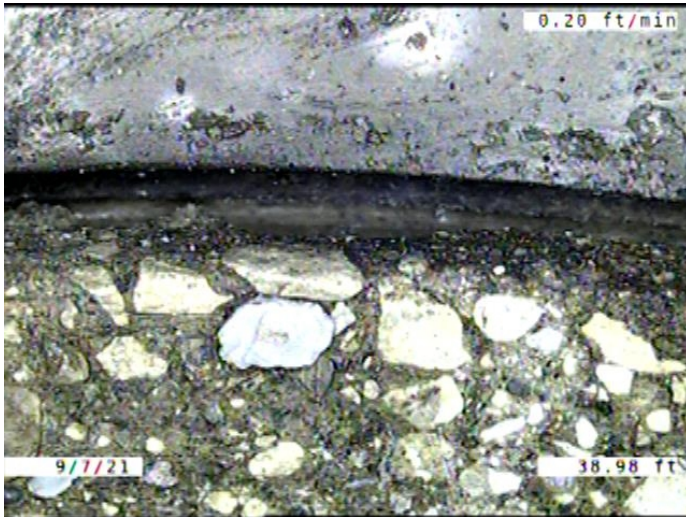
Code: **MMC**
Description: **Miscellaneous Material Change**

Distance (ft): **39.0**
Structural Grade: **0**
O&M Grade: **0**
Clock Start/From:
Clock To:
1st Value:
2nd Value:
Value Percent:
Continuous Index:
Within 8" of Joint: **NO**
Remarks: **VCP TO CONCRETE**

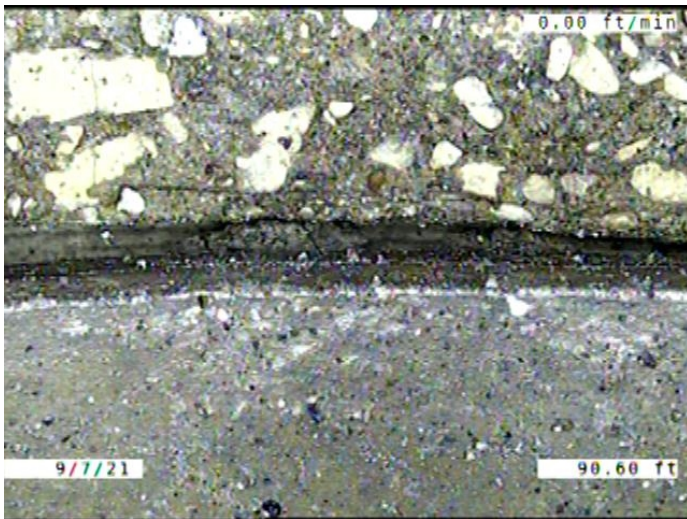
Code: **MMC**
 Description: **Miscellaneous Material Change**

Distance (ft): **90.6**
 Structural Grade: **0**
 O&M Grade: **0**
 Clock Start/From:
 Clock To:
 1st Value:
 2nd Value:
 Value Percent:
 Continuous Index:
 Within 8" of Joint: **NO**
 Remarks: **CONCRETE TO VCP**

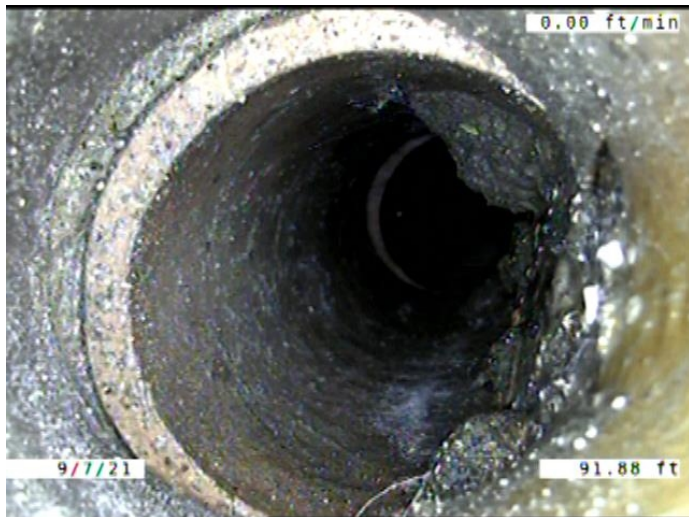
Code: **TF**
 Description: **Tap Factory**

Distance (ft): **91.9**
 Structural Grade: **0**
 O&M Grade: **0**
 Clock Start/From: **2**
 Clock To:
 1st Value: **4.000**
 2nd Value:
 Value Percent:
 Continuous Index:
 Within 8" of Joint: **YES**
 Remarks:

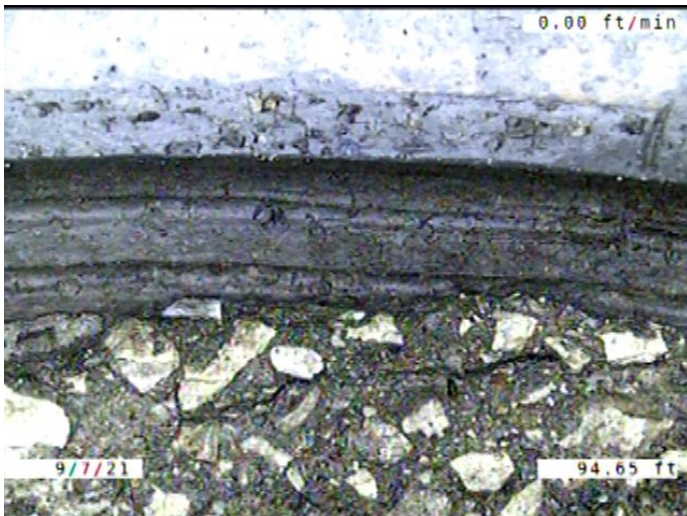
Code: **MMC**
 Description: **Miscellaneous Material Change**

Distance (ft): **94.6**
 Structural Grade: **0**
 O&M Grade: **0**
 Clock Start/From:
 Clock To:
 1st Value:
 2nd Value:
 Value Percent:
 Continuous Index:
 Within 8" of Joint: **NO**
 Remarks: **VCP TO CONCRETE**

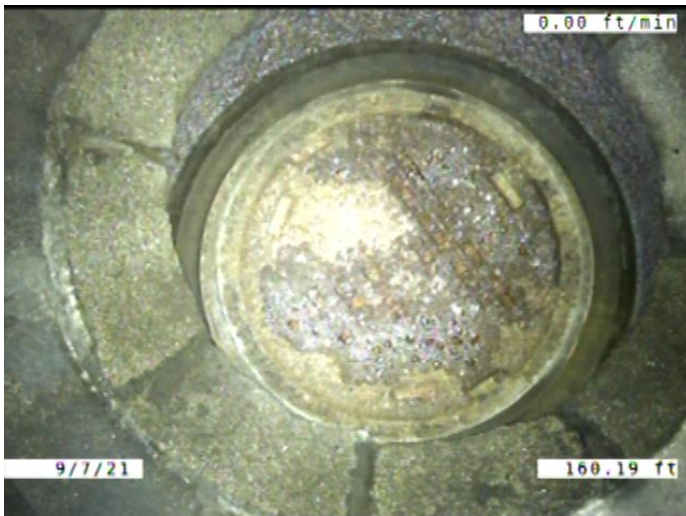
Code: **AMH**
 Description: **Manhole**

Distance (ft): **160.2**
 Structural Grade: **0**
 O&M Grade: **0**
 Clock Start/From:
 Clock To:
 1st Value:
 2nd Value:
 Value Percent:
 Continuous Index:
 Within 8" of Joint: **NO**
 Remarks: **M-503-032**
