Profile/Photo Observation Report

Street:	W 42ND AVE	Flow Control:	Not Controlled
City:	Hobart, IN	Year Renewed:	
Location:	Light Highway	Tape/Media #:	
Purpose:	Not Known	Dia/Height:	12"
Use:	Sanitary	Material:	VCP
Drain Area:	NA	Lining:	
Category:	NA		
Comment:

Location Details:		Direction of Survey:	Upstream
US MH:	M-504-117	DS MH:	M-504-118
		Total Length Surveyed (ft):	13.8

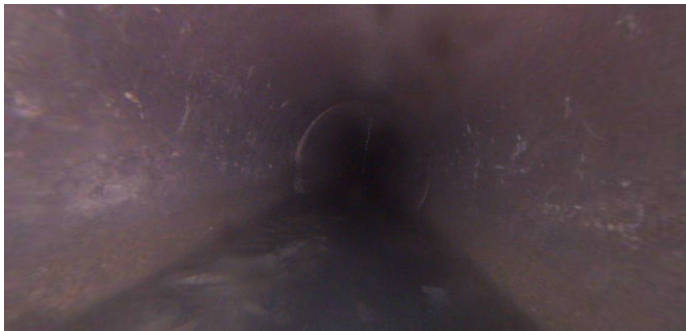
Code: **AMH**
Description: **Manhole**

Distance (ft): **.0**
Structural Grade: **0**
O&M Grade: **0**
Clock Start/From:
Clock To:
1st Value:
2nd Value:
Value Percent:
Continuous Index:
Within 8" of Joint: **NO**
Remarks: **M-504-117**
