Profile/Photo Observation Report

Date:	09/06/2021	Weather:		Coding:	PACP 7.0
Pipe Length (ft):	205.3	Owner:	City of Hobart	Pre Clean:	Heavy Cleaning
P.O.#:	YES502259	Surveyor:	S. Bucklin	PSR:	P-504-118-117
Customer:	City of Hobart	Clean Date:	09/03/2021	Shape:	C

Street:	42nd Avenue	Flow Control:	Not Controlled
City:	Hobart, IN	Year Renewed:	
Location:	Alley	Tape/Media #:	
Purpose:	Routine Assessment	Dia/Height:	12"
Use:	Sanitary Sewage Pipe	Material:	VCP
Drain Area:		Lining:	None
Category:	NA		
Comment:			
Location Details:		Direction of Survey:	Upstream
US MH:	M-504-117	DS MH:	M-504-118
		Total Length Surveyed (ft):	205.3

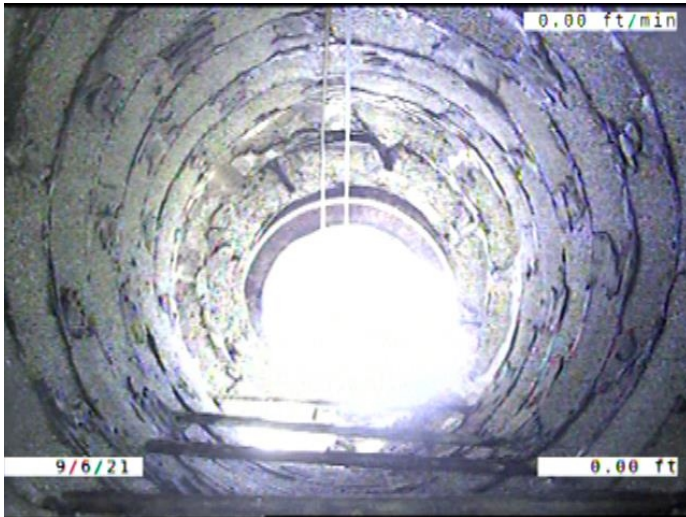
Code: **AMH**
Description: **Manhole**

Distance (ft): **.0**
Structural Grade: **0**
O&M Grade: **0**
Clock Start/From:
Clock To:
1st Value:
2nd Value:
Value Percent:
Continuous Index:
Within 8" of Joint: **NO**
Remarks: **M-504-118**

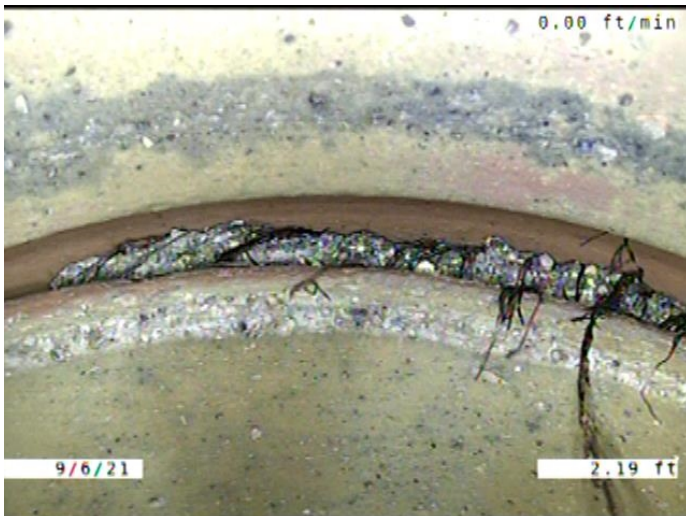
Code: **JOM**
 Description: **Joint Offset Medium**

Distance (ft): **2.2**
 Structural Grade: **3**
 O&M Grade: **0**
 Clock Start/From:
 Clock To:
 1st Value:
 2nd Value:
 Value Percent:
 Continuous Index:
 Within 8" of Joint: **NO**
 Remarks:

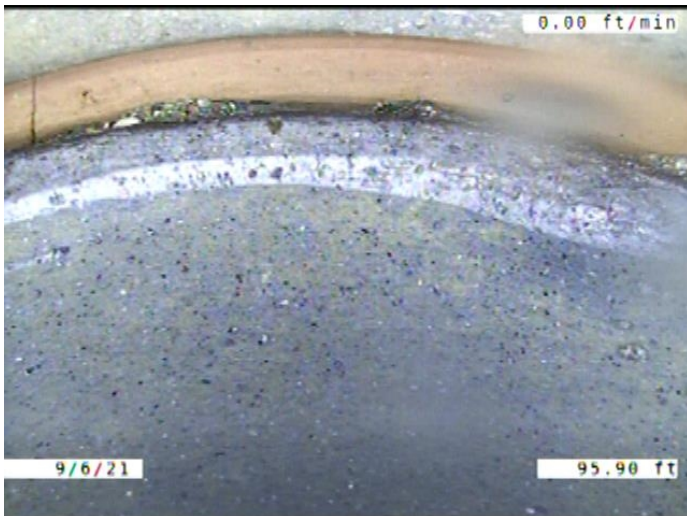
Code: **JOM**
 Description: **Joint Offset Medium**

Distance (ft): **95.9**
 Structural Grade: **3**
 O&M Grade: **0**
 Clock Start/From:
 Clock To:
 1st Value:
 2nd Value:
 Value Percent:
 Continuous Index:
 Within 8" of Joint: **NO**
 Remarks:

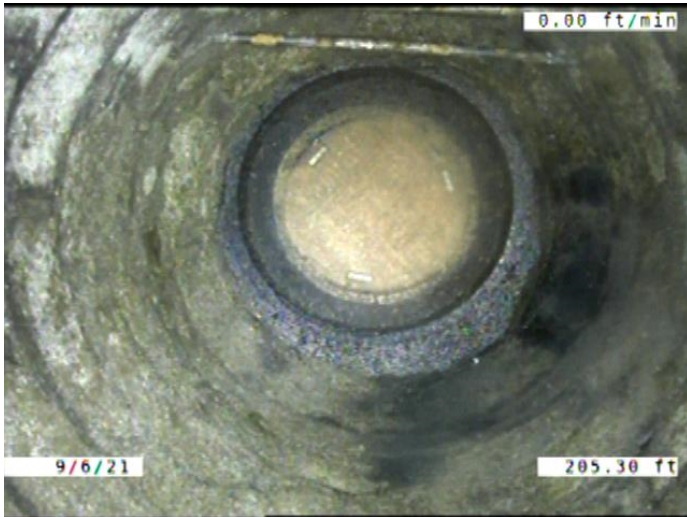
Code:	AMH
Description:	Manhole
Distance (ft):	205.3
Structural Grade:	0
O&M Grade:	0
Clock Start/From:	
Clock To:	
1st Value:	
2nd Value:	
Value Percent:	
Continuous Index:	
Within 8" of Joint:	NO
Remarks:	M-504-117
