Profile/Photo Observation Report

Date:	09/06/2021	Weather:		Coding:	PACP 7.0
Pipe Length (ft):	205.3	Owner:	City of Hobart	Pre Clean:	Heavy Cleaning
P.O.#:	YES502259	Surveyor:	S. Bucklin	PSR:	P-504-118-117
Customer:	City of Hobart	Clean Date:	09/03/2021	Shape:	C

Street:	42nd Avenue	Flow Control:	Not Controlled
City:	Hobart, IN	Year Renewed:	
Location:	Alley	Tape/Media #:	
Purpose:	Routine Assessment	Dia/Height:	12"
Use:	Sanitary Sewage Pipe	Material:	VCP
Drain Area:		Lining:	None
Category:	NA		
Comment:			
Location Details:		Direction of Survey:	Upstream
US MH:	M-504-117	DS MH:	M-504-118
		Total Length Surveyed (ft):	205.3

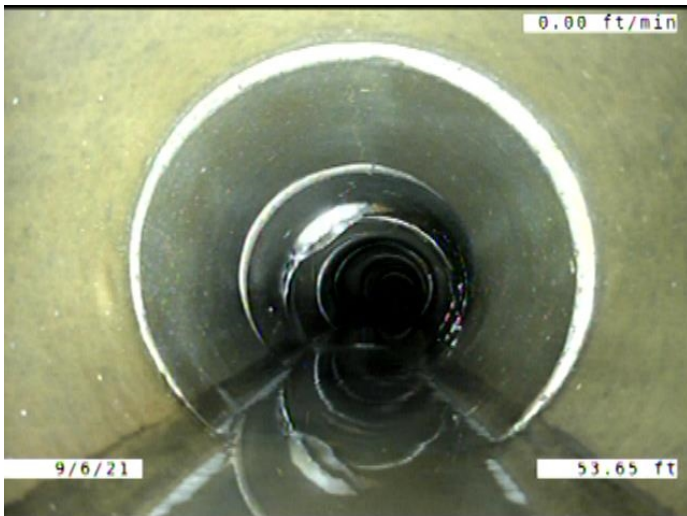
Code: **DAE**
 Description: **Deposits Attached Encrustation**

Distance (ft): **53.6**
 Structural Grade: **0**
 O&M Grade: **2**
 Clock Start/From: **4**
 Clock To: **9**
 1st Value:
 2nd Value:
 Value Percent: **5.000**
 Continuous Index:
 Within 8" of Joint: **YES**
 Remarks:

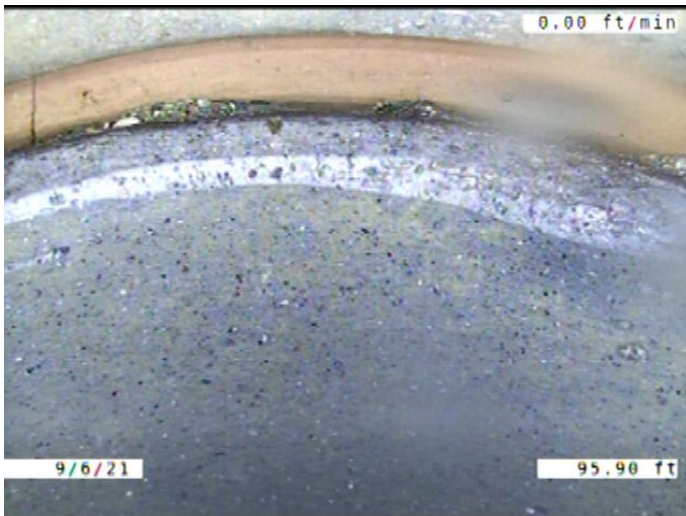
Code: **DAE**
 Description: **Deposits Attached Encrustation**

Distance (ft): **91.7**
 Structural Grade: **0**
 O&M Grade: **2**
 Clock Start/From: **4**
 Clock To: **7**
 1st Value:
 2nd Value:
 Value Percent: **5.000**
 Continuous Index:
 Within 8" of Joint: **YES**
 Remarks:

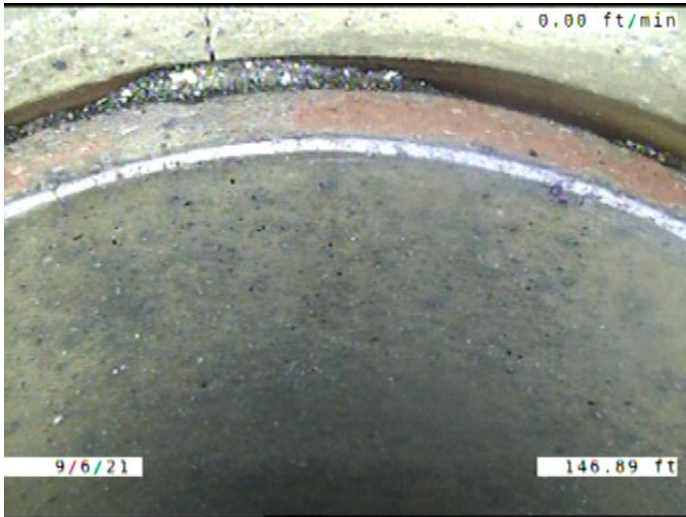
Code: **JOM**
 Description: **Joint Offset Medium**

Distance (ft): **138.4**
 Structural Grade: **3**
 O&M Grade: **0**
 Clock Start/From:
 Clock To:
 1st Value:
 2nd Value:
 Value Percent:
 Continuous Index:
 Within 8" of Joint: **NO**
 Remarks:

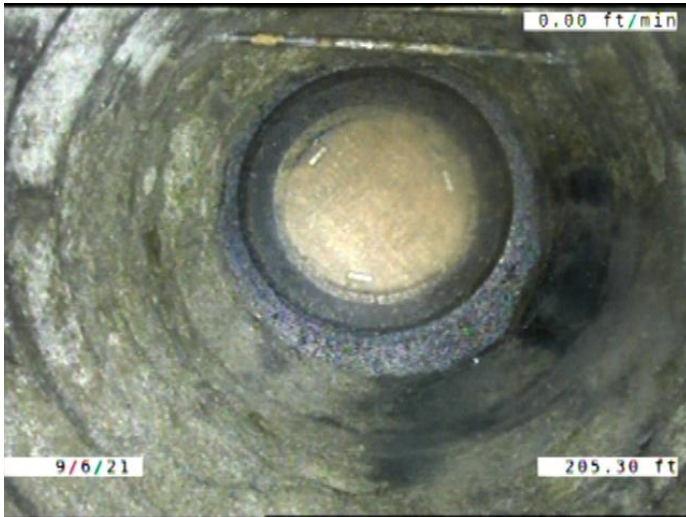
Code: **DSF**
 Description: **Deposits Settled Fine**

Distance (ft): **203.2**
 Structural Grade: **0**
 O&M Grade: **2**
 Clock Start/From: **5**
 Clock To: **7**
 1st Value:
 2nd Value:
 Value Percent: **5.000**
 Continuous Index: **F02**
 Within 8" of Joint: **YES**
 Remarks:
