RedZone
ROBOTICS

Street:	41st Avenue	Flow Control:	Not Controlled
City:	Hobart, IN	Year Renewed:	
Location:	Alley	Tape/Media #:	
Purpose:	Routine Assessment	Dia/Height:	12"
Use:	Sanitary Sewage Pipe	Material:	VCP
Drain Area:		Lining:	None
Category:	NA		
Comment:			
Location Details:		Direction of Survey:	Downstream
US MH:	M-504-118	DS MH:	M-504-119
		Total Length Surveyed (ft):	201.0

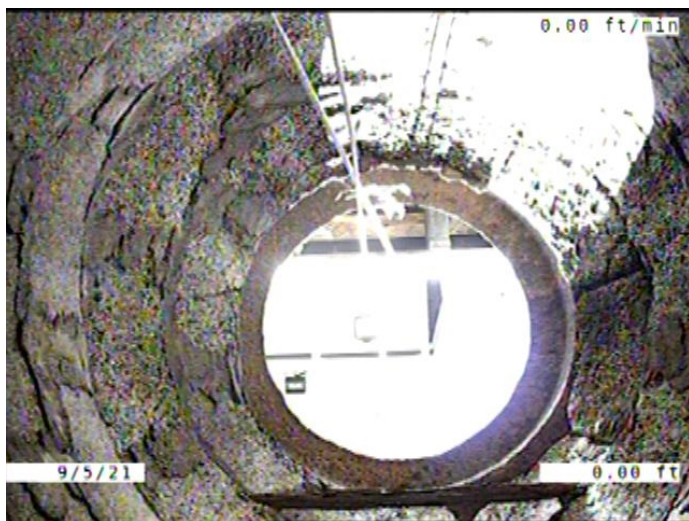
Code: **AMH**
 Description: **Manhole**

Distance (ft): **.0**
 Structural Grade: **0**
 O&M Grade: **0**
 Clock Start/From:
 Clock To:
 1st Value:
 2nd Value:
 Value Percent:
 Continuous Index:
 Within 8" of Joint: **NO**
 Remarks: **M-504-118**

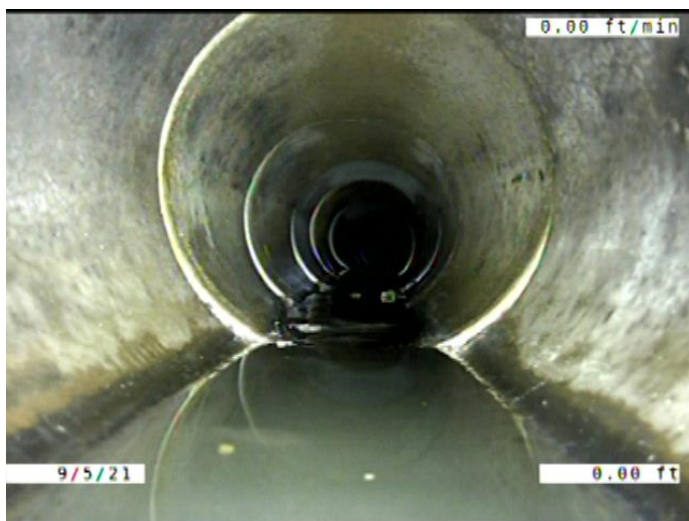
Code: **MWL**
 Description: **Miscellaneous Water Level**

Distance (ft): **.0**
 Structural Grade: **0**
 O&M Grade: **0**
 Clock Start/From:
 Clock To:
 1st Value:
 2nd Value:
 Value Percent: **5.000**
 Continuous Index:
 Within 8" of Joint: **NO**
 Remarks:

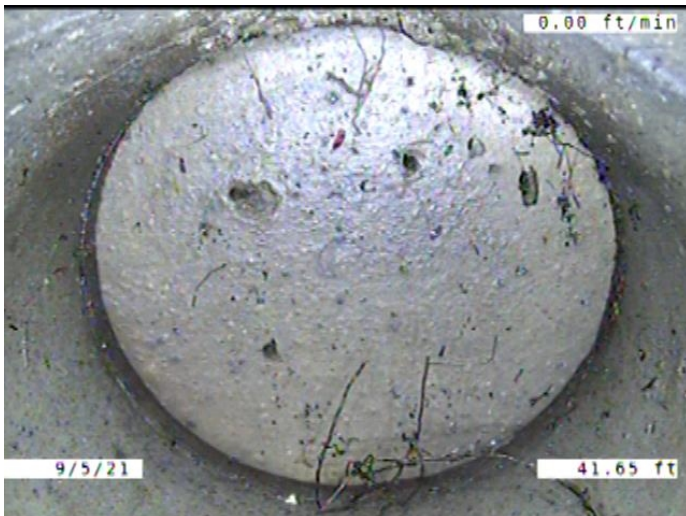
Code: **TFC**
 Description: **Tap Factory Capped**

Distance (ft): **41.6**
 Structural Grade: **0**
 O&M Grade: **0**
 Clock Start/From: **12**
 Clock To:
 1st Value: **6.000**
 2nd Value:
 Value Percent:
 Continuous Index:
 Within 8" of Joint: **YES**
 Remarks:

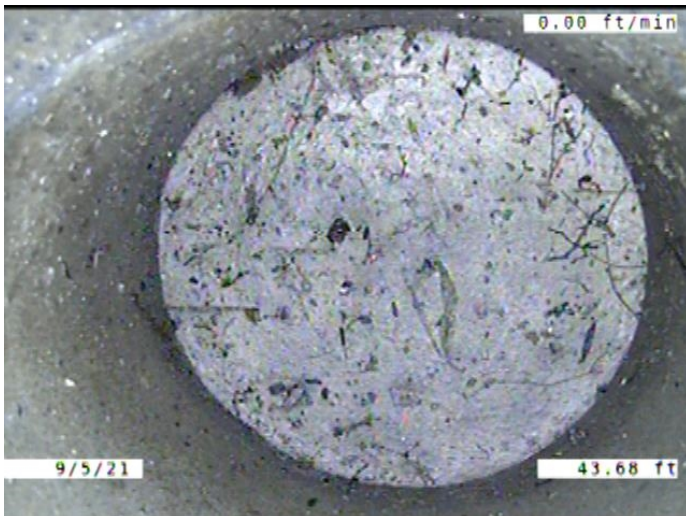
Code: **TFC**
 Description: **Tap Factory Capped**

Distance (ft): **43.7**
 Structural Grade: **0**
 O&M Grade: **0**
 Clock Start/From: **1**
 Clock To:
 1st Value: **6.000**
 2nd Value:
 Value Percent:
 Continuous Index:
 Within 8" of Joint: **YES**
 Remarks:

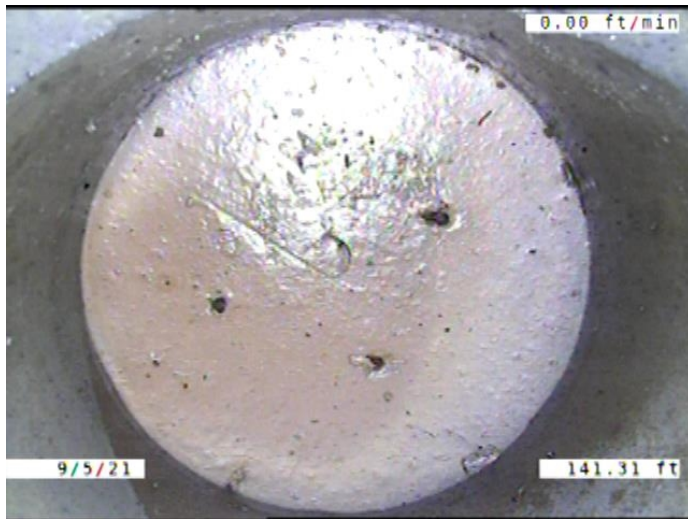
Code: **TFC**
 Description: **Tap Factory Capped**

Distance (ft): **141.3**
 Structural Grade: **0**
 O&M Grade: **0**
 Clock Start/From: **11**
 Clock To:
 1st Value: **6.000**
 2nd Value:
 Value Percent:
 Continuous Index:
 Within 8" of Joint: **YES**
 Remarks:

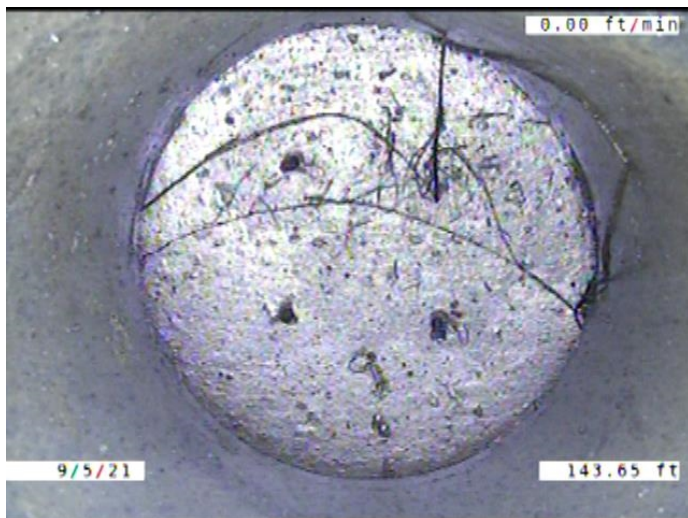
Code: **TFC**
 Description: **Tap Factory Capped**

Distance (ft): **143.6**
 Structural Grade: **0**
 O&M Grade: **0**
 Clock Start/From: **1**
 Clock To:
 1st Value: **6.000**
 2nd Value:
 Value Percent:
 Continuous Index:
 Within 8" of Joint: **YES**
 Remarks:

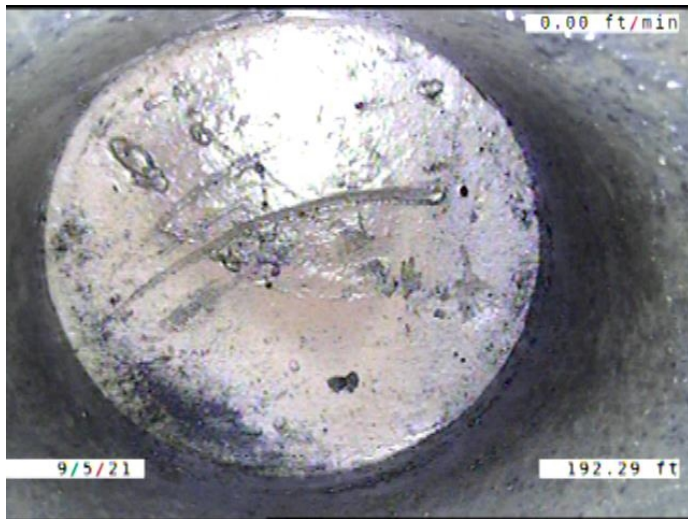
Code: **TFC**
 Description: **Tap Factory Capped**

Distance (ft): **192.3**
 Structural Grade: **0**
 O&M Grade: **0**
 Clock Start/From: **11**
 Clock To:
 1st Value: **6.000**
 2nd Value:
 Value Percent:
 Continuous Index:
 Within 8" of Joint: **YES**
 Remarks:

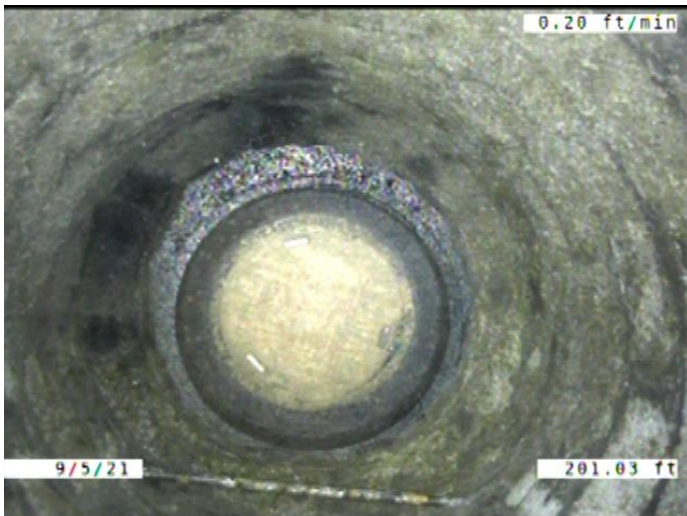
Code: **AMH**
 Description: **Manhole**

Distance (ft): **201.0**
 Structural Grade: **0**
 O&M Grade: **0**
 Clock Start/From:
 Clock To:
 1st Value:
 2nd Value:
 Value Percent:
 Continuous Index:
 Within 8" of Joint: **NO**
 Remarks: **M-504-119**
