# Profile/Photo Observation Report

Date:	09/03/2021	Weather:		Coding:	PACP 7.0
Pipe Length (ft):	140.7	Owner:	City of Hobart	Pre Clean:	Light Cleaning
P.O.#:	YES502259	Surveyor:	S. Bucklin	PSR:	P-504-122-121
Customer:	City of Hobart	Clean Date:	09/02/2021	Shape:	C

Street:	42nd Avenue	Flow Control:	Not Controlled
City:	Hobart, IN	Year Renewed:	
Location:	Alley	Tape/Media #:	
Purpose:	Routine Assessment	Dia/Height:	12"
Use:	Sanitary Sewage Pipe	Material:	VCP
Drain Area:		Lining:	
Category:	NA		
Comment:			
Location Details:		Direction of Survey:	Downstream
US MH:	M-504-122	DS MH:	M-504-121
		Total Length Surveyed (ft):	140.7

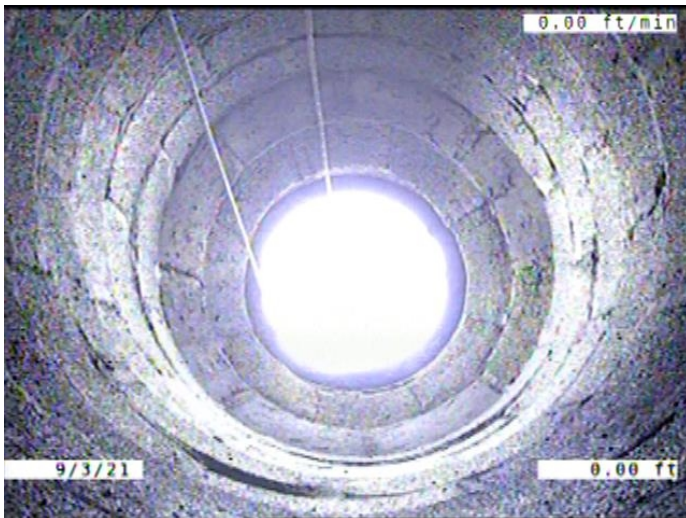
Code: **AMH**  
Description: **Manhole**

Distance (ft): **.0**  
Structural Grade: **0**  
O&M Grade: **0**  
Clock Start/From:  
Clock To:  
1st Value:  
2nd Value:  
Value Percent:  
Continuous Index:  
Within 8" of Joint: **NO**  
Remarks: **M-504-122**

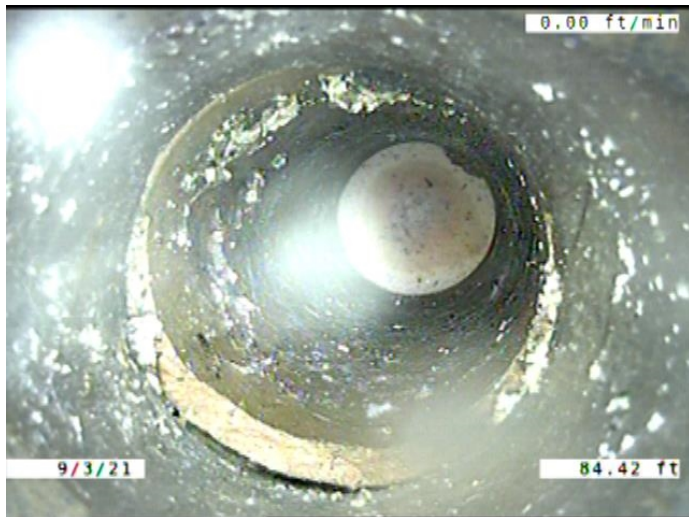
Code: **TFC**  
 Description: **Tap Factory Capped**

Distance (ft): **84.4**  
 Structural Grade: **0**  
 O&M Grade: **0**  
 Clock Start/From: **1**  
 Clock To:  
 1st Value: **6.000**  
 2nd Value:  
 Value Percent:  
 Continuous Index:  
 Within 8" of Joint: **YES**  
 Remarks:

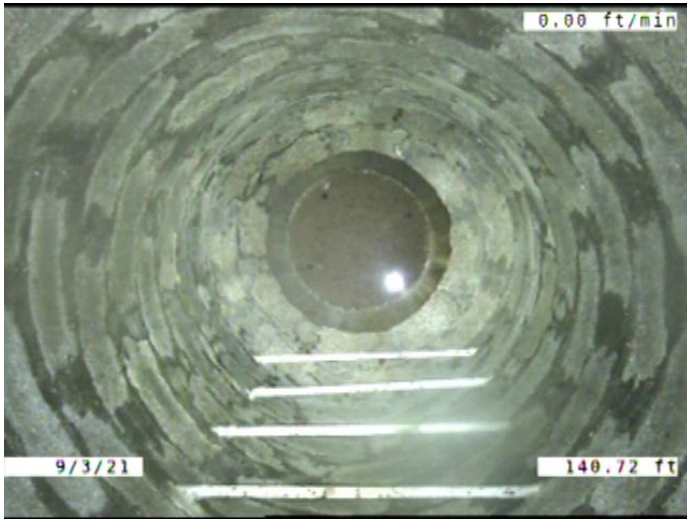
Code:	<b>AMH</b>
Description:	<b>Manhole</b>
Distance (ft):	<b>140.7</b>
Structural Grade:	<b>0</b>
O&M Grade:	<b>0</b>
Clock Start/From:	
Clock To:	
1st Value:	
2nd Value:	
Value Percent:	
Continuous Index:	
Within 8" of Joint:	<b>NO</b>
Remarks:	<b>M-504-121</b>
