Profile/Photo Observation Report

Date:	04/16/2018	Weather:		Coding:	PACP 6.0
Pipe Length (ft):	320.0	Owner:	NA	Pre Clean:	Not Known
P.O.#:		Surveyor:	Selasie Honu	PSR:	P-504-126.1-126
Customer:		Clean Date:	01/01/1900	Shape:	C

Street:	ALLEY BETWEEN N GUYER ST & N WI	Flow Control:	Not Controlled
City:	Hobart, IN	Year Renewed:	
Location:	Light Highway	Tape/Media #:	
Purpose:	Not Known	Dia/Height:	10"
Use:	Sanitary	Material:	CP
Drain Area:	NA	Lining:	
Category:	NA		
Comment:			
Location Details:		Direction of Survey:	Downstream
US MH:	M-504-126	DS MH:	M-504-126.1
		Total Length Surveyed (ft):	261.0

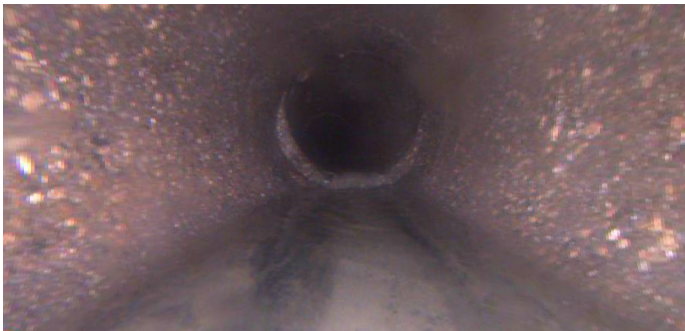
Code: **AMH**
Description: **Manhole**

Distance (ft): **.0**
Structural Grade: **0**
O&M Grade: **0**
Clock Start/From:
Clock To:
1st Value:
2nd Value:
Value Percent:
Continuous Index:
Within 8" of Joint: **NO**
Remarks: **M-504-126**

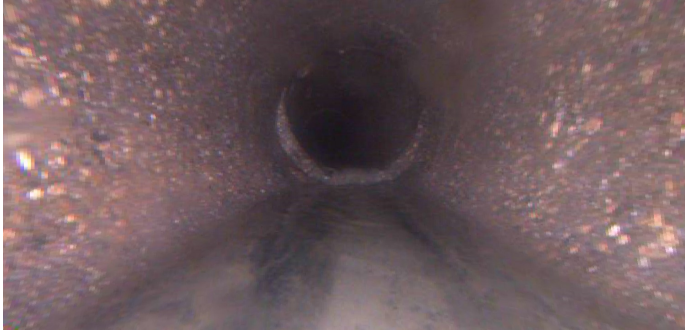
Code: **MWL**
Description: **Water Level**

Distance (ft): **.0**
Structural Grade: **0**
O&M Grade: **0**
Clock Start/From:
Clock To:
1st Value:
2nd Value:
Value Percent: **5.000**
Continuous Index:
Within 8" of Joint: **NO**
Remarks:

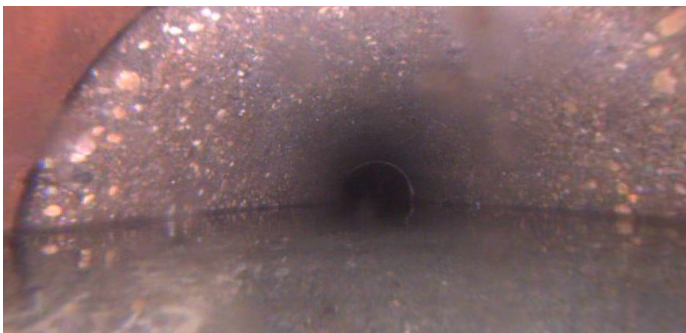
Code: **MWL**
Description: **Water Level**

Distance (ft): **258.4**
Structural Grade: **0**
O&M Grade: **0**
Clock Start/From:
Clock To:
1st Value:
2nd Value:
Value Percent: **40.000**
Continuous Index:
Within 8" of Joint: **NO**
Remarks:
