Profile/Photo Observation Report

Date:	09/03/2021	Weather:		Coding:	PACP 7.0
Pipe Length (ft):	277.0	Owner:	City of Hobart	Pre Clean:	Light Cleaning
P.O.#:	YES502259	Surveyor:	S. Bucklin	PSR:	P-504-126.1-126
Customer:	City of Hobart	Clean Date:	08/30/2021	Shape:	C

Street:	Old Ridge Road	Flow Control:	Not Controlled
City:	Hobart, IN	Year Renewed:	
Location:	Alley	Tape/Media #:	
Purpose:	Routine Assessment	Dia/Height:	10"
Use:	Sanitary Sewage Pipe	Material:	CP
Drain Area:		Lining:	
Category:	NA		
Comment:			
Location Details:		Direction of Survey:	Downstream
US MH:	M-504-126	DS MH:	M-504-126.1
		Total Length Surveyed (ft):	277.0

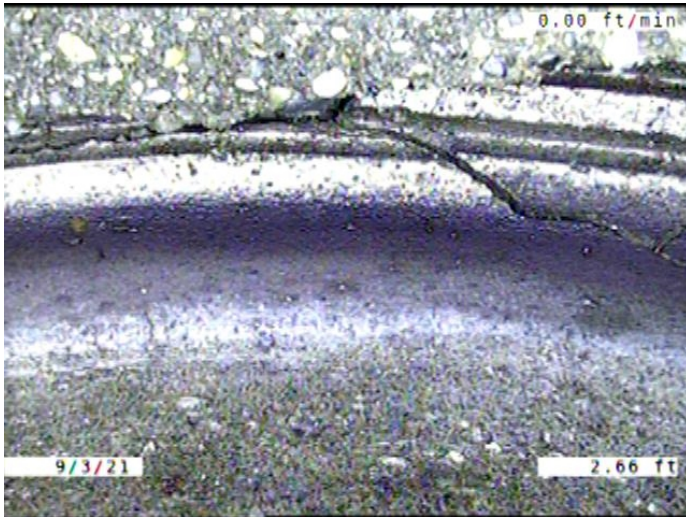
Code: **MMC**
Description: **Miscellaneous Material Change**

Distance (ft): **2.7**
Structural Grade: **0**
O&M Grade: **0**
Clock Start/From:
Clock To:
1st Value:
2nd Value:
Value Percent:
Continuous Index:
Within 8" of Joint: **NO**
Remarks: **CONCRETE TO VCP**

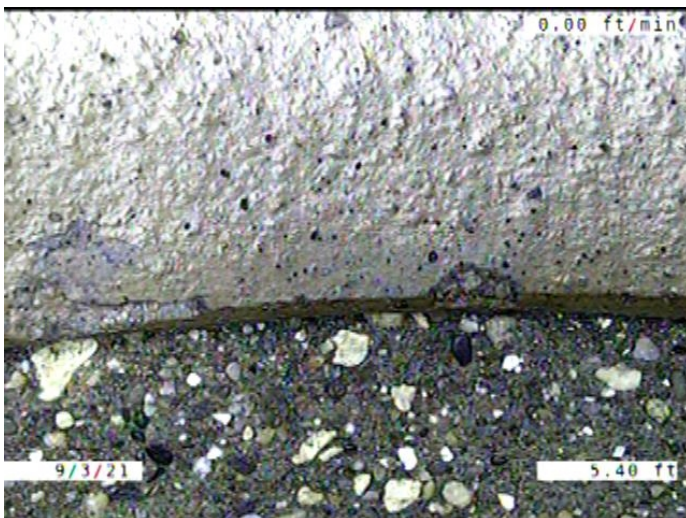
Code: **MMC**
Description: **Miscellaneous Material Change**

Distance (ft): **5.4**
Structural Grade: **0**
O&M Grade: **0**
Clock Start/From:
Clock To:
1st Value:
2nd Value:
Value Percent:
Continuous Index:
Within 8" of Joint: **NO**
Remarks: **VCP TO CONCRETE**

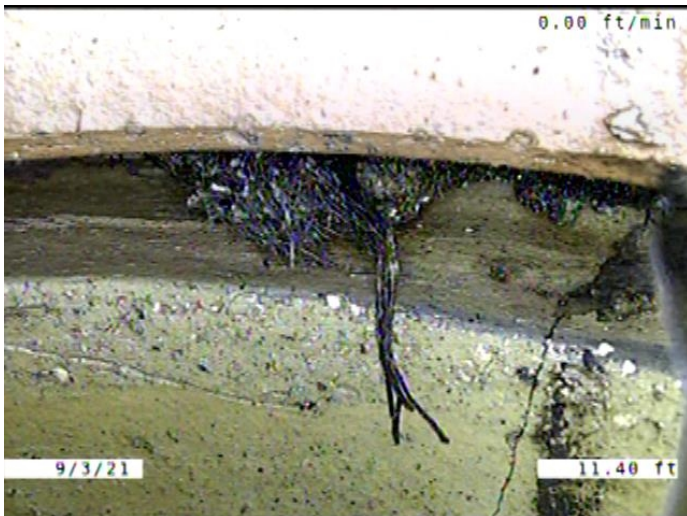
Code: **RFJ**
 Description: **Roots Fine Joint**

Distance (ft): **11.4**
 Structural Grade: **0**
 O&M Grade: **1**
 Clock Start/From: **2**
 Clock To: **3**
 1st Value:
 2nd Value:
 Value Percent:
 Continuous Index:
 Within 8" of Joint: **YES**
 Remarks:

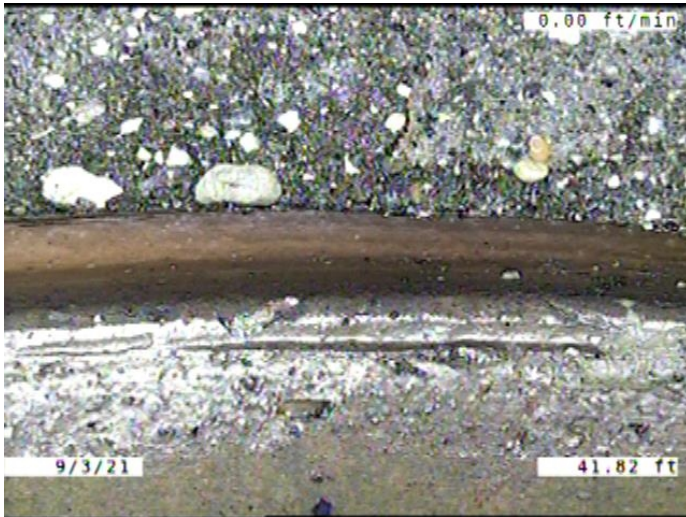
Code:	MMC
Description:	Miscellaneous Material Change
Distance (ft):	41.8
Structural Grade:	0
O&M Grade:	0
Clock Start/From:	
Clock To:	
1st Value:	
2nd Value:	
Value Percent:	
Continuous Index:	
Within 8" of Joint:	NO
Remarks:	CONCRETE TO VCP

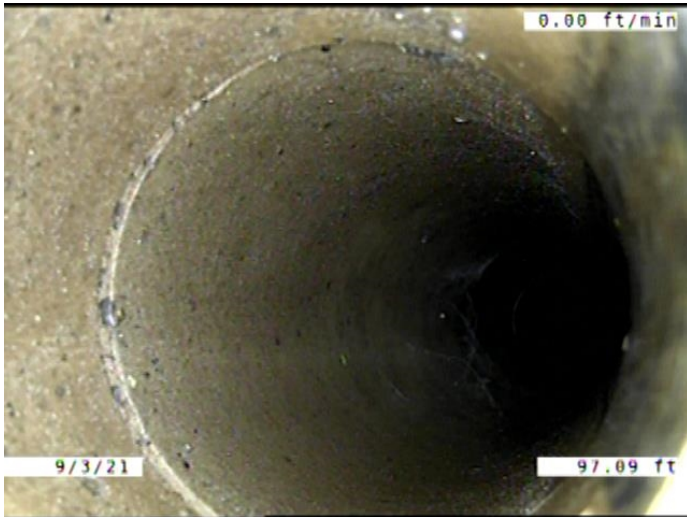
Code: **TBI**
 Description: **Tap Break-in Intruding**

Distance (ft): **97.1**
 Structural Grade: **0**
 O&M Grade: **2**
 Clock Start/From: **2**
 Clock To:
 1st Value: **6.000**
 2nd Value: **1.000**
 Value Percent:
 Continuous Index:
 Within 8" of Joint: **NO**
 Remarks:

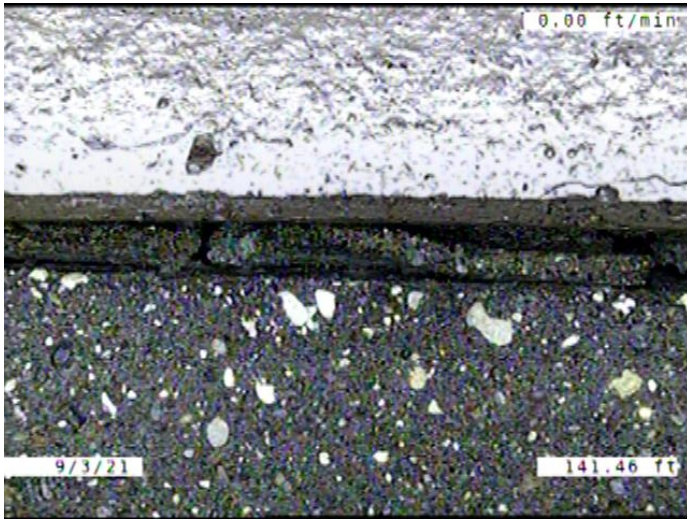
Code: **MMC**
Description: **Miscellaneous Material Change**

Distance (ft): **141.5**
Structural Grade: **0**
O&M Grade: **0**
Clock Start/From:
Clock To:
1st Value:
2nd Value:
Value Percent:
Continuous Index:
Within 8" of Joint: **NO**
Remarks: **VCP TO CONCRETE**

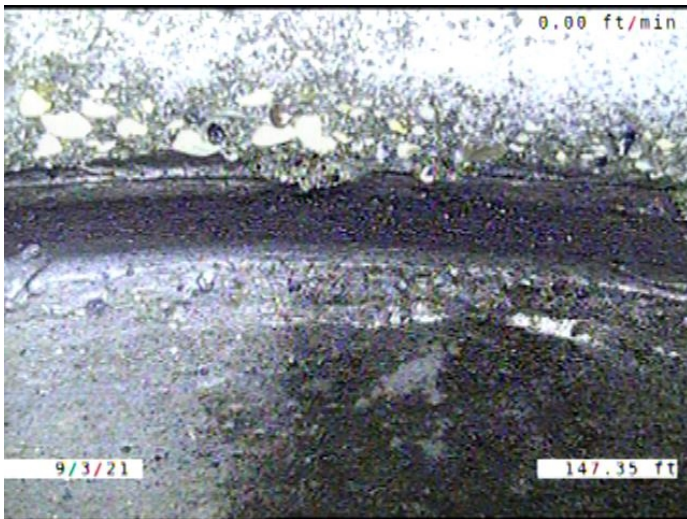
Code: **MMC**
Description: **Miscellaneous Material Change**

Distance (ft): **147.4**
Structural Grade: **0**
O&M Grade: **0**
Clock Start/From:
Clock To:
1st Value:
2nd Value:
Value Percent:
Continuous Index:
Within 8" of Joint: **NO**
Remarks: **CONCRETE TO VCP**

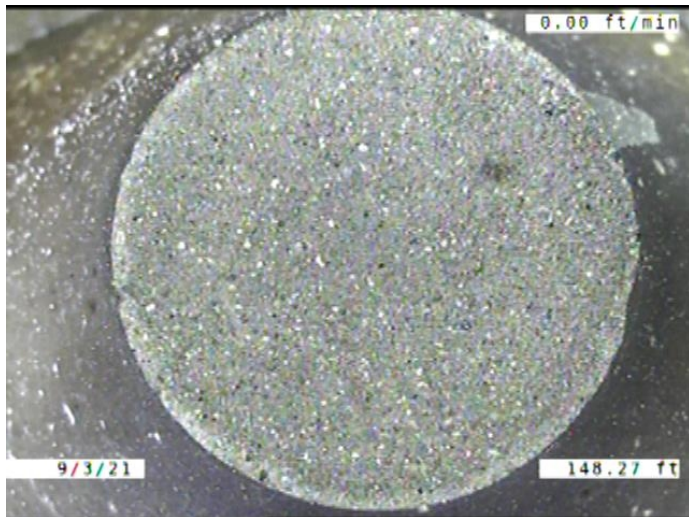
Code: **TFC**
 Description: **Tap Factory Capped**

Distance (ft): **148.3**
 Structural Grade: **0**
 O&M Grade: **0**
 Clock Start/From: **1**
 Clock To:
 1st Value: **6.000**
 2nd Value:
 Value Percent:
 Continuous Index:
 Within 8" of Joint: **YES**
 Remarks:

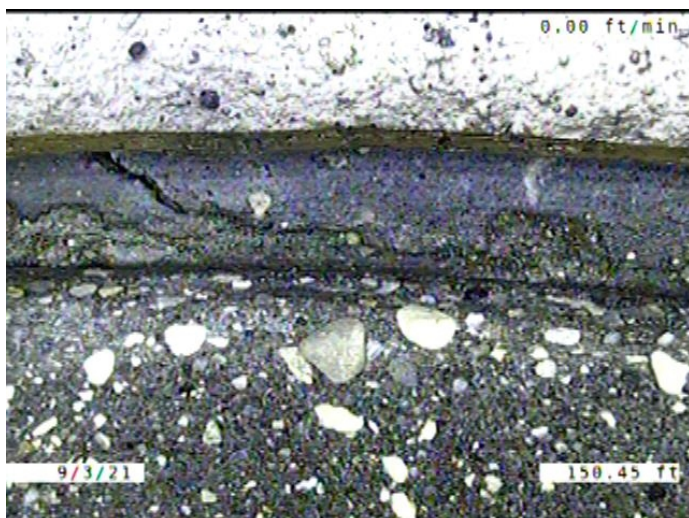
Code: **MMC**
 Description: **Miscellaneous Material Change**

Distance (ft): **150.4**
 Structural Grade: **0**
 O&M Grade: **0**
 Clock Start/From:
 Clock To:
 1st Value:
 2nd Value:
 Value Percent:
 Continuous Index:
 Within 8" of Joint: **NO**
 Remarks: **VCP TO CONCRETE**

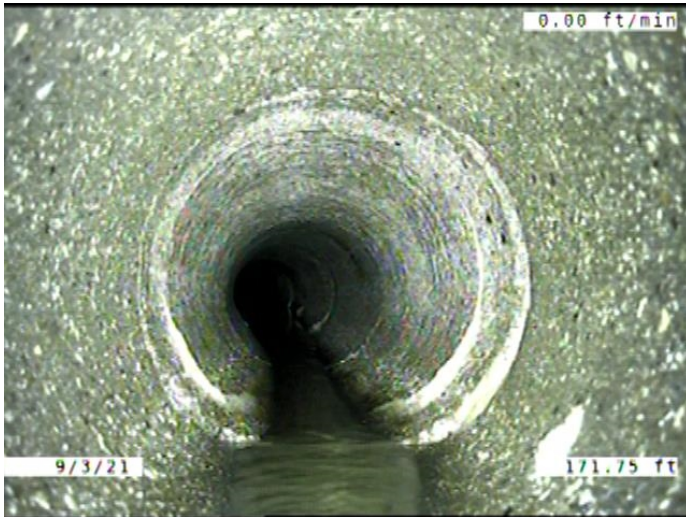
Code: **LL**
Description: **Line Left**

Distance (ft): **171.8**
Structural Grade: **0**
O&M Grade: **1**
Clock Start/From:
Clock To:
1st Value:
2nd Value:
Value Percent: **5.000**
Continuous Index:
Within 8" of Joint: **NO**
Remarks:

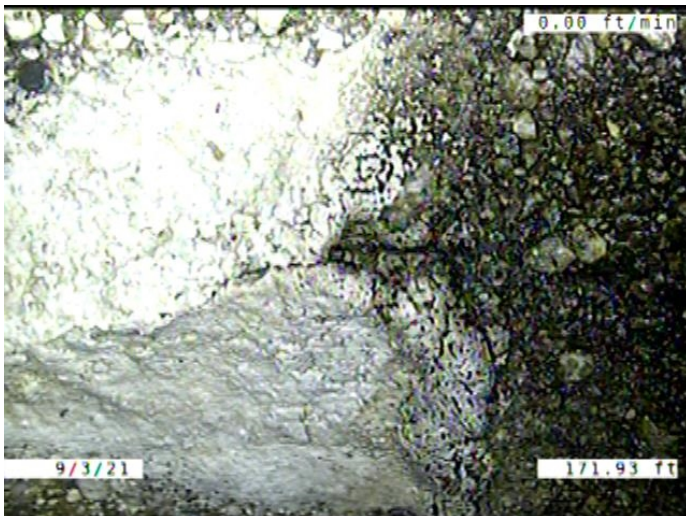
Code: **DAE**
Description: **Deposits Attached Encrustation**

Distance (ft): **171.9**
Structural Grade: **0**
O&M Grade: **2**
Clock Start/From: **8**
Clock To: **5**
1st Value:
2nd Value:
Value Percent: **5.000**
Continuous Index:
Within 8" of Joint: **YES**
Remarks:

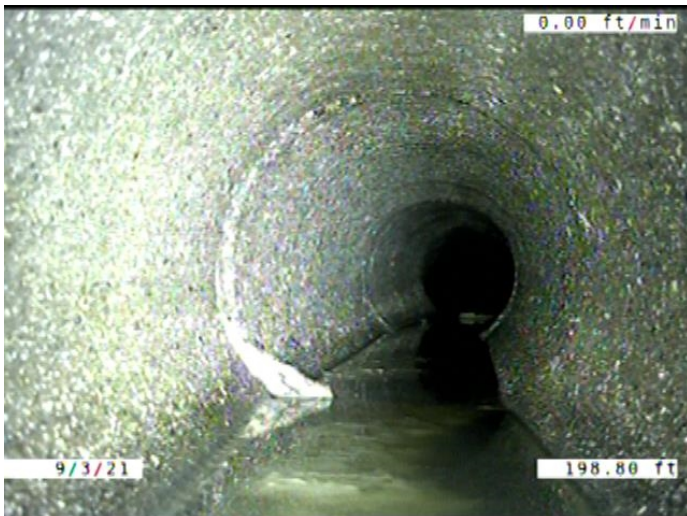
Code: **LR**
Description: **Line Right**

Distance (ft): **198.8**
Structural Grade: **0**
O&M Grade: **1**
Clock Start/From:
Clock To:
1st Value:
2nd Value:
Value Percent: **5.000**
Continuous Index:
Within 8" of Joint: **NO**
Remarks:

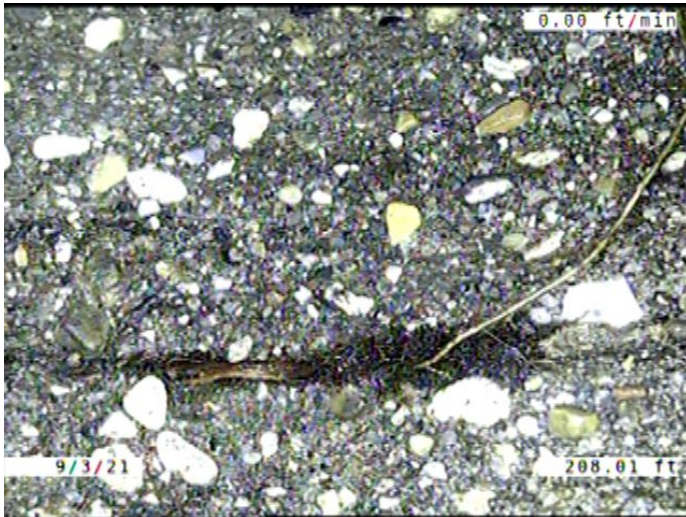
Code: **RFJ**
 Description: **Roots Fine Joint**

Distance (ft): **208.0**
 Structural Grade: **0**
 O&M Grade: **1**
 Clock Start/From: **8**
 Clock To:
 1st Value:
 2nd Value:
 Value Percent:
 Continuous Index:
 Within 8" of Joint: **YES**
 Remarks:

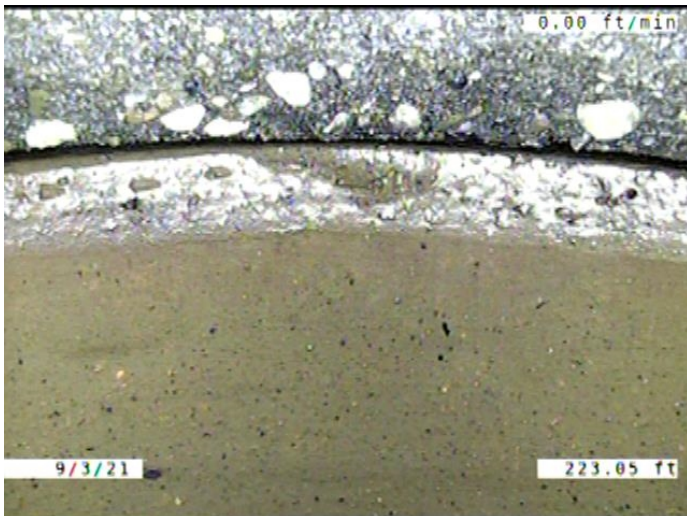
Code: **MMC**
 Description: **Miscellaneous Material Change**

Distance (ft): **223.1**
 Structural Grade: **0**
 O&M Grade: **0**
 Clock Start/From:
 Clock To:
 1st Value:
 2nd Value:
 Value Percent:
 Continuous Index:
 Within 8" of Joint: **NO**
 Remarks: **CONCRETE TO VCP**

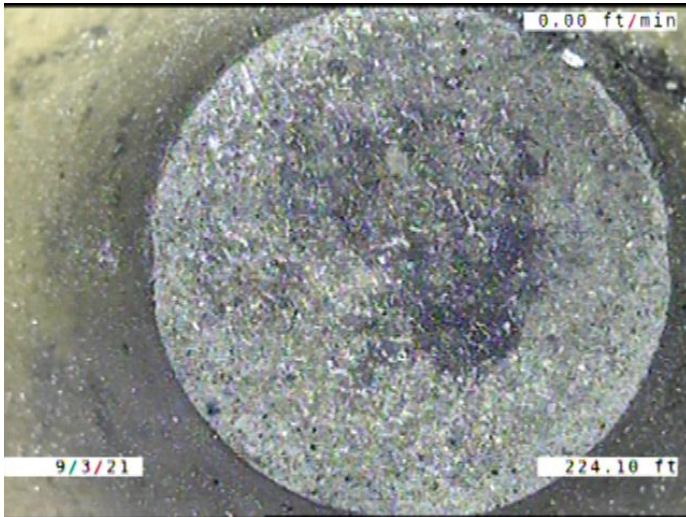
Code: **TFC**
 Description: **Tap Factory Capped**

Distance (ft): **224.1**
 Structural Grade: **0**
 O&M Grade: **0**
 Clock Start/From: **1**
 Clock To:
 1st Value: **6.000**
 2nd Value:
 Value Percent:
 Continuous Index:
 Within 8" of Joint: **YES**
 Remarks:

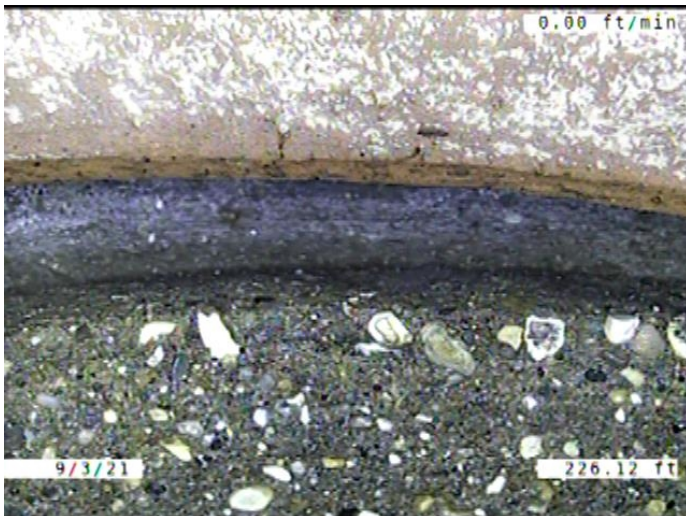
Code: **MMC**
 Description: **Miscellaneous Material Change**

Distance (ft): **226.1**
 Structural Grade: **0**
 O&M Grade: **0**
 Clock Start/From:
 Clock To:
 1st Value:
 2nd Value:
 Value Percent:
 Continuous Index:
 Within 8" of Joint: **NO**
 Remarks: **VCP TO CONCRETE**

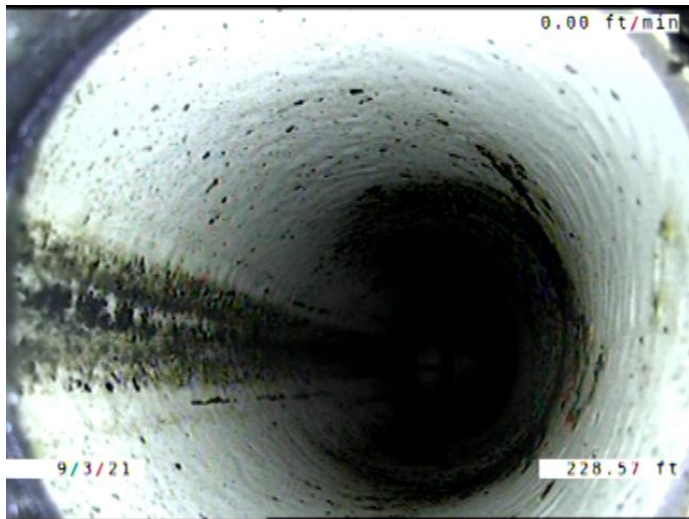
Code: **TB**
 Description: **Tap Break-in/Hammer**

Distance (ft): **228.6**
 Structural Grade: **0**
 O&M Grade: **0**
 Clock Start/From: **10**
 Clock To:
 1st Value: **4.000**
 2nd Value:
 Value Percent:
 Continuous Index:
 Within 8" of Joint: **NO**
 Remarks:

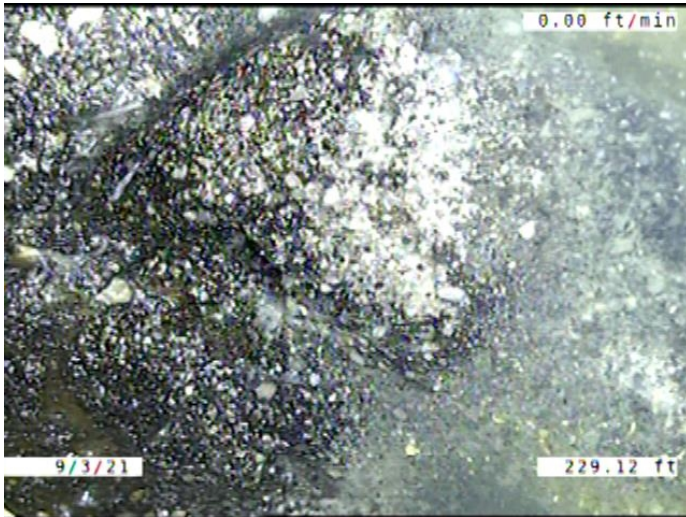
Code: **DAE**
 Description: **Deposits Attached Encrustation**

Distance (ft): **229.1**
 Structural Grade: **0**
 O&M Grade: **2**
 Clock Start/From: **4**
 Clock To: **7**
 1st Value:
 2nd Value:
 Value Percent: **5.000**
 Continuous Index:
 Within 8" of Joint: **YES**
 Remarks:

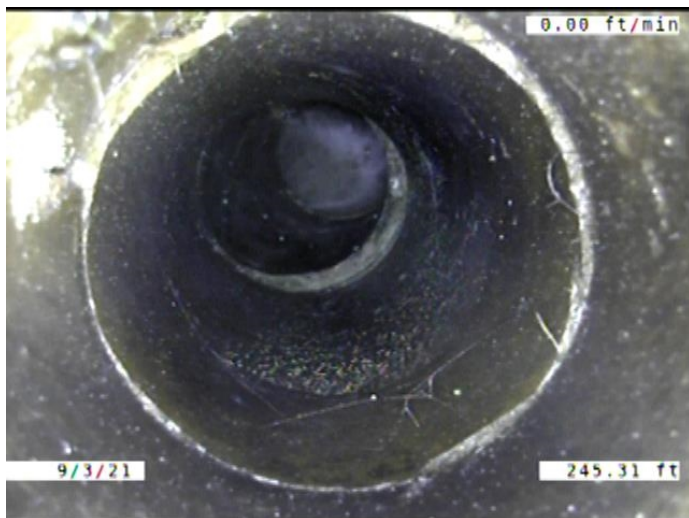
Code: **CM**
 Description: **Crack Multiple**

Distance (ft): **244.3**
 Structural Grade: **3**
 O&M Grade: **0**
 Clock Start/From: **10**
 Clock To: **2**
 1st Value:
 2nd Value:
 Value Percent:
 Continuous Index:
 Within 8" of Joint: **YES**
 Remarks:
