# Profile/Photo Observation Report

Date:	09/03/2021	Weather:		Coding:	PACP 7.0
Pipe Length (ft):	277.0	Owner:	City of Hobart	Pre Clean:	Light Cleaning
P.O.#:	YES502259	Surveyor:	S. Bucklin	PSR:	P-504-126.1-126
Customer:	City of Hobart	Clean Date:	08/30/2021	Shape:	C

Street:	Old Ridge Road	Flow Control:	Not Controlled
City:	Hobart, IN	Year Renewed:	
Location:	Alley	Tape/Media #:	
Purpose:	Routine Assessment	Dia/Height:	10"
Use:	Sanitary Sewage Pipe	Material:	CP
Drain Area:		Lining:	
Category:	NA		
Comment:			
Location Details:		Direction of Survey:	Downstream
US MH:	M-504-126	DS MH:	M-504-126.1
		Total Length Surveyed (ft):	277.0

O&M Index:	1.79	O&M Quick:	312N	O&M Rating:	184.00
Structural Index:	2.85	Structural Quick:	5243	Structural Rating:	94.00
Overall Index:	2.04	Overall Quick:	5243	Overall Rating:	278.00

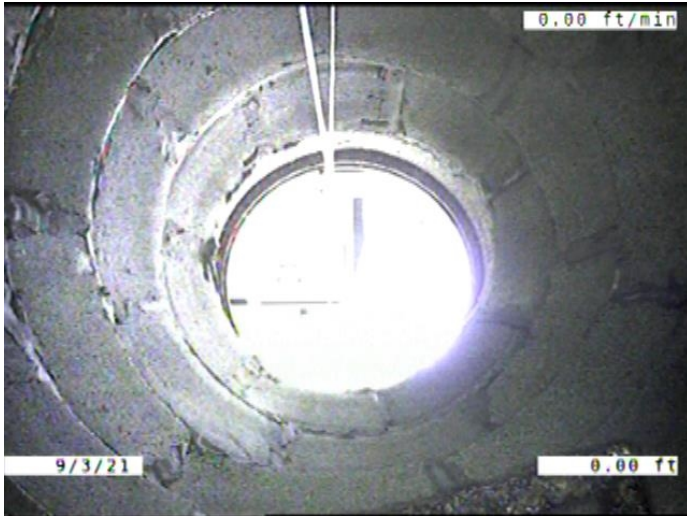
**M-504-126.1**

Code: **AMH**  
Description: **Manhole**

Distance (ft): **.0**  
Structural Grade: **0**  
O&M Grade: **0**  
Clock Start/From:  
Clock To:  
1st Value:  
2nd Value:  
Value Percent:  
Continuous Index:  
Within 8" of Joint: **NO**  
Remarks: **M-504-126**

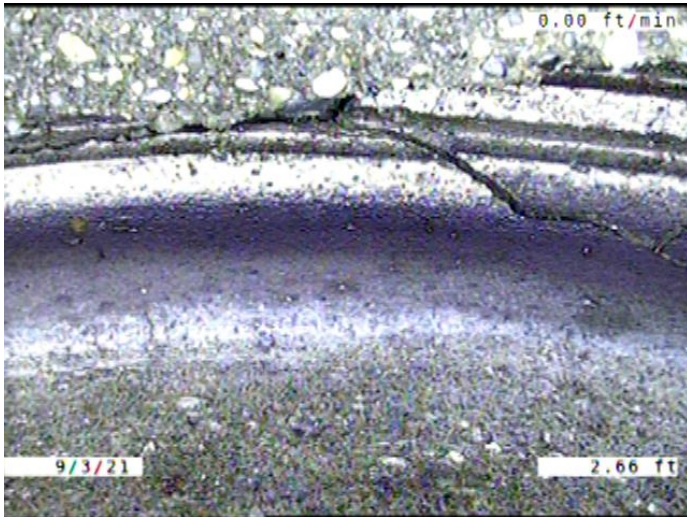
Code: **MMC**  
 Description: **Miscellaneous Material Change**

Distance (ft): **2.7**  
 Structural Grade: **0**  
 O&M Grade: **0**  
 Clock Start/From:  
 Clock To:  
 1st Value:  
 2nd Value:  
 Value Percent:  
 Continuous Index:  
 Within 8" of Joint: **NO**  
 Remarks: **CONCRETE TO VCP**

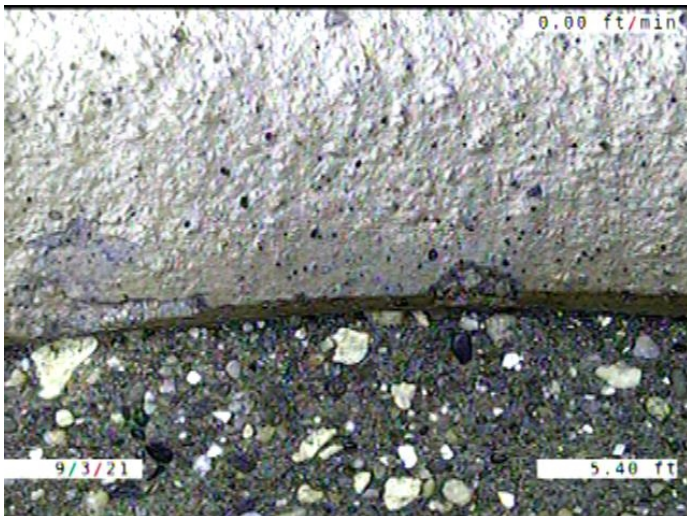
Code: **MMC**  
 Description: **Miscellaneous Material Change**

Distance (ft): **5.4**  
 Structural Grade: **0**  
 O&M Grade: **0**  
 Clock Start/From:  
 Clock To:  
 1st Value:  
 2nd Value:  
 Value Percent:  
 Continuous Index:  
 Within 8" of Joint: **NO**  
 Remarks: **VCP TO CONCRETE**

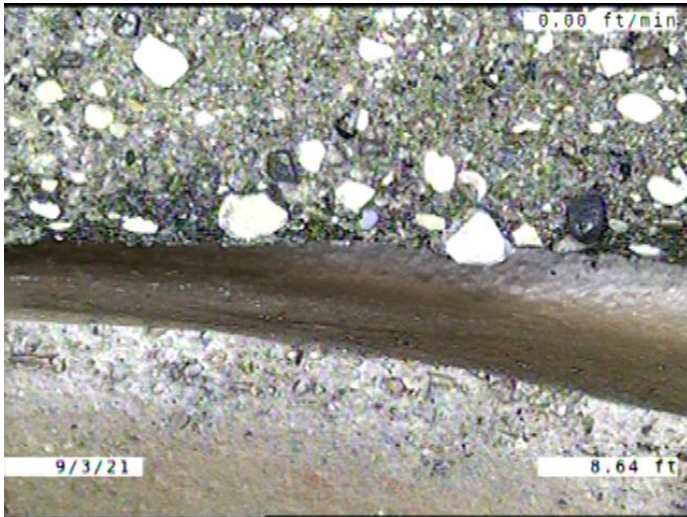
Code: **MMC**  
 Description: **Miscellaneous Material Change**

Distance (ft): **8.6**  
 Structural Grade: **0**  
 O&M Grade: **0**  
 Clock Start/From:  
 Clock To:  
 1st Value:  
 2nd Value:  
 Value Percent:  
 Continuous Index:  
 Within 8" of Joint: **NO**  
 Remarks: **CONCRETE TO VCP**

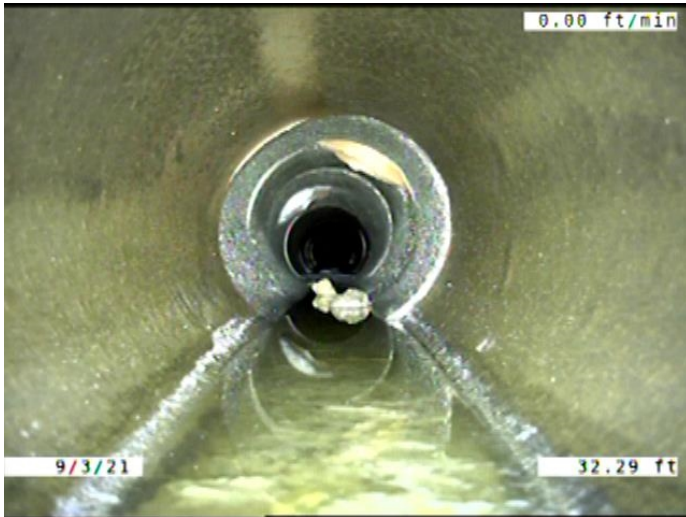
Code: **MWLS**  
Description: **Miscellaneous Water Level Sag**

Distance (ft): **32.3**  
Structural Grade: **2**  
O&M Grade: **0**  
Clock Start/From:  
Clock To:  
1st Value:  
2nd Value:  
Value Percent: **5.000**  
Continuous Index:  
Within 8" of Joint: **NO**  
Remarks:

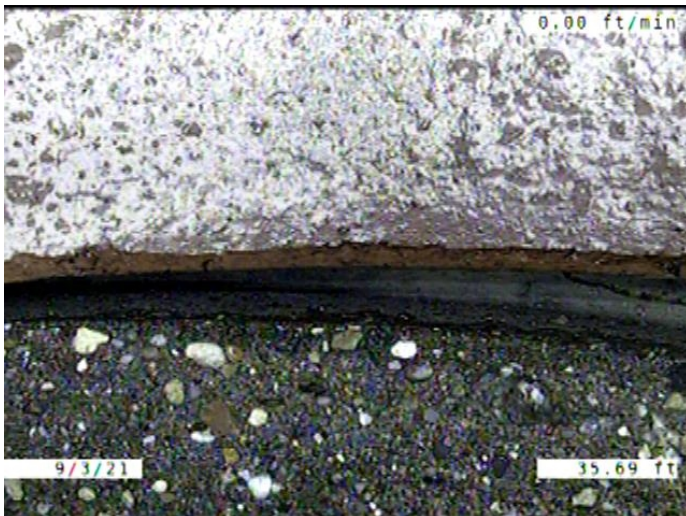
Code: **MMC**  
Description: **Miscellaneous Material Change**

Distance (ft): **35.7**  
Structural Grade: **0**  
O&M Grade: **0**  
Clock Start/From:  
Clock To:  
1st Value:  
2nd Value:  
Value Percent:  
Continuous Index:  
Within 8" of Joint: **NO**  
Remarks: **VCP TO CONCRETE**

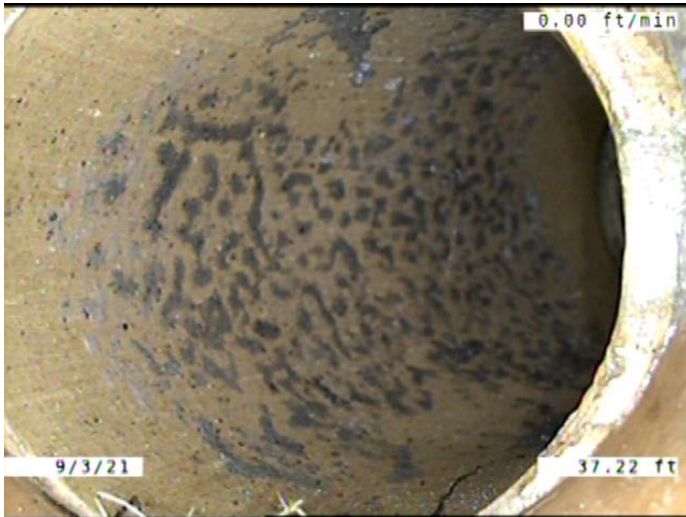
Code: **TBI**  
 Description: **Tap Break-in Intruding**

Distance (ft): **37.2**  
 Structural Grade: **0**  
 O&M Grade: **2**  
 Clock Start/From: **1**  
 Clock To:  
 1st Value: **6.000**  
 2nd Value: **1.000**  
 Value Percent:  
 Continuous Index:  
 Within 8" of Joint: **NO**  
 Remarks:

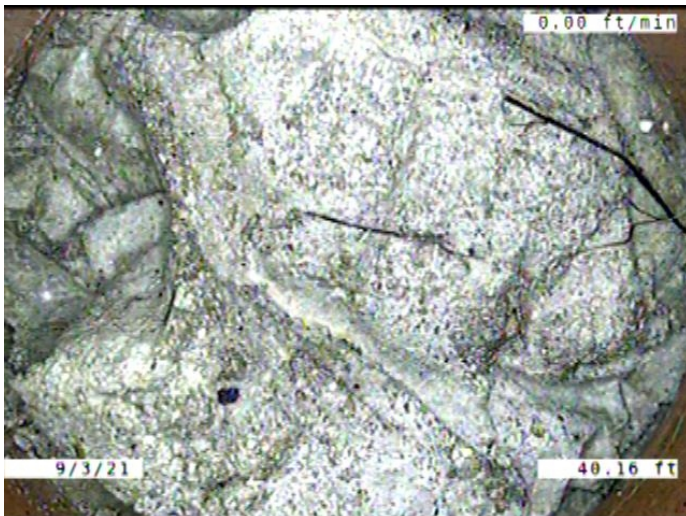
Code: **TBI**  
 Description: **Tap Break-in Intruding**

Distance (ft): **40.2**  
 Structural Grade: **0**  
 O&M Grade: **2**  
 Clock Start/From: **11**  
 Clock To:  
 1st Value: **6.000**  
 2nd Value: **1.000**  
 Value Percent:  
 Continuous Index:  
 Within 8" of Joint: **NO**  
 Remarks: **LOOKS TO BE PLUGGED OFF**

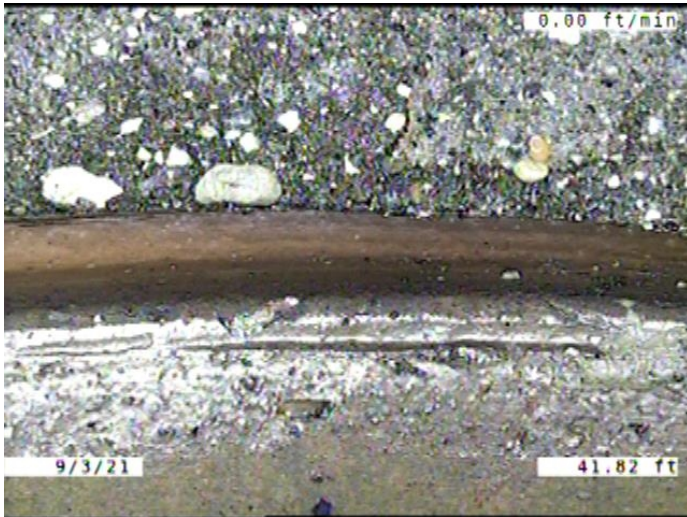
Code: **MMC**  
 Description: **Miscellaneous Material Change**

Distance (ft): **41.8**  
 Structural Grade: **0**  
 O&M Grade: **0**  
 Clock Start/From:  
 Clock To:  
 1st Value:  
 2nd Value:  
 Value Percent:  
 Continuous Index:  
 Within 8" of Joint: **NO**  
 Remarks: **CONCRETE TO VCP**

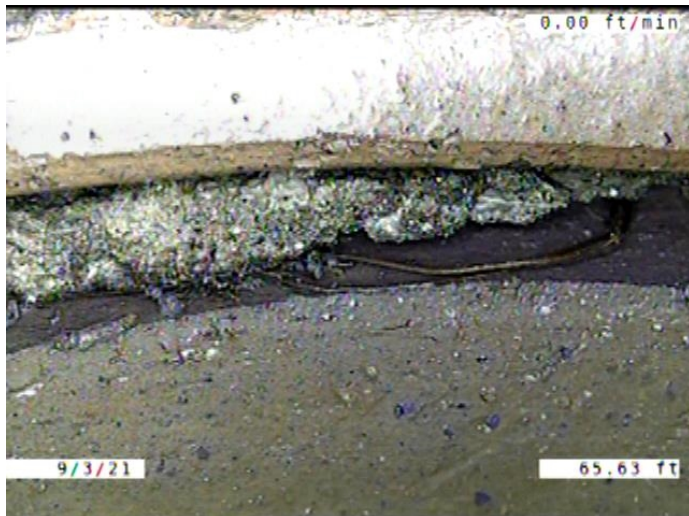
Code: **RFJ**  
 Description: **Roots Fine Joint**

Distance (ft): **65.6**  
 Structural Grade: **0**  
 O&M Grade: **1**  
 Clock Start/From: **10**  
 Clock To: **11**  
 1st Value:  
 2nd Value:  
 Value Percent:  
 Continuous Index:  
 Within 8" of Joint: **YES**  
 Remarks:

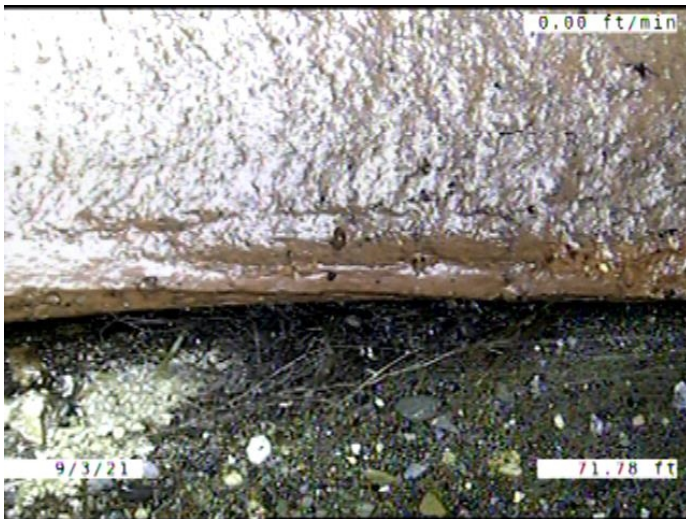
Code: **RFJ**  
 Description: **Roots Fine Joint**

Distance (ft): **71.8**  
 Structural Grade: **0**  
 O&M Grade: **1**  
 Clock Start/From: **9**  
 Clock To: **10**  
 1st Value:  
 2nd Value:  
 Value Percent:  
 Continuous Index:  
 Within 8" of Joint: **YES**  
 Remarks:

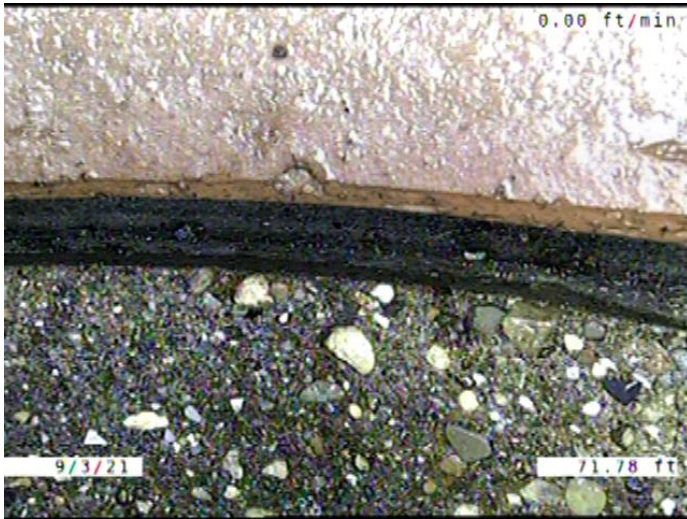
Code: **MMC**  
 Description: **Miscellaneous Material Change**

Distance (ft): **71.8**  
 Structural Grade: **0**  
 O&M Grade: **0**  
 Clock Start/From:  
 Clock To:  
 1st Value:  
 2nd Value:  
 Value Percent:  
 Continuous Index:  
 Within 8" of Joint: **NO**  
 Remarks: **VCP TO CONCRETE**

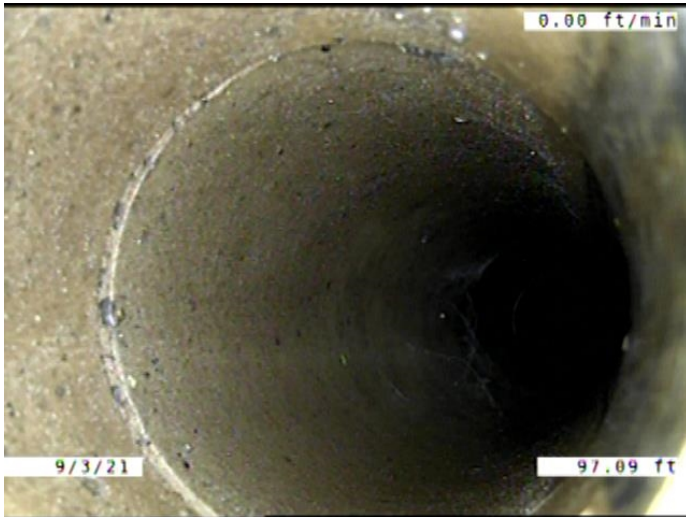
Code: **TBI**  
 Description: **Tap Break-in Intruding**

Distance (ft): **97.1**  
 Structural Grade: **0**  
 O&M Grade: **2**  
 Clock Start/From: **2**  
 Clock To:  
 1st Value: **6.000**  
 2nd Value: **1.000**  
 Value Percent:  
 Continuous Index:  
 Within 8" of Joint: **NO**  
 Remarks:

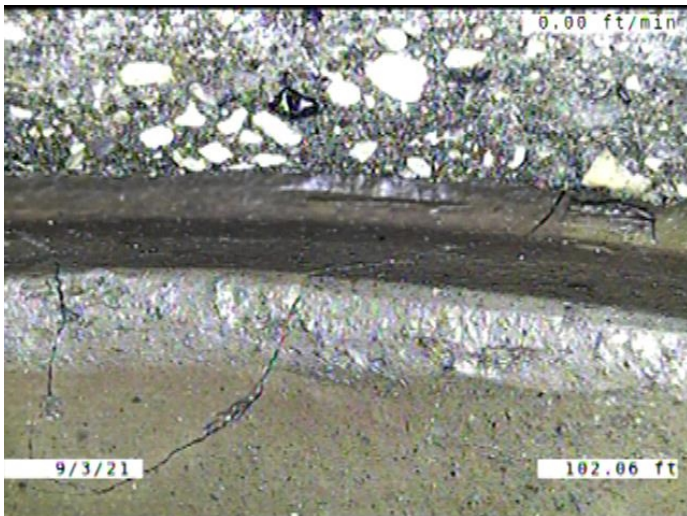
Code: **MMC**  
 Description: **Miscellaneous Material Change**

Distance (ft): **102.1**  
 Structural Grade: **0**  
 O&M Grade: **0**  
 Clock Start/From:  
 Clock To:  
 1st Value:  
 2nd Value:  
 Value Percent:  
 Continuous Index:  
 Within 8" of Joint: **NO**  
 Remarks: **CONCRETE TO VCP**

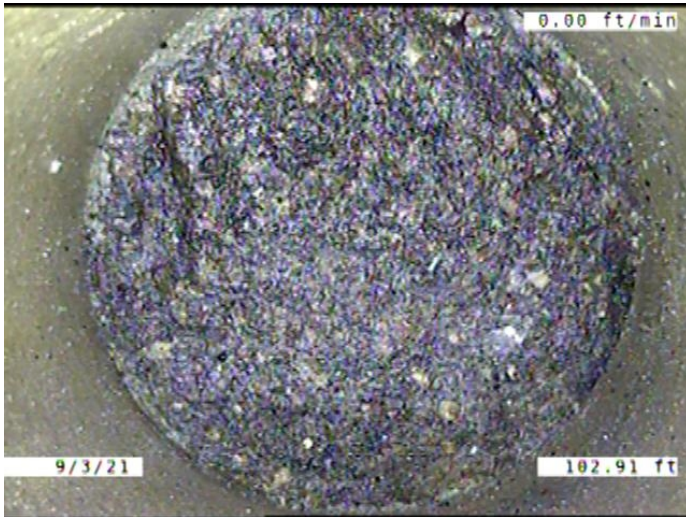
Code: **TFC**  
 Description: **Tap Factory Capped**

Distance (ft): **102.9**  
 Structural Grade: **0**  
 O&M Grade: **0**  
 Clock Start/From: **11**  
 Clock To:  
 1st Value: **6.000**  
 2nd Value:  
 Value Percent:  
 Continuous Index:  
 Within 8" of Joint: **YES**  
 Remarks:

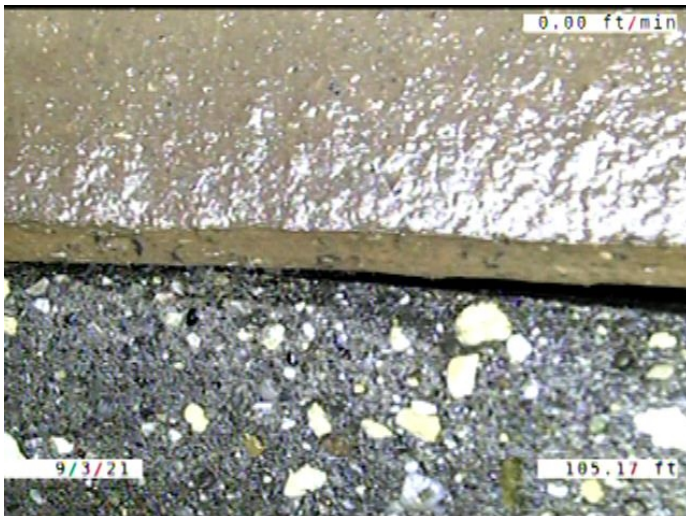
Code: **MMC**  
 Description: **Miscellaneous Material Change**

Distance (ft): **105.2**  
 Structural Grade: **0**  
 O&M Grade: **0**  
 Clock Start/From:  
 Clock To:  
 1st Value:  
 2nd Value:  
 Value Percent:  
 Continuous Index:  
 Within 8" of Joint: **NO**  
 Remarks: **VCP TO CONCRETE**

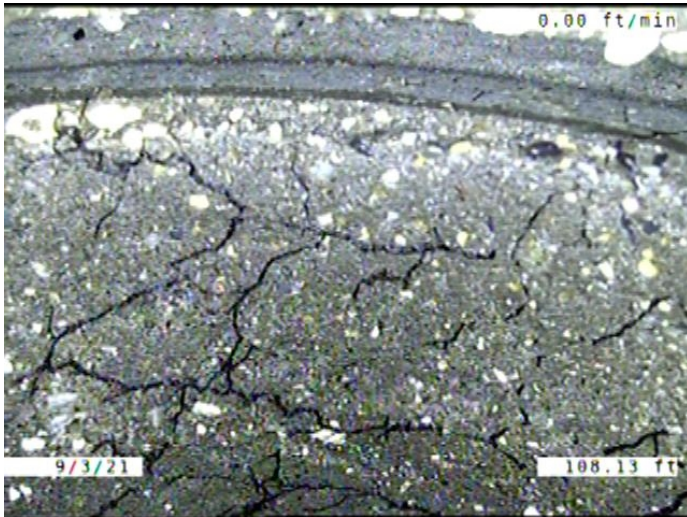
Code: **RFJ**  
 Description: **Roots Fine Joint**

Distance (ft): **108.1**  
 Structural Grade: **0**  
 O&M Grade: **1**  
 Clock Start/From: **10**  
 Clock To: **3**  
 1st Value:  
 2nd Value:  
 Value Percent:  
 Continuous Index:  
 Within 8" of Joint: **YES**  
 Remarks:

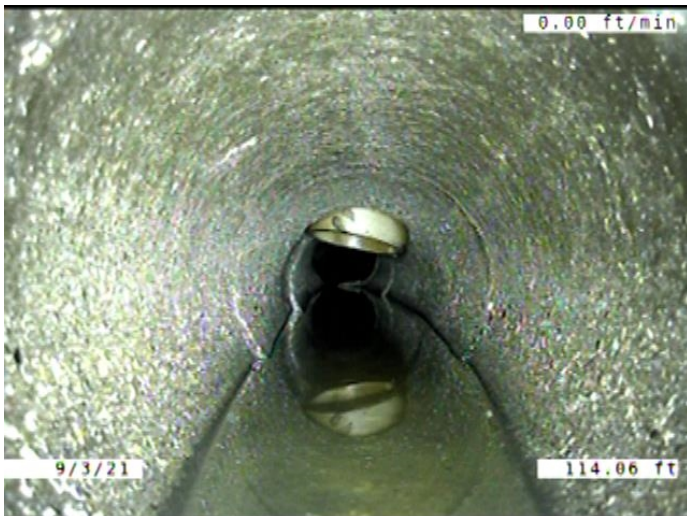
Code: **MWLS**  
 Description: **Miscellaneous Water Level Sag**

Distance (ft): **114.1**  
 Structural Grade: **2**  
 O&M Grade: **0**  
 Clock Start/From:  
 Clock To:  
 1st Value:  
 2nd Value:  
 Value Percent: **10.000**  
 Continuous Index: **S04**  
 Within 8" of Joint: **NO**  
 Remarks:

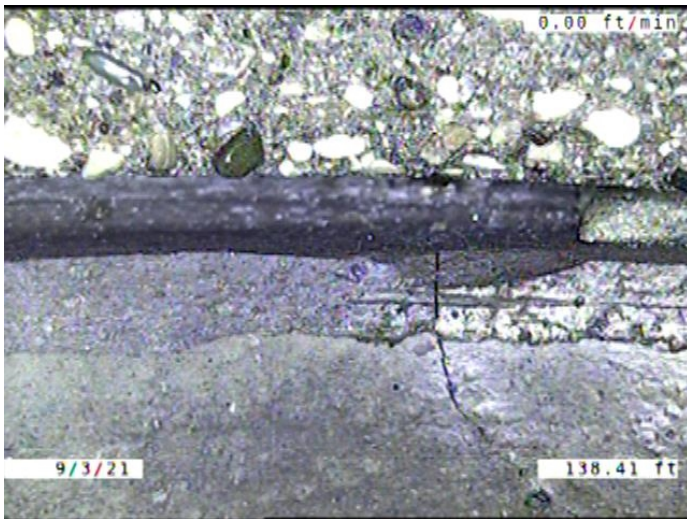
Code: **MMC**  
 Description: **Miscellaneous Material Change**

Distance (ft): **138.4**  
 Structural Grade: **0**  
 O&M Grade: **0**  
 Clock Start/From:  
 Clock To:  
 1st Value:  
 2nd Value:  
 Value Percent:  
 Continuous Index:  
 Within 8" of Joint: **NO**  
 Remarks: **CONCRETE TO VCP**

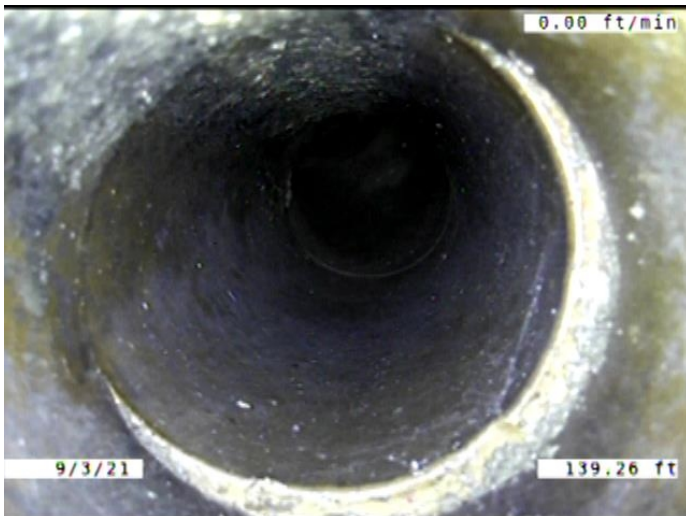
Code: **TF**  
 Description: **Tap Factory**

Distance (ft): **139.3**  
 Structural Grade: **0**  
 O&M Grade: **0**  
 Clock Start/From: **11**  
 Clock To:  
 1st Value: **6.000**  
 2nd Value:  
 Value Percent:  
 Continuous Index:  
 Within 8" of Joint: **YES**  
 Remarks:

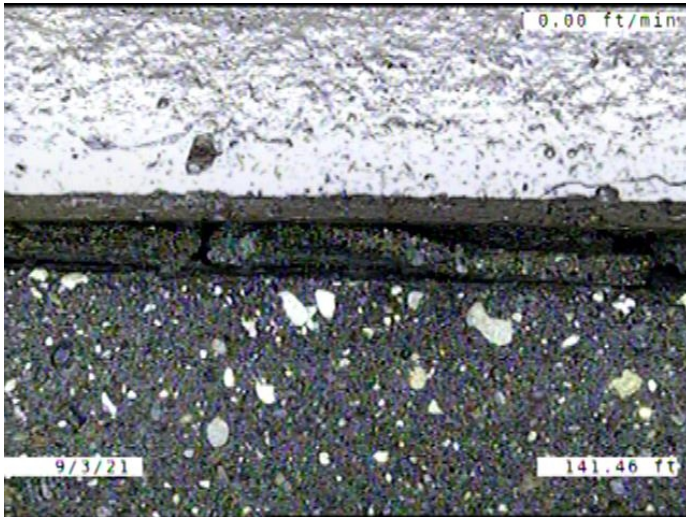
Code: **MMC**  
 Description: **Miscellaneous Material Change**

Distance (ft): **141.5**  
 Structural Grade: **0**  
 O&M Grade: **0**  
 Clock Start/From:  
 Clock To:  
 1st Value:  
 2nd Value:  
 Value Percent:  
 Continuous Index:  
 Within 8" of Joint: **NO**  
 Remarks: **VCP TO CONCRETE**

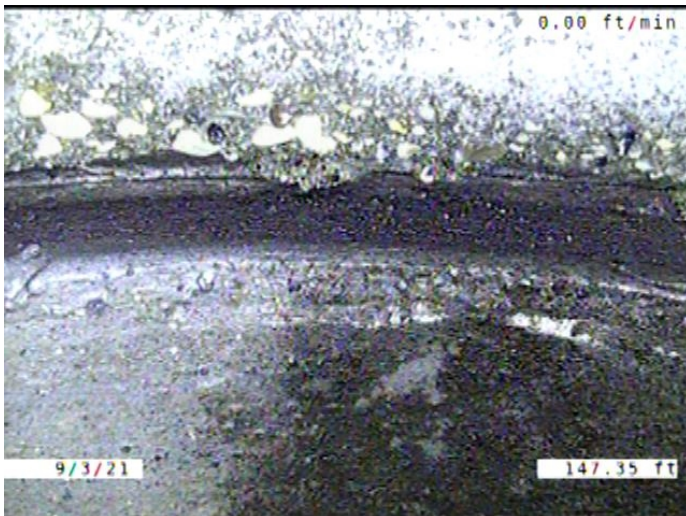
Code: **MMC**  
 Description: **Miscellaneous Material Change**

Distance (ft): **147.4**  
 Structural Grade: **0**  
 O&M Grade: **0**  
 Clock Start/From:  
 Clock To:  
 1st Value:  
 2nd Value:  
 Value Percent:  
 Continuous Index:  
 Within 8" of Joint: **NO**  
 Remarks: **CONCRETE TO VCP**

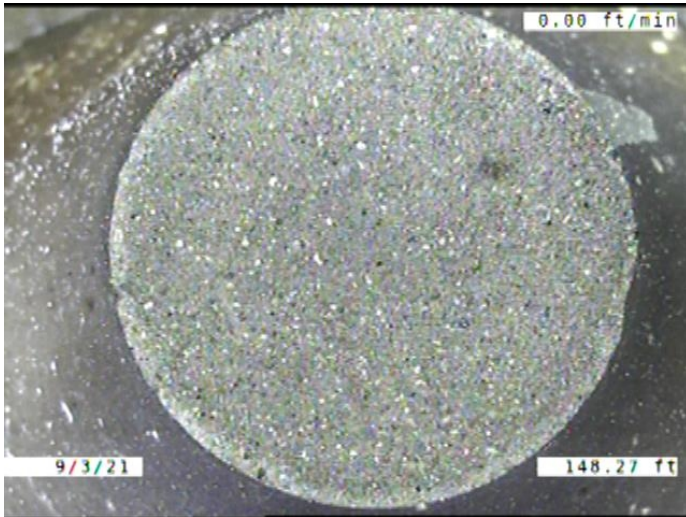
Code: **TFC**  
 Description: **Tap Factory Capped**

Distance (ft): **148.3**  
 Structural Grade: **0**  
 O&M Grade: **0**  
 Clock Start/From: **1**  
 Clock To:  
 1st Value: **6.000**  
 2nd Value:  
 Value Percent:  
 Continuous Index:  
 Within 8" of Joint: **YES**  
 Remarks:

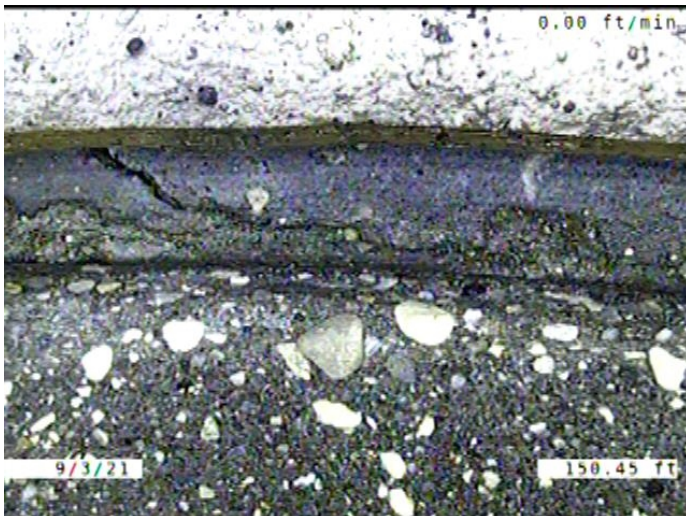
Code: **MMC**  
 Description: **Miscellaneous Material Change**

Distance (ft): **150.4**  
 Structural Grade: **0**  
 O&M Grade: **0**  
 Clock Start/From:  
 Clock To:  
 1st Value:  
 2nd Value:  
 Value Percent:  
 Continuous Index:  
 Within 8" of Joint: **NO**  
 Remarks: **VCP TO CONCRETE**

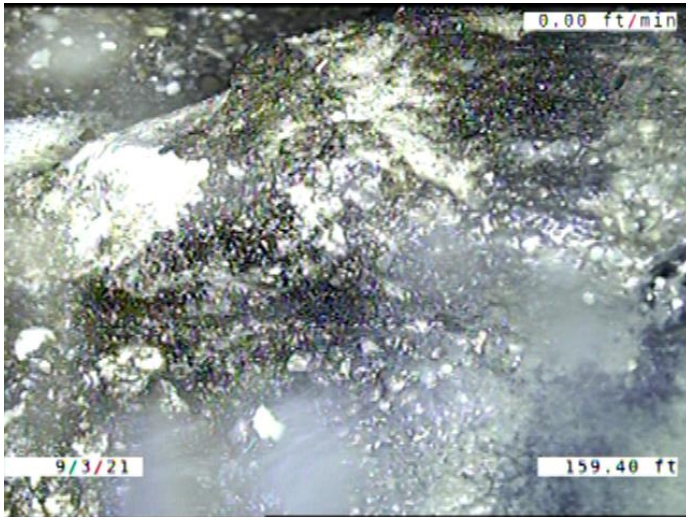
Code: **DAE**  
 Description: **Deposits Attached Encrustation**

Distance (ft): **159.4**  
 Structural Grade: **0**  
 O&M Grade: **2**  
 Clock Start/From: **4**  
 Clock To: **8**  
 1st Value:  
 2nd Value:  
 Value Percent: **5.000**  
 Continuous Index:  
 Within 8" of Joint: **YES**  
 Remarks:

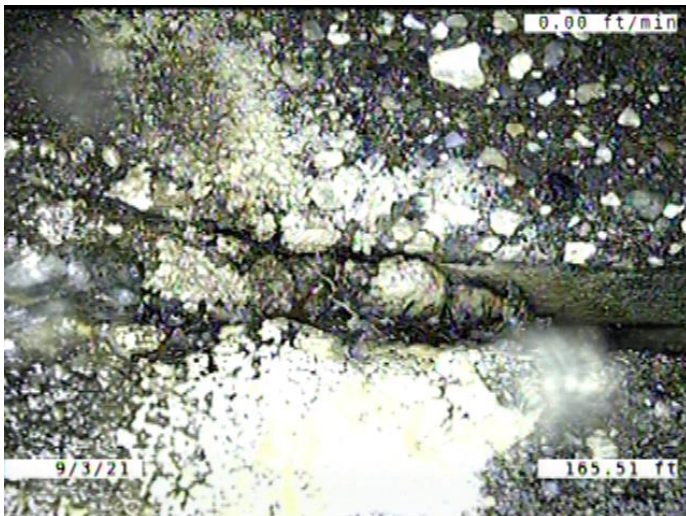
Code: **DAE**  
 Description: **Deposits Attached Encrustation**

Distance (ft): **165.5**  
 Structural Grade: **0**  
 O&M Grade: **2**  
 Clock Start/From: **4**  
 Clock To:  
 1st Value:  
 2nd Value:  
 Value Percent: **5.000**  
 Continuous Index:  
 Within 8" of Joint: **YES**  
 Remarks:

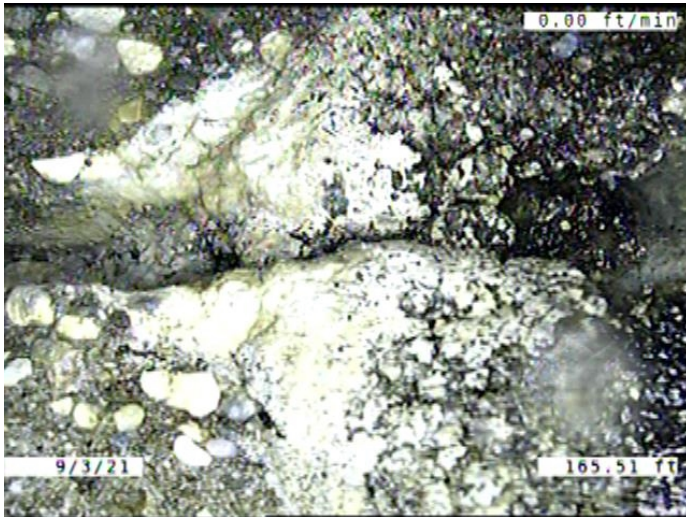
Code: **DAE**  
 Description: **Deposits Attached Encrustation**

Distance (ft): **165.5**  
 Structural Grade: **0**  
 O&M Grade: **2**  
 Clock Start/From: **7**  
 Clock To: **8**  
 1st Value:  
 2nd Value:  
 Value Percent: **5.000**  
 Continuous Index:  
 Within 8" of Joint: **YES**  
 Remarks:

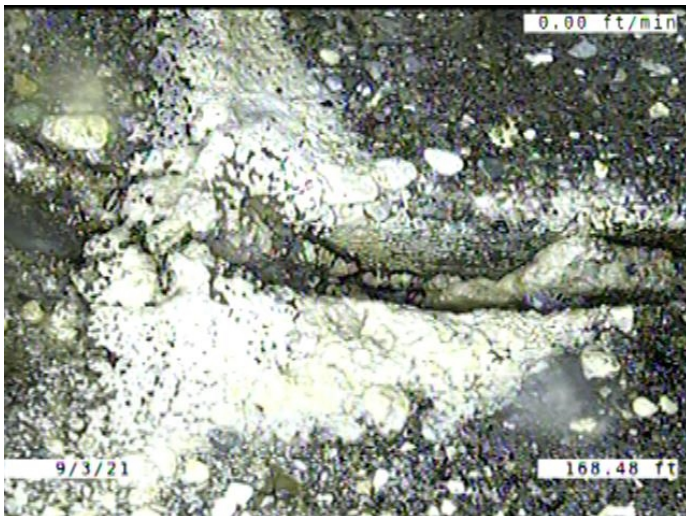
Code: **DAE**  
 Description: **Deposits Attached Encrustation**

Distance (ft): **168.5**  
 Structural Grade: **0**  
 O&M Grade: **2**  
 Clock Start/From: **4**  
 Clock To:  
 1st Value:  
 2nd Value:  
 Value Percent: **5.000**  
 Continuous Index:  
 Within 8" of Joint: **YES**  
 Remarks:

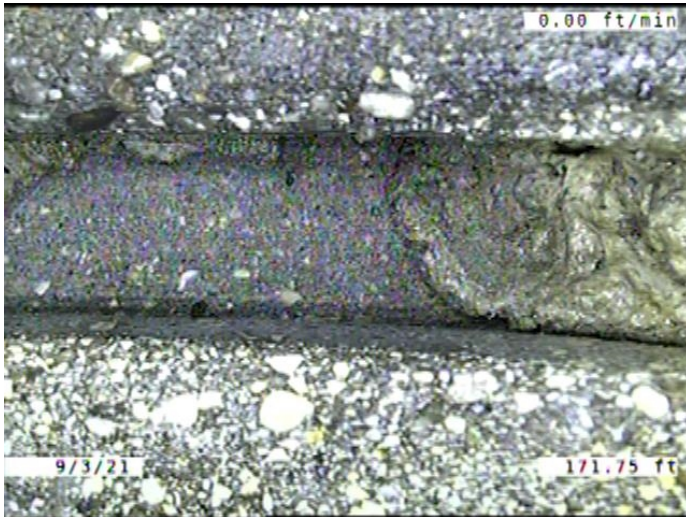
Code: **JAM**  
 Description: **Joint Angular Medium**

Distance (ft): **171.8**  
 Structural Grade: **3**  
 O&M Grade: **0**  
 Clock Start/From:  
 Clock To:  
 1st Value:  
 2nd Value:  
 Value Percent:  
 Continuous Index:  
 Within 8" of Joint: **NO**  
 Remarks:

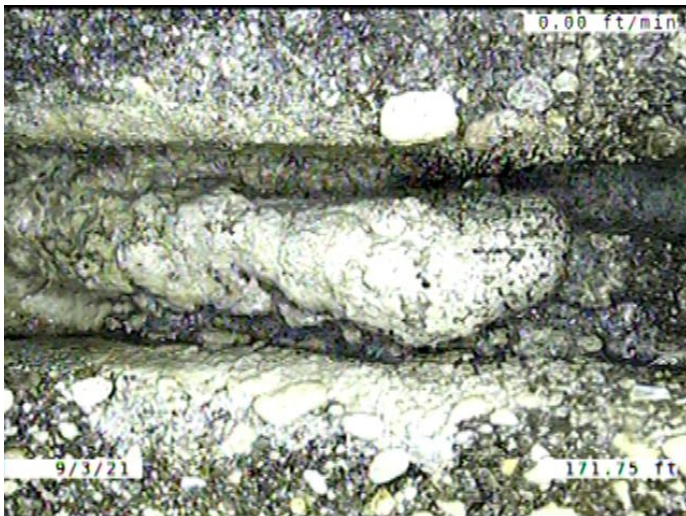
Code: **DAE**  
 Description: **Deposits Attached Encrustation**

Distance (ft): **171.8**  
 Structural Grade: **0**  
 O&M Grade: **2**  
 Clock Start/From: **4**  
 Clock To:  
 1st Value:  
 2nd Value:  
 Value Percent: **5.000**  
 Continuous Index:  
 Within 8" of Joint: **YES**  
 Remarks:

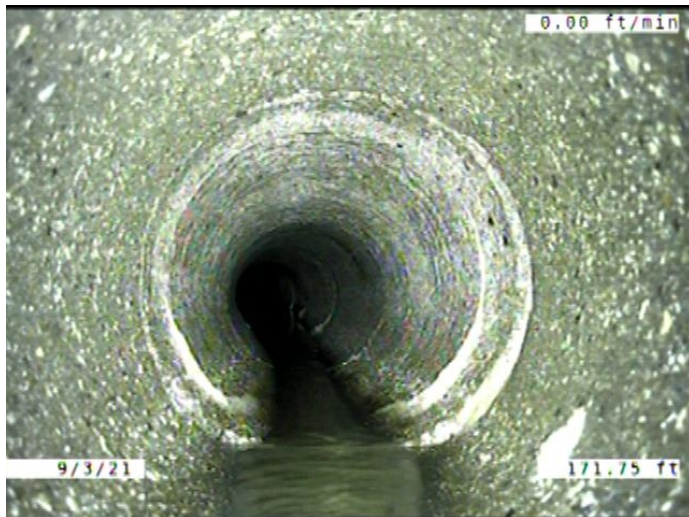
Code: **LL**  
 Description: **Line Left**

Distance (ft): **171.8**  
 Structural Grade: **0**  
 O&M Grade: **1**  
 Clock Start/From:  
 Clock To:  
 1st Value:  
 2nd Value:  
 Value Percent: **5.000**  
 Continuous Index:  
 Within 8" of Joint: **NO**  
 Remarks:

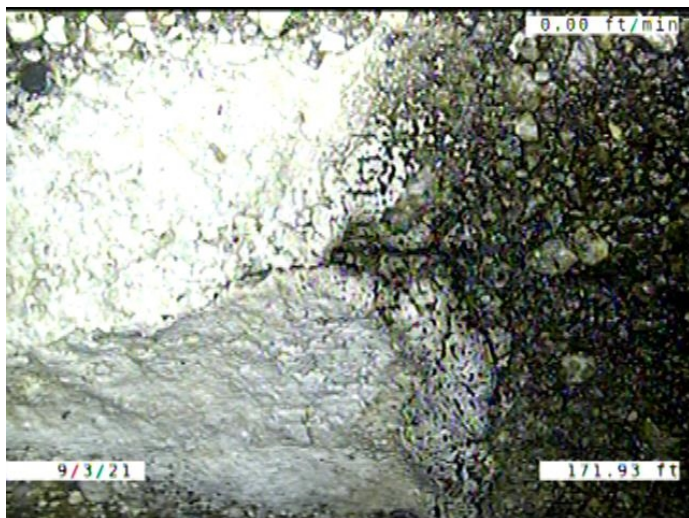
Code: **DAE**  
 Description: **Deposits Attached Encrustation**

Distance (ft): **171.9**  
 Structural Grade: **0**  
 O&M Grade: **2**  
 Clock Start/From: **8**  
 Clock To: **5**  
 1st Value:  
 2nd Value:  
 Value Percent: **5.000**  
 Continuous Index:  
 Within 8" of Joint: **YES**  
 Remarks:

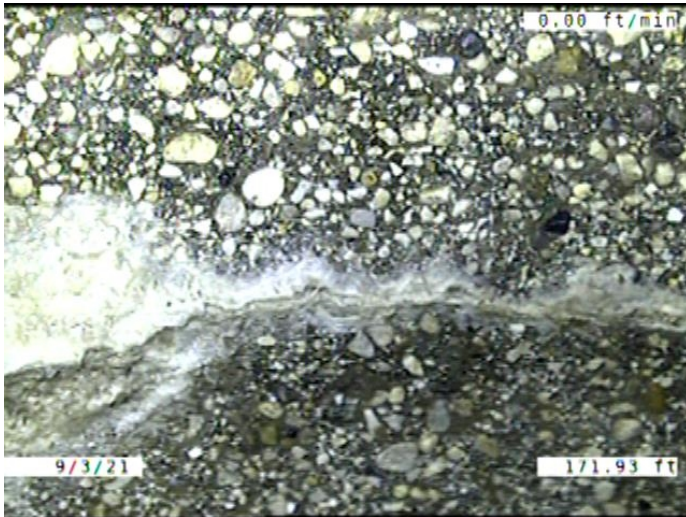
Code: **CM**  
 Description: **Crack Multiple**

Distance (ft): **171.9**  
 Structural Grade: **3**  
 O&M Grade: **0**  
 Clock Start/From: **12**  
 Clock To: **12**  
 1st Value:  
 2nd Value:  
 Value Percent:  
 Continuous Index:  
 Within 8" of Joint: **YES**  
 Remarks:

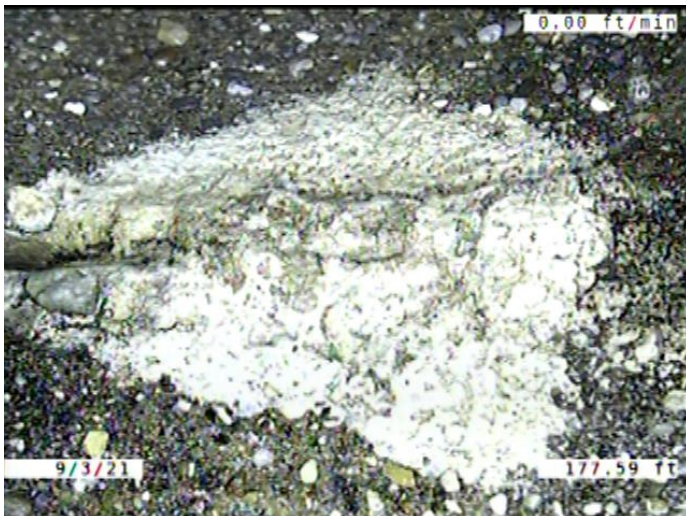
Code: **DAE**  
 Description: **Deposits Attached Encrustation**

Distance (ft): **177.6**  
 Structural Grade: **0**  
 O&M Grade: **2**  
 Clock Start/From: **8**  
 Clock To:  
 1st Value:  
 2nd Value:  
 Value Percent: **5.000**  
 Continuous Index:  
 Within 8" of Joint: **YES**  
 Remarks:

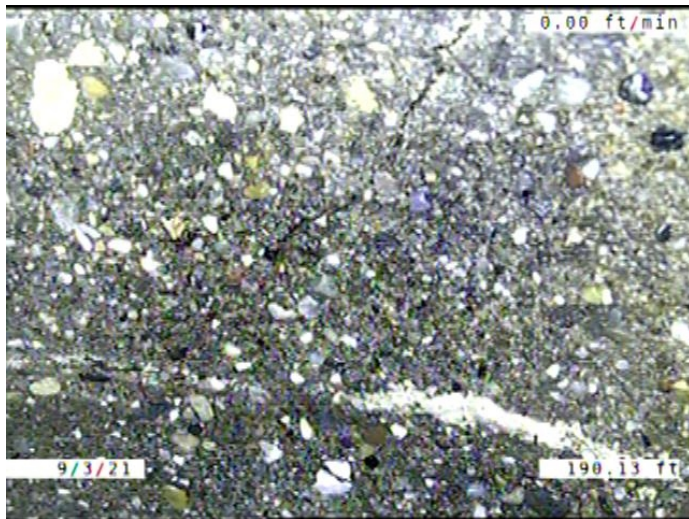
Code: **CM**  
 Description: **Crack Multiple**

Distance (ft): **190.1**  
 Structural Grade: **3**  
 O&M Grade: **0**  
 Clock Start/From: **12**  
 Clock To: **3**  
 1st Value:  
 2nd Value:  
 Value Percent:  
 Continuous Index:  
 Within 8" of Joint: **YES**  
 Remarks:

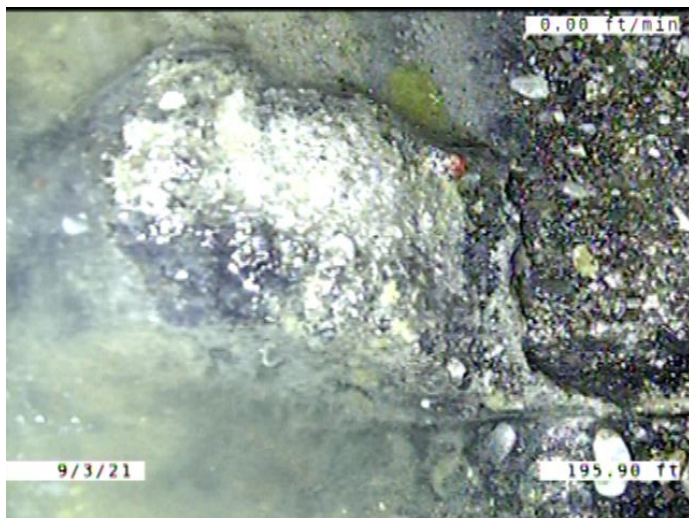
Code: **DAE**  
 Description: **Deposits Attached Encrustation**

Distance (ft): **195.9**  
 Structural Grade: **0**  
 O&M Grade: **2**  
 Clock Start/From: **4**  
 Clock To: **7**  
 1st Value:  
 2nd Value:  
 Value Percent: **5.000**  
 Continuous Index:  
 Within 8" of Joint: **YES**  
 Remarks:

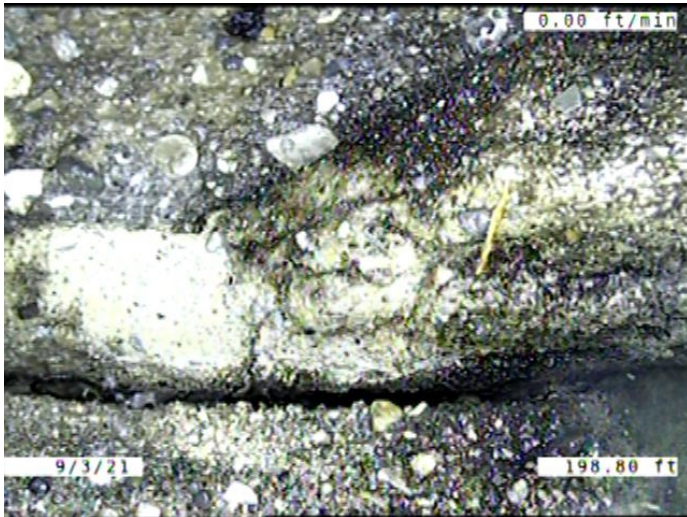
Code: **DAE**  
 Description: **Deposits Attached Encrustation**

Distance (ft): **198.8**  
 Structural Grade: **0**  
 O&M Grade: **2**  
 Clock Start/From: **4**  
 Clock To: **8**  
 1st Value:  
 2nd Value:  
 Value Percent: **5.000**  
 Continuous Index:  
 Within 8" of Joint: **YES**  
 Remarks:

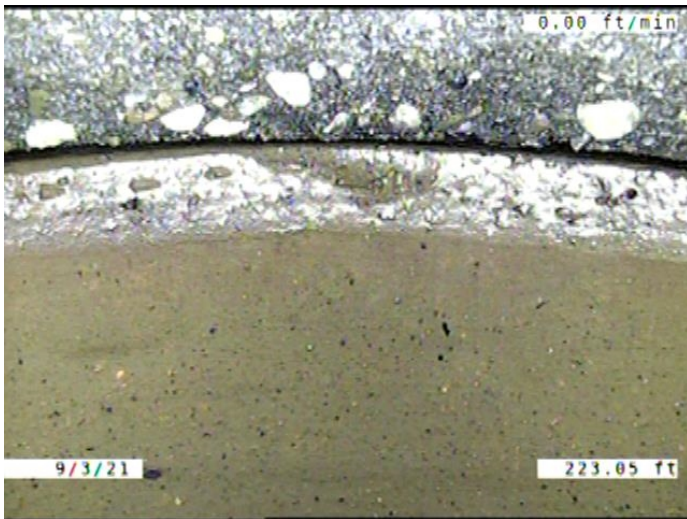
Code: **RFJ**  
 Description: **Roots Fine Joint**

Distance (ft): **217.1**  
 Structural Grade: **0**  
 O&M Grade: **1**  
 Clock Start/From: **8**  
 Clock To: **9**  
 1st Value:  
 2nd Value:  
 Value Percent:  
 Continuous Index:  
 Within 8" of Joint: **YES**  
 Remarks:

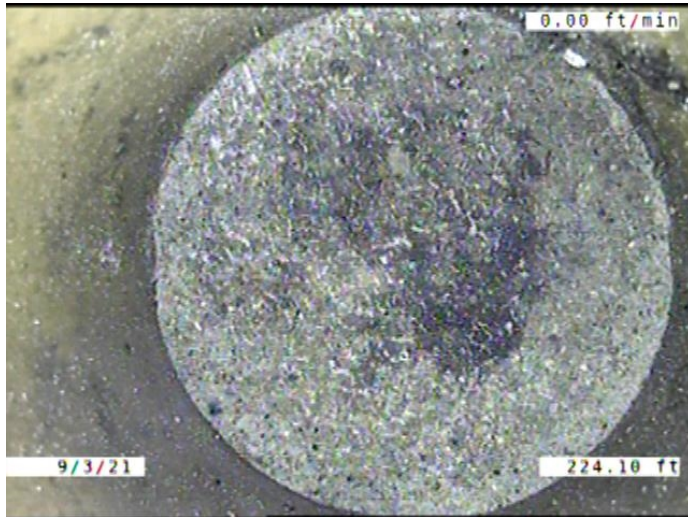
Code: **MMC**  
 Description: **Miscellaneous Material Change**

Distance (ft): **223.1**  
 Structural Grade: **0**  
 O&M Grade: **0**  
 Clock Start/From:  
 Clock To:  
 1st Value:  
 2nd Value:  
 Value Percent:  
 Continuous Index:  
 Within 8" of Joint: **NO**  
 Remarks: **CONCRETE TO VCP**

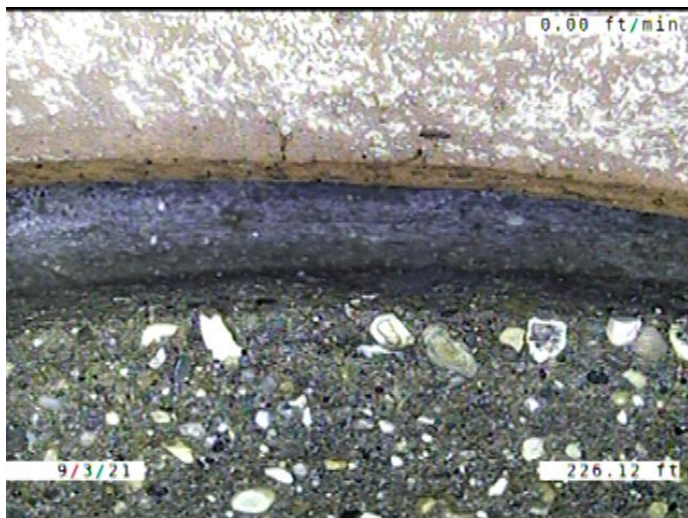
Code: **TFC**  
 Description: **Tap Factory Capped**

Distance (ft): **224.1**  
 Structural Grade: **0**  
 O&M Grade: **0**  
 Clock Start/From: **1**  
 Clock To:  
 1st Value: **6.000**  
 2nd Value:  
 Value Percent:  
 Continuous Index:  
 Within 8" of Joint: **YES**  
 Remarks:

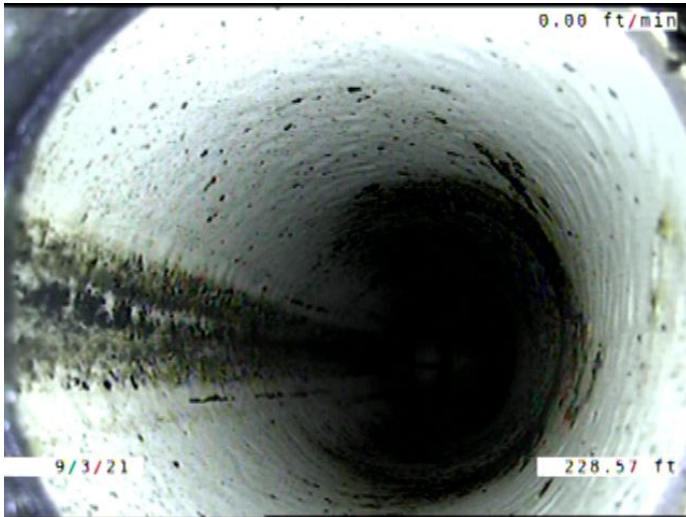
Code: **MMC**  
 Description: **Miscellaneous Material Change**

Distance (ft): **226.1**  
 Structural Grade: **0**  
 O&M Grade: **0**  
 Clock Start/From:  
 Clock To:  
 1st Value:  
 2nd Value:  
 Value Percent:  
 Continuous Index:  
 Within 8" of Joint: **NO**  
 Remarks: **VCP TO CONCRETE**

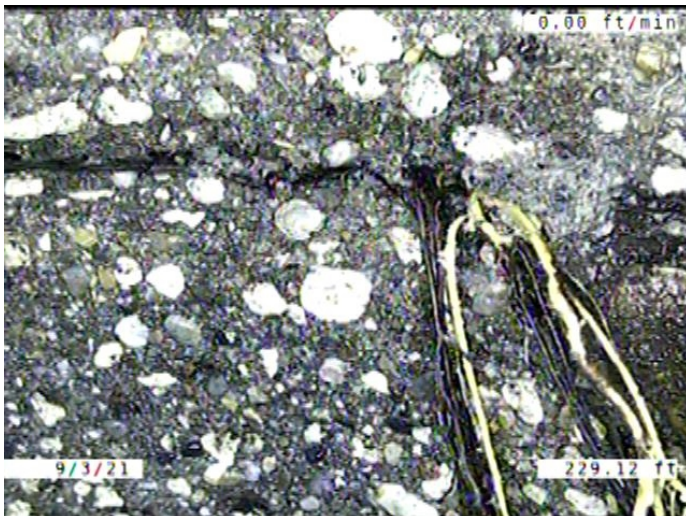
Code: **TB**  
 Description: **Tap Break-in/Hammer**

Distance (ft): **228.6**  
 Structural Grade: **0**  
 O&M Grade: **0**  
 Clock Start/From: **10**  
 Clock To:  
 1st Value: **4.000**  
 2nd Value:  
 Value Percent:  
 Continuous Index:  
 Within 8" of Joint: **NO**  
 Remarks:

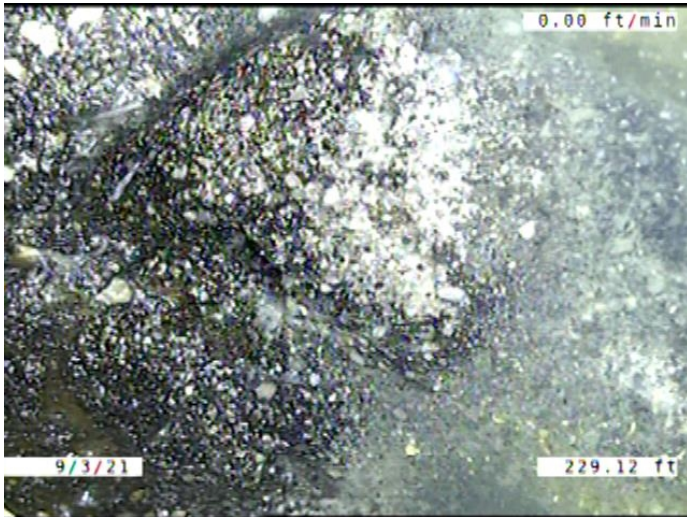
Code: **RFJ**  
 Description: **Roots Fine Joint**

Distance (ft): **229.1**  
 Structural Grade: **0**  
 O&M Grade: **1**  
 Clock Start/From: **3**  
 Clock To:  
 1st Value:  
 2nd Value:  
 Value Percent:  
 Continuous Index:  
 Within 8" of Joint: **YES**  
 Remarks:

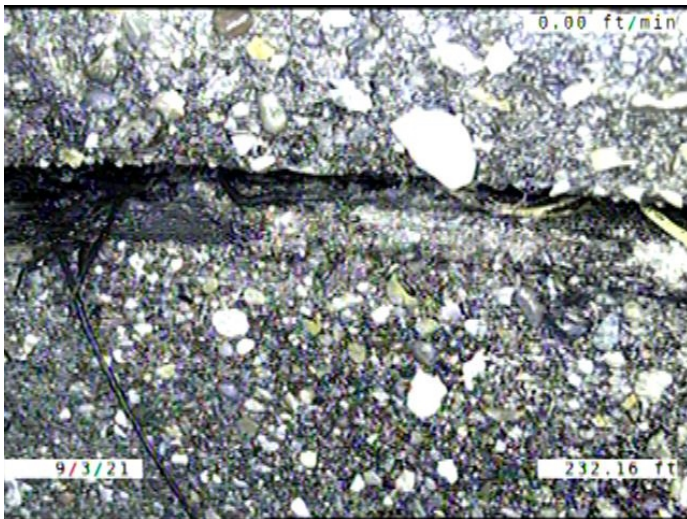
Code: **DAE**  
 Description: **Deposits Attached Encrustation**

Distance (ft): **229.1**  
 Structural Grade: **0**  
 O&M Grade: **2**  
 Clock Start/From: **4**  
 Clock To: **7**  
 1st Value:  
 2nd Value:  
 Value Percent: **5.000**  
 Continuous Index:  
 Within 8" of Joint: **YES**  
 Remarks:

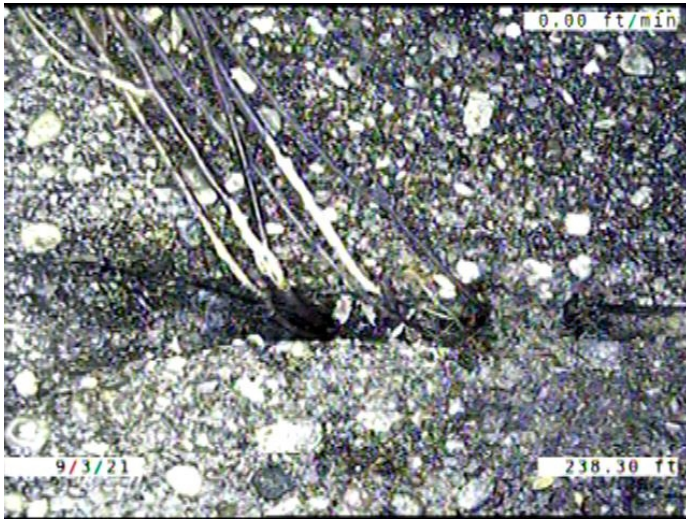
Code: **RFJ**  
 Description: **Roots Fine Joint**

Distance (ft): **232.2**  
 Structural Grade: **0**  
 O&M Grade: **1**  
 Clock Start/From: **3**  
 Clock To: **4**  
 1st Value:  
 2nd Value:  
 Value Percent:  
 Continuous Index:  
 Within 8" of Joint: **YES**  
 Remarks:

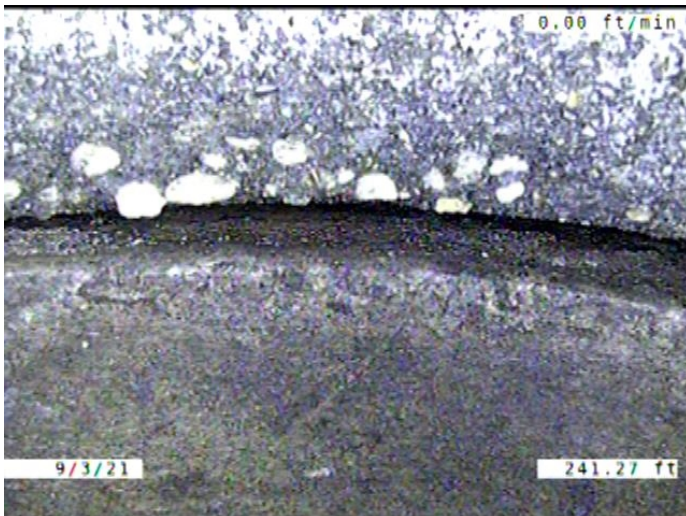
Code: **RFJ**  
Description: **Roots Fine Joint**

Distance (ft): **238.3**  
Structural Grade: **0**  
O&M Grade: **1**  
Clock Start/From: **4**  
Clock To:  
1st Value:  
2nd Value:  
Value Percent:  
Continuous Index:  
Within 8" of Joint: **YES**  
Remarks:

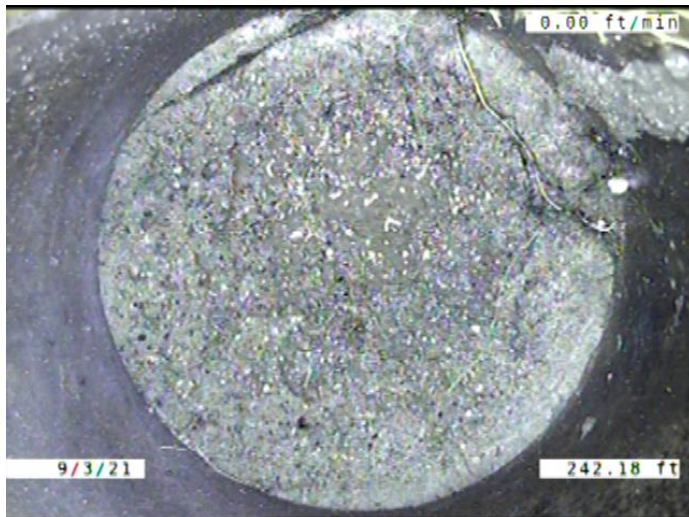
Code: **MMC**  
Description: **Miscellaneous Material Change**

Distance (ft): **241.3**  
Structural Grade: **0**  
O&M Grade: **0**  
Clock Start/From:  
Clock To:  
1st Value:  
2nd Value:  
Value Percent:  
Continuous Index:  
Within 8" of Joint: **NO**  
Remarks: **CONCRETE TO VCP**

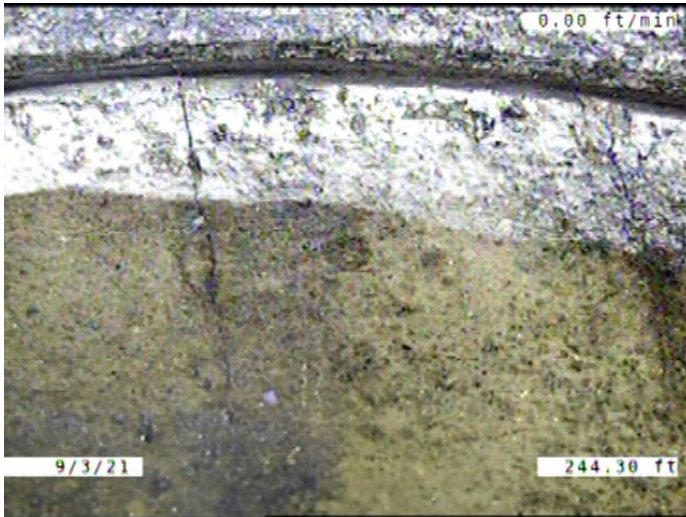
Code:	<b>RFJ</b>
Description:	<b>Roots Fine Joint</b>
Distance (ft):	<b>244.3</b>
Structural Grade:	<b>0</b>
O&M Grade:	<b>1</b>
Clock Start/From:	<b>8</b>
Clock To:	<b>4</b>
1st Value:	
2nd Value:	
Value Percent:	
Continuous Index:	
Within 8" of Joint:	<b>YES</b>
Remarks:

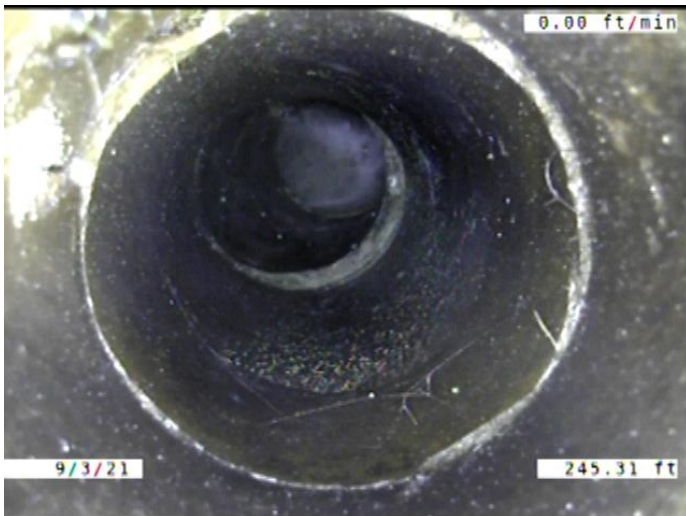
Code: **CM**  
 Description: **Crack Multiple**

Distance (ft): **244.3**  
 Structural Grade: **3**  
 O&M Grade: **0**  
 Clock Start/From: **10**  
 Clock To: **2**  
 1st Value:  
 2nd Value:  
 Value Percent:  
 Continuous Index:  
 Within 8" of Joint: **YES**  
 Remarks:

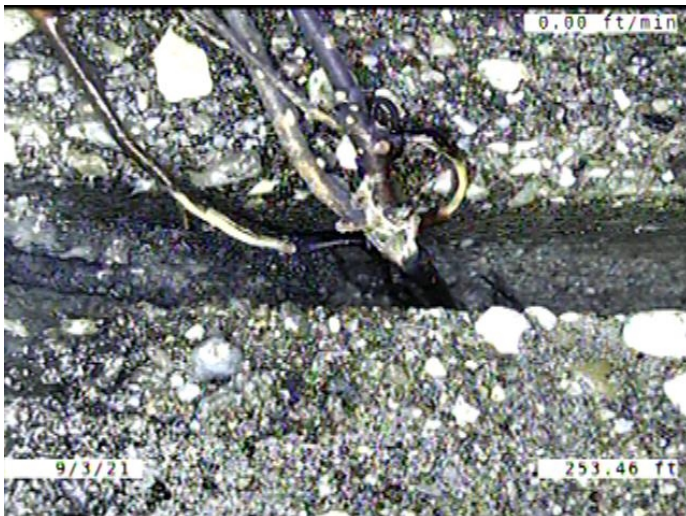
Code: **RFJ**  
Description: **Roots Fine Joint**

Distance (ft): **253.5**  
Structural Grade: **0**  
O&M Grade: **1**  
Clock Start/From: **8**  
Clock To: **9**  
1st Value:  
2nd Value:  
Value Percent:  
Continuous Index:  
Within 8" of Joint: **YES**  
Remarks:

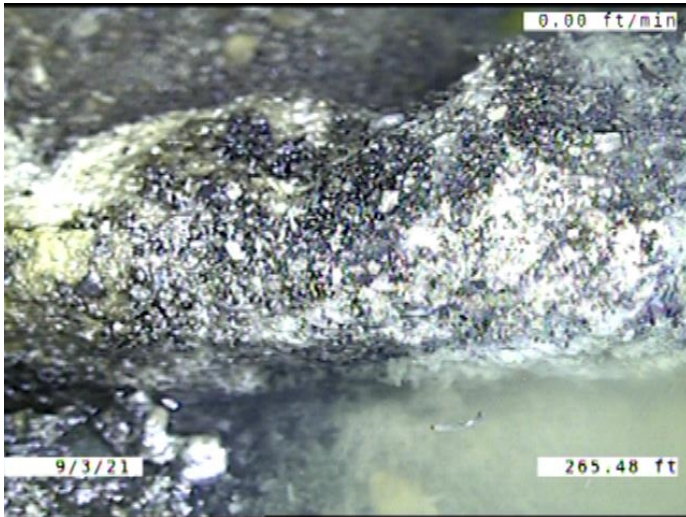
Code: **DAE**  
 Description: **Deposits Attached Encrustation**

Distance (ft): **259.3**  
 Structural Grade: **0**  
 O&M Grade: **2**  
 Clock Start/From: **4**  
 Clock To: **5**  
 1st Value:  
 2nd Value:  
 Value Percent: **5.000**  
 Continuous Index:  
 Within 8" of Joint: **YES**  
 Remarks:

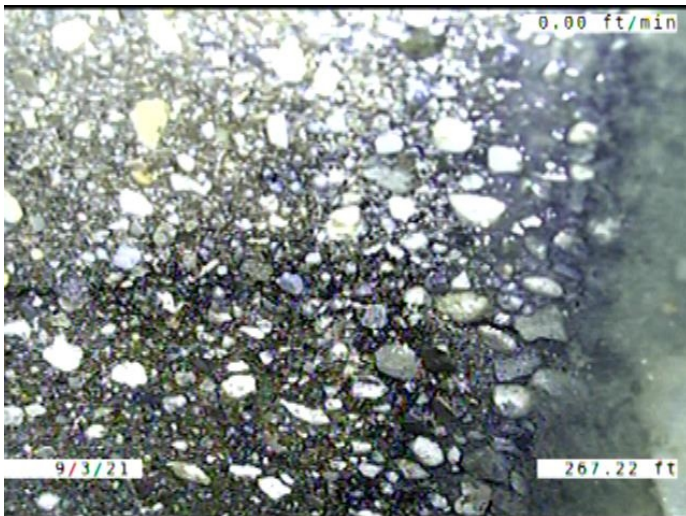
Code: **DAE**  
 Description: **Deposits Attached Encrustation**

Distance (ft): **265.5**  
 Structural Grade: **0**  
 O&M Grade: **2**  
 Clock Start/From: **4**  
 Clock To: **8**  
 1st Value:  
 2nd Value:  
 Value Percent: **5.000**  
 Continuous Index:  
 Within 8" of Joint: **YES**  
 Remarks:
