Profile/Photo Observation Report

Street:	ALLEY BETWEEN N GUYER ST & N WI	Flow Control:	Not Controlled
City:	Hobart, IN	Year Renewed:	
Location:	Light Highway	Tape/Media #:	
Purpose:	Not Known	Dia/Height:	10"
Use:	Sanitary	Material:	CP
Drain Area:	NA	Lining:	
Category:	NA		
Comment:

Location Details:		Direction of Survey:	Downstream
US MH:	M-504-127	DS MH:	M-504-126
		Total Length Surveyed (ft):	72.2

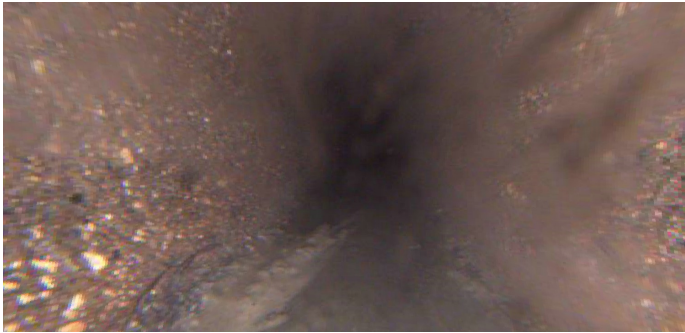
Code:	AMH
Description:	Manhole

Distance (ft):	.0
Structural Grade:	0
O&M Grade:	0
Clock Start/From:	
Clock To:	
1st Value:	
2nd Value:	
Value Percent:	
Continuous Index:	
Within 8" of Joint:	NO
Remarks:	M-504-127

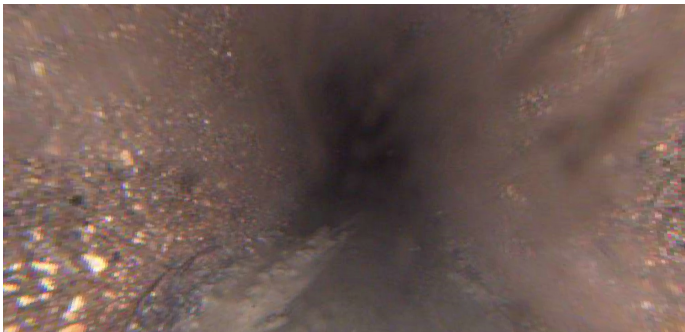
Code:	MWL
Description:	Water Level

Distance (ft):	.0
Structural Grade:	0
O&M Grade:	0
Clock Start/From:	
Clock To:	
1st Value:	
2nd Value:	
Value Percent:	5.000
Continuous Index:	
Within 8" of Joint:	NO
Remarks:

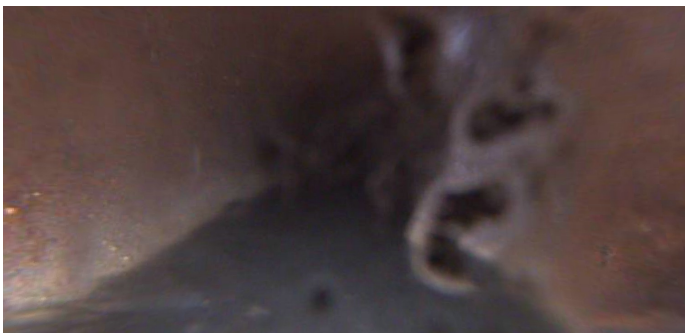
Code: **MMC**
Description: **Material Change**

Distance (ft): **68.4**
Structural Grade: **0**
O&M Grade: **0**
Clock Start/From:
Clock To:
1st Value:
2nd Value:
Value Percent:
Continuous Index:
Within 8" of Joint: **NO**
Remarks: **vcp**

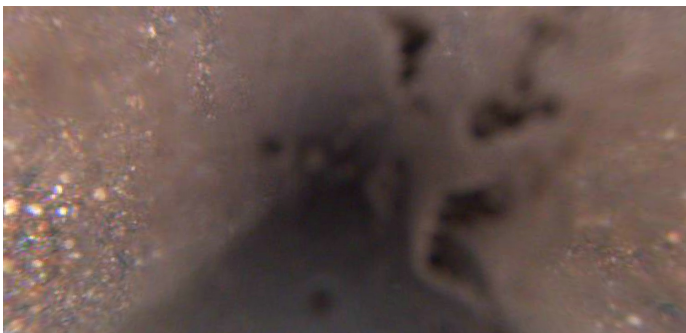
Code: **MMC**
Description: **Material Change**

Distance (ft): **72.2**
Structural Grade: **0**
O&M Grade: **0**
Clock Start/From:
Clock To:
1st Value:
2nd Value:
Value Percent:
Continuous Index:
Within 8" of Joint: **NO**
Remarks: **CP**
