Profile/Photo Observation Report

Date:	09/02/2021	Weather:		Coding:	PACP 7.0
Pipe Length (ft):	357.6	Owner:	City of Hobart	Pre Clean:	Light Cleaning
P.O.#:	YES502259	Surveyor:	S. Bucklin	PSR:	P-504-126-127
Customer:	City of Hobart	Clean Date:	08/30/2021	Shape:	C

Street:	North Wilson Street	Flow Control:	Not Controlled
City:	Hobart, IN	Year Renewed:	
Location:	Alley	Tape/Media #:	
Purpose:	Routine Assessment	Dia/Height:	10"
Use:	Sanitary Sewage Pipe	Material:	CP
Drain Area:		Lining:	
Category:	NA		
Comment:			
Location Details:		Direction of Survey:	Downstream
US MH:	M-504-127	DS MH:	M-504-126
		Total Length Surveyed (ft):	357.6

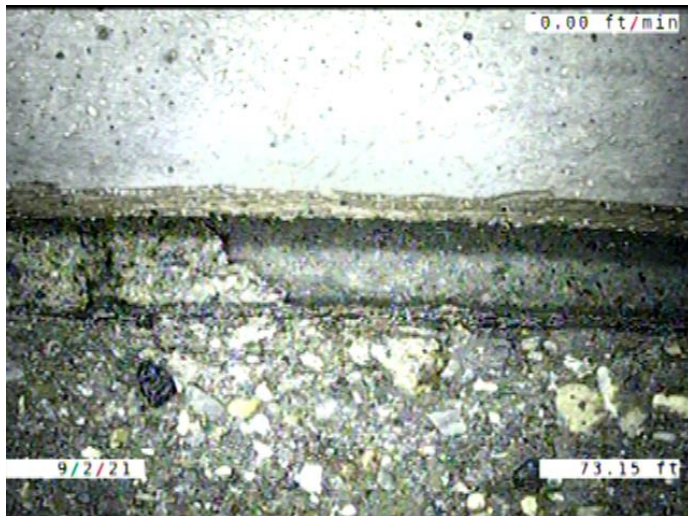
Code: **TF**
Description: **Tap Factory**

Distance (ft): **71.0**
Structural Grade: **0**
O&M Grade: **0**
Clock Start/From: **2**
Clock To:
1st Value: **6.000**
2nd Value:
Value Percent:
Continuous Index:
Within 8" of Joint: **YES**
Remarks: **ROOTS GROWING IN THE TAP**

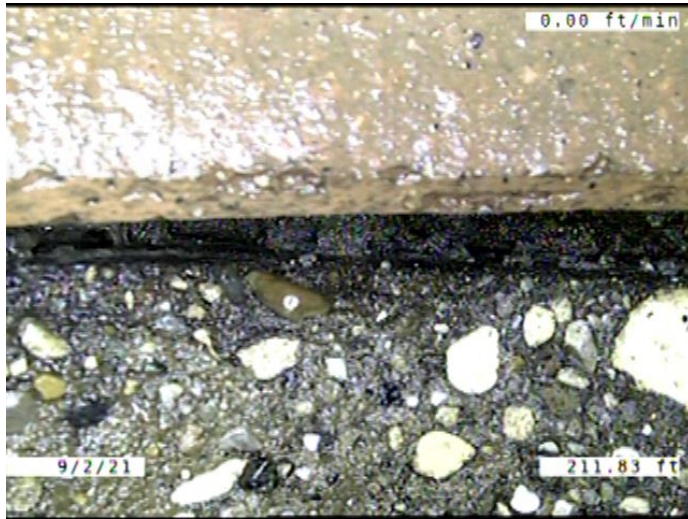
Code: **TFD**
 Description: **Tap Factory Defective**

Distance (ft): **209.5**
 Structural Grade: **0**
 O&M Grade: **3**
 Clock Start/From: **2**
 Clock To:
 1st Value: **6.000**
 2nd Value:
 Value Percent:
 Continuous Index:
 Within 8" of Joint: **YES**
 Remarks: **Debris**

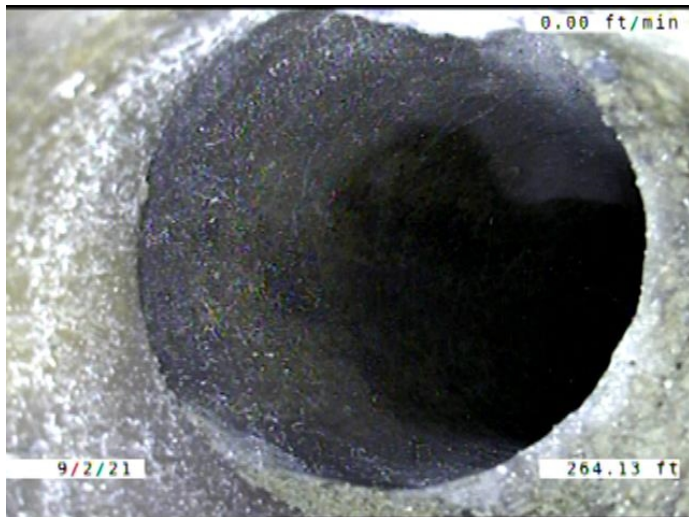
Code: **FM**
 Description: **Fracture Multiple**

Distance (ft): **263.1**
 Structural Grade: **4**
 O&M Grade: **0**
 Clock Start/From: **11**
 Clock To: **1**
 1st Value:
 2nd Value:
 Value Percent:
 Continuous Index:
 Within 8" of Joint: **YES**
 Remarks:

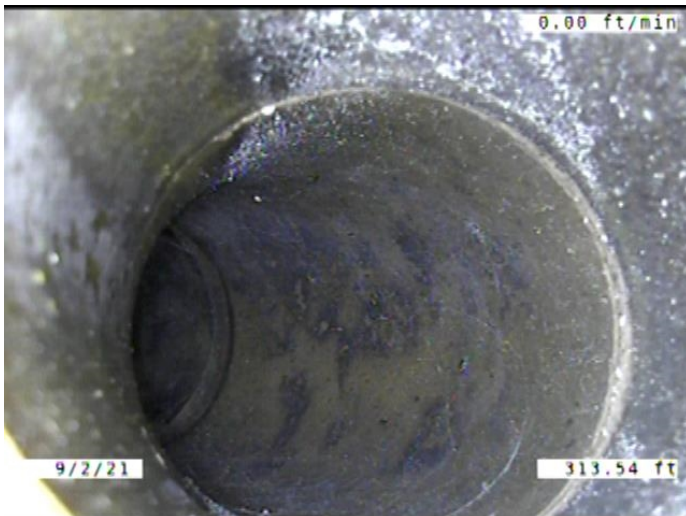
Code: **ISB**
Description: **Infiltration Stain Barrel**

Distance (ft): **312.5**
Structural Grade: **0**
O&M Grade: **1**
Clock Start/From: **7**
Clock To: **10**
1st Value:
2nd Value:
Value Percent:
Continuous Index:
Within 8" of Joint: **YES**
Remarks:

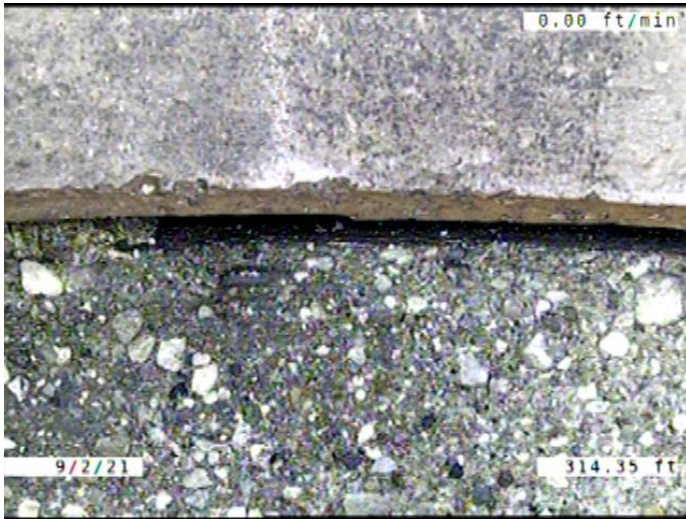
Code: **TB**
Description: **Tap Break-in/Hammer**

Distance (ft): **313.5**
Structural Grade: **0**
O&M Grade: **0**
Clock Start/From: **11**
Clock To:
1st Value: **6.000**
2nd Value:
Value Percent:
Continuous Index:
Within 8" of Joint: **YES**
Remarks:

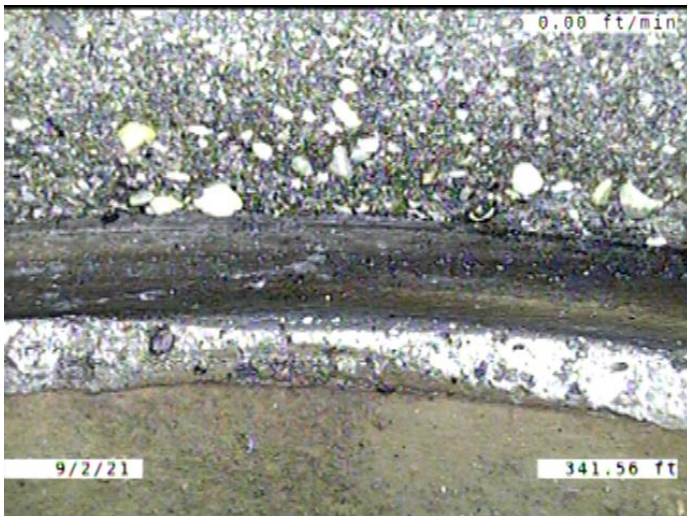
Code: **MWLS**
 Description: **Miscellaneous Water Level Sag**

Distance (ft): **332.0**
 Structural Grade: **2**
 O&M Grade: **0**
 Clock Start/From:
 Clock To:
 1st Value:
 2nd Value:
 Value Percent: **5.000**
 Continuous Index: **F06**
 Within 8" of Joint: **NO**
 Remarks:
