# Profile/Photo Observation Report

Date:	09/02/2021	Weather:		Coding:	PACP 7.0
Pipe Length (ft):	357.6	Owner:	City of Hobart	Pre Clean:	Light Cleaning
P.O.#:	YES502259	Surveyor:	S. Bucklin	PSR:	P-504-126-127
Customer:	City of Hobart	Clean Date:	08/30/2021	Shape:	C

Street:	North Wilson Street	Flow Control:	Not Controlled
City:	Hobart, IN	Year Renewed:	
Location:	Alley	Tape/Media #:	
Purpose:	Routine Assessment	Dia/Height:	10"
Use:	Sanitary Sewage Pipe	Material:	CP
Drain Area:		Lining:	
Category:	NA		
Comment:			
Location Details:		Direction of Survey:	Downstream
US MH:	M-504-127	DS MH:	M-504-126
		Total Length Surveyed (ft):	357.6

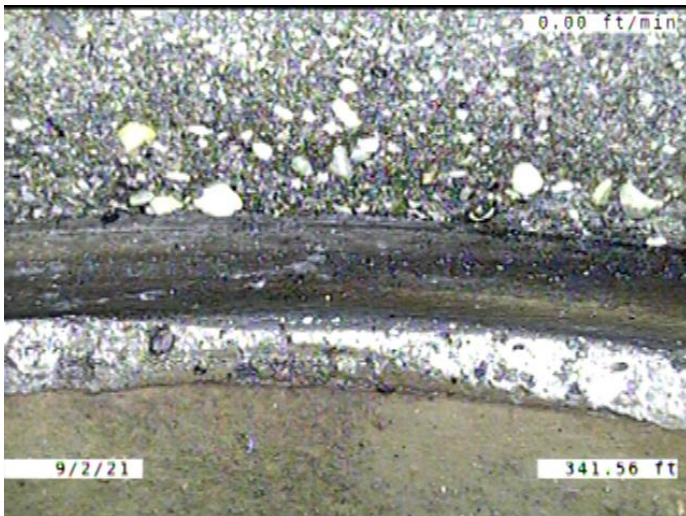
Code: **MWLS**  
 Description: **Miscellaneous Water Level Sag**

Distance (ft): **332.0**  
 Structural Grade: **2**  
 O&M Grade: **0**  
 Clock Start/From:  
 Clock To:  
 1st Value:  
 2nd Value:  
 Value Percent: **5.000**  
 Continuous Index: **F06**  
 Within 8" of Joint: **NO**  
 Remarks:

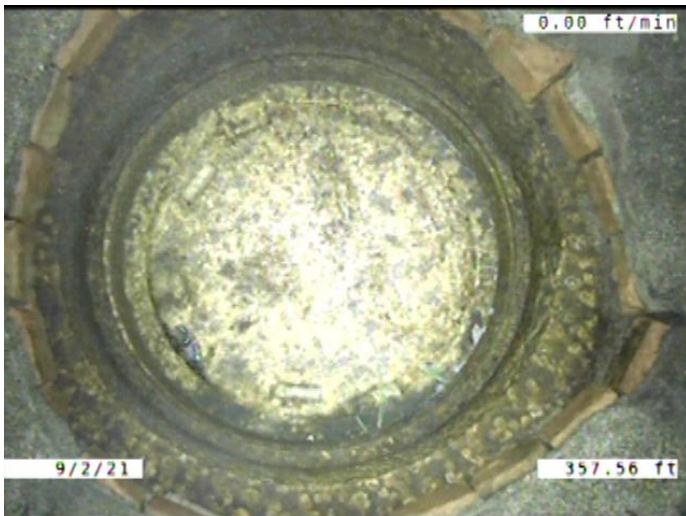
Code: **DSF**  
 Description: **Deposits Settled Fine**

Distance (ft): **356.2**  
 Structural Grade: **0**  
 O&M Grade: **2**  
 Clock Start/From: **5**  
 Clock To: **7**  
 1st Value:  
 2nd Value:  
 Value Percent: **5.000**  
 Continuous Index: **F04**  
 Within 8" of Joint: **YES**  
 Remarks:
