Profile/Photo Observation Report

Date:	09/02/2021	Weather:		Coding:	PACP 7.0
Pipe Length (ft):	286.3	Owner:	City of Hobart	Pre Clean:	Light Cleaning
P.O.#:	YES502259	Surveyor:	S. Bucklin	PSR:	P-504-127-128
Customer:	City of Hobart	Clean Date:	08/30/2021	Shape:	C

Street:	North Wilson Street	Flow Control:	Not Controlled
City:	Hobart, IN	Year Renewed:	
Location:	Alley	Tape/Media #:	
Purpose:	Routine Assessment	Dia/Height:	10"
Use:	Sanitary Sewage Pipe	Material:	CP
Drain Area:		Lining:	
Category:	NA		
Comment:			
Location Details:		Direction of Survey:	Downstream
US MH:	M-504-128	DS MH:	M-504-127
		Total Length Surveyed (ft):	286.3

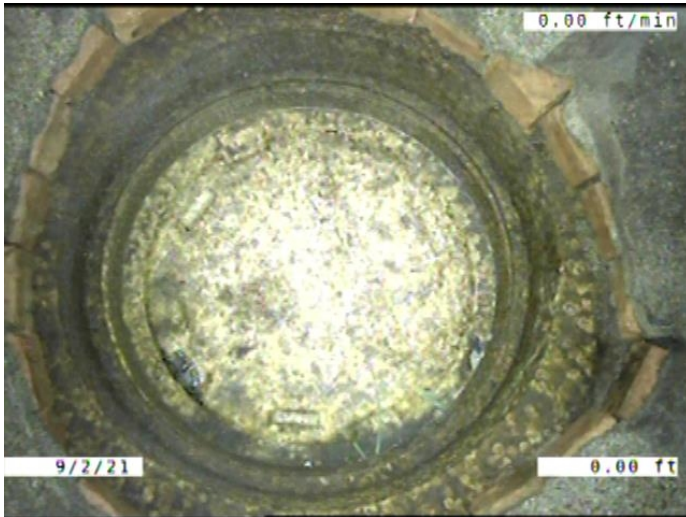
Code: **AMH**
Description: **Manhole**

Distance (ft): **.0**
Structural Grade: **0**
O&M Grade: **0**
Clock Start/From:
Clock To:
1st Value:
2nd Value:
Value Percent:
Continuous Index:
Within 8" of Joint: **NO**
Remarks: **M-504-128**

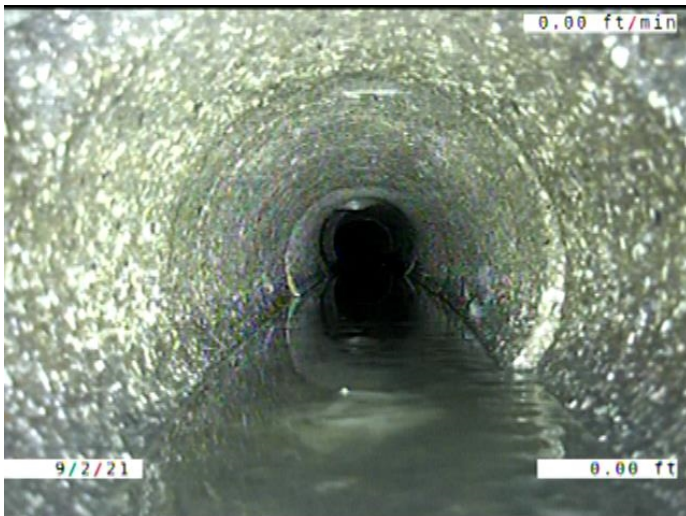
Code: **MWL**
Description: **Miscellaneous Water Level**

Distance (ft): **.0**
Structural Grade: **0**
O&M Grade: **0**
Clock Start/From:
Clock To:
1st Value:
2nd Value:
Value Percent: **5.000**
Continuous Index:
Within 8" of Joint: **NO**
Remarks:

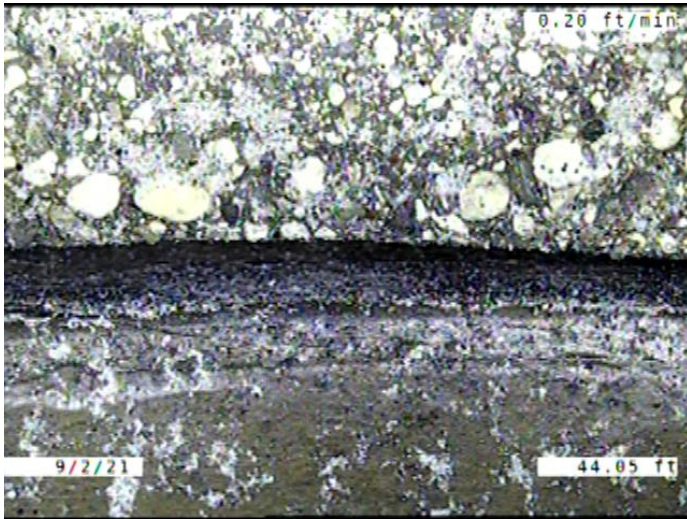
Code: **MMC**
 Description: **Miscellaneous Material Change**

Distance (ft): **44.0**
 Structural Grade: **0**
 O&M Grade: **0**
 Clock Start/From:
 Clock To:
 1st Value:
 2nd Value:
 Value Percent:
 Continuous Index:
 Within 8" of Joint: **NO**
 Remarks: **CONCRETE TO VCP**

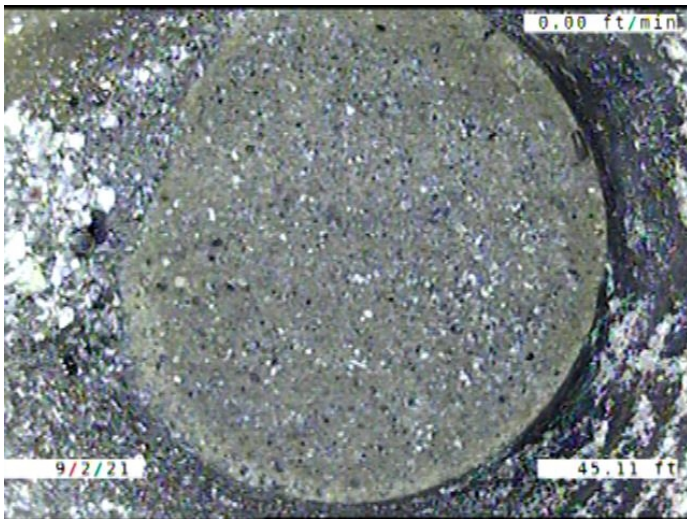
Code: **TFC**
 Description: **Tap Factory Capped**

Distance (ft): **45.1**
 Structural Grade: **0**
 O&M Grade: **0**
 Clock Start/From: **10**
 Clock To:
 1st Value: **6.000**
 2nd Value:
 Value Percent:
 Continuous Index:
 Within 8" of Joint: **YES**
 Remarks:

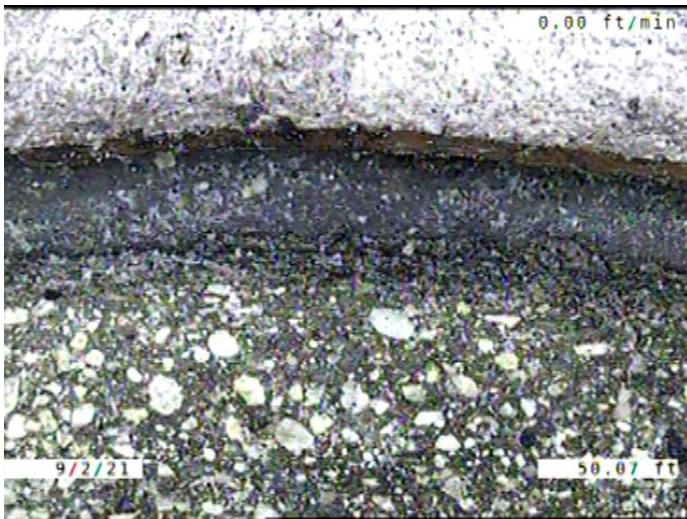
Code: **MMC**
 Description: **Miscellaneous Material Change**

Distance (ft): **50.1**
 Structural Grade: **0**
 O&M Grade: **0**
 Clock Start/From:
 Clock To:
 1st Value:
 2nd Value:
 Value Percent:
 Continuous Index:
 Within 8" of Joint: **NO**
 Remarks: **VCP TO CONCRETE**

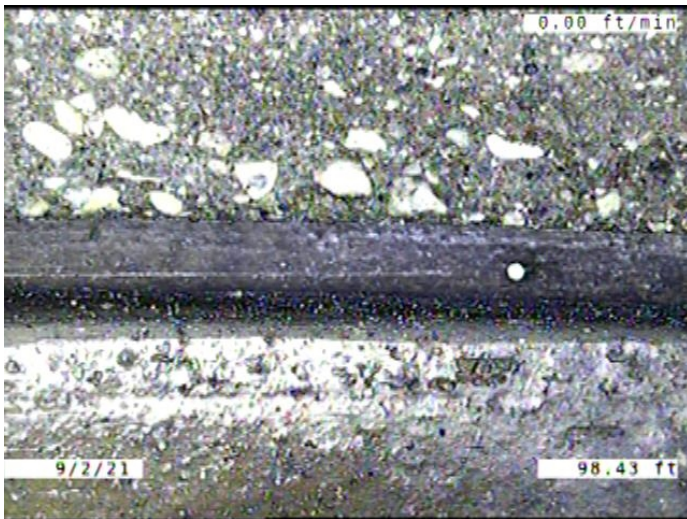
Code: **MMC**
Description: **Miscellaneous Material Change**

Distance (ft): **98.4**
Structural Grade: **0**
O&M Grade: **0**
Clock Start/From:
Clock To:
1st Value:
2nd Value:
Value Percent:
Continuous Index:
Within 8" of Joint: **NO**
Remarks: **CONCRETE TO VCP**

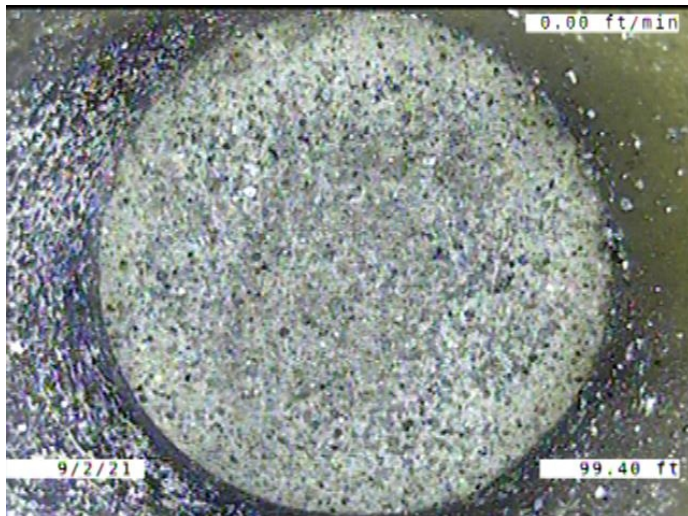
Code: **TFC**
 Description: **Tap Factory Capped**

Distance (ft): **99.4**
 Structural Grade: **0**
 O&M Grade: **0**
 Clock Start/From: **1**
 Clock To:
 1st Value: **6.000**
 2nd Value:
 Value Percent:
 Continuous Index:
 Within 8" of Joint: **YES**
 Remarks:

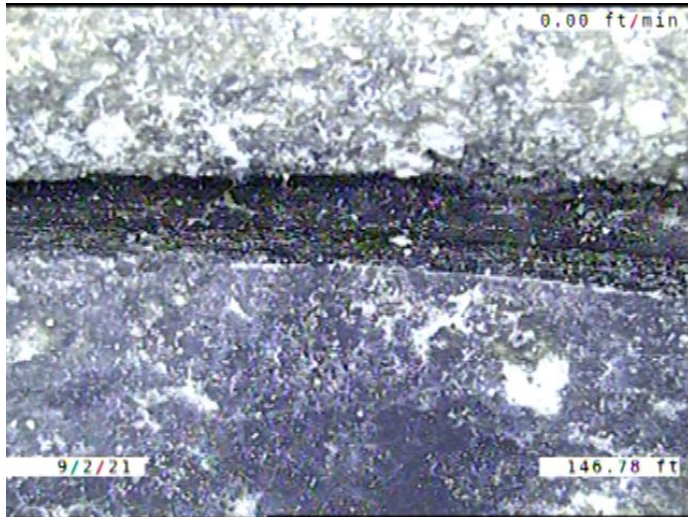
Code: **MMC**
 Description: **Miscellaneous Material Change**

Distance (ft): **146.8**
 Structural Grade: **0**
 O&M Grade: **0**
 Clock Start/From:
 Clock To:
 1st Value:
 2nd Value:
 Value Percent:
 Continuous Index:
 Within 8" of Joint: **NO**
 Remarks: **CONCRETE TO VCP**

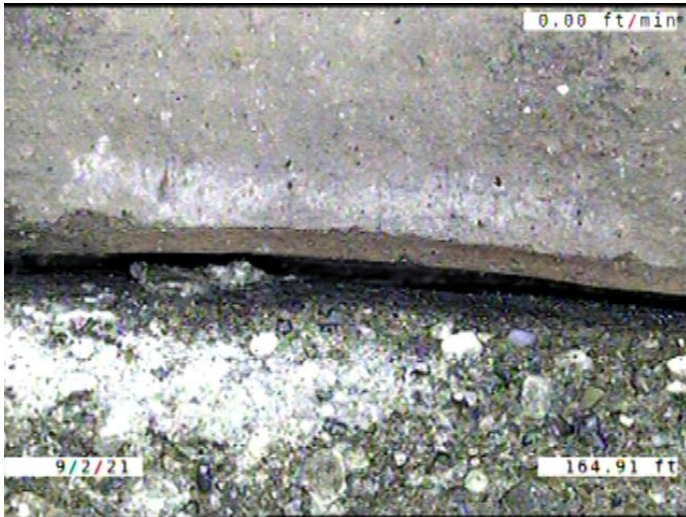
Code: **MMC**
Description: **Miscellaneous Material Change**

Distance (ft): **164.9**
Structural Grade: **0**
O&M Grade: **0**
Clock Start/From:
Clock To:
1st Value:
2nd Value:
Value Percent:
Continuous Index:
Within 8" of Joint: **NO**
Remarks: **VCP TO CONCRETE**

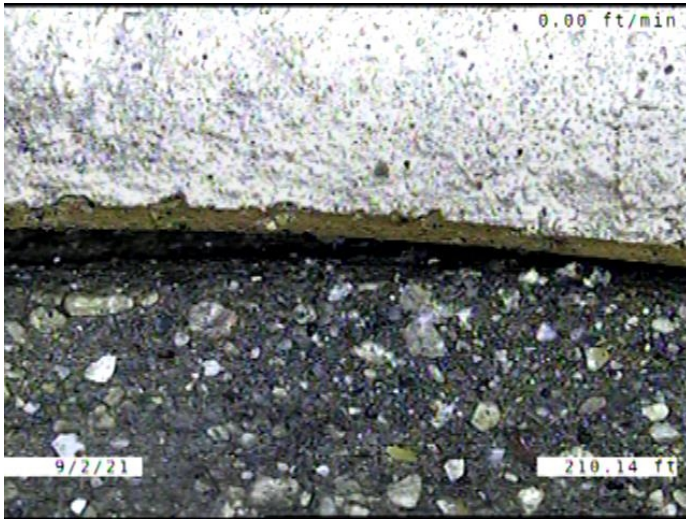
Code: **MMC**
 Description: **Miscellaneous Material Change**

Distance (ft): **210.1**
 Structural Grade: **0**
 O&M Grade: **0**
 Clock Start/From:
 Clock To:
 1st Value:
 2nd Value:
 Value Percent:
 Continuous Index:
 Within 8" of Joint: **NO**
 Remarks: **VCP TO CONCRETE**
