# Profile/Photo Observation Report

Date:	09/12/2021	Weather:		Coding:	PACP 7.0
Pipe Length (ft):	167.2	Owner:	City of Hobart	Pre Clean:	Heavy Cleaning
P.O.#:	YES502259	Surveyor:	S. Bucklin	PSR:	P-504-088-130
Customer:	City of Hobart	Clean Date:	08/29/2021	Shape:	C

Street:	West 42nd Avenue	Flow Control:	Not Controlled
City:	Hobart, IN	Year Renewed:	
Location:	Alley	Tape/Media #:	
Purpose:	Routine Assessment	Dia/Height:	12"
Use:	Sanitary Sewage Pipe	Material:	VCP
Drain Area:		Lining:	None
Category:	NA		
Comment:			
Location Details:		Direction of Survey:	Downstream
US MH:	M-504-130	DS MH:	M-504-088
		Total Length Surveyed (ft):	167.2

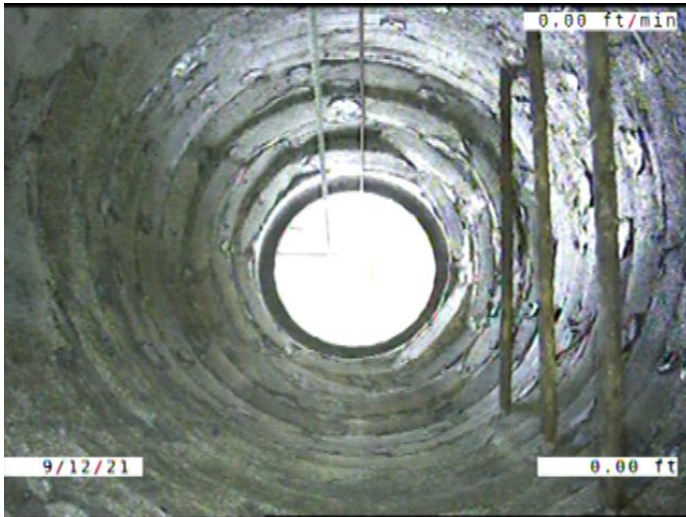
Code: **AMH**  
 Description: **Manhole**

Distance (ft): **.0**  
 Structural Grade: **0**  
 O&M Grade: **0**  
 Clock Start/From:  
 Clock To:  
 1st Value:  
 2nd Value:  
 Value Percent:  
 Continuous Index:  
 Within 8" of Joint: **NO**  
 Remarks: **M-504-130**

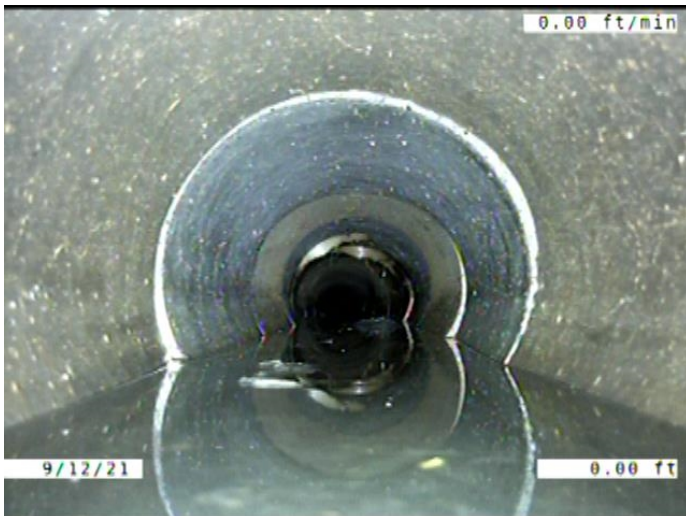
Code: **MWL**  
 Description: **Miscellaneous Water Level**

Distance (ft): **.0**  
 Structural Grade: **0**  
 O&M Grade: **0**  
 Clock Start/From:  
 Clock To:  
 1st Value:  
 2nd Value:  
 Value Percent: **10.000**  
 Continuous Index:  
 Within 8" of Joint: **NO**  
 Remarks:

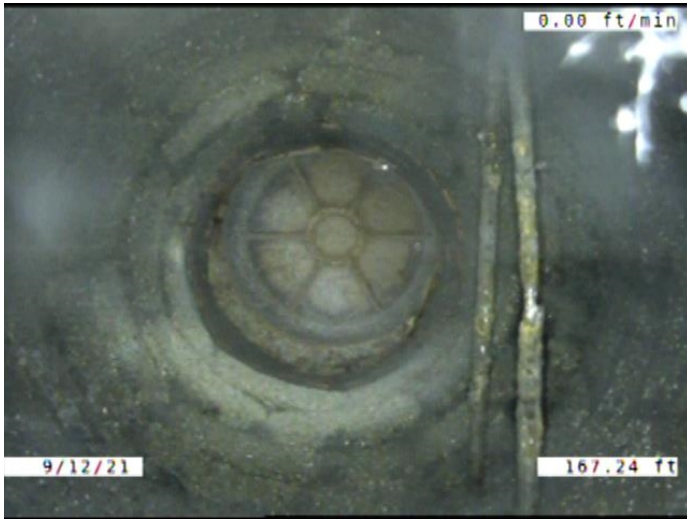
Code:	<b>AMH</b>
Description:	<b>Manhole</b>
Distance (ft):	<b>167.2</b>
Structural Grade:	<b>0</b>
O&M Grade:	<b>0</b>
Clock Start/From:	
Clock To:	
1st Value:	
2nd Value:	
Value Percent:	
Continuous Index:	
Within 8" of Joint:	<b>NO</b>
Remarks:	<b>M-504-088</b>
