Profile/Photo Observation Report

Date:	09/12/2021	Weather:		Coding:	PACP 7.0
Pipe Length (ft):	255.7	Owner:	City of Hobart	Pre Clean:	Heavy Cleaning
P.O.#:	YES502259	Surveyor:	S. Bucklin	PSR:	P-504-105-130
Customer:	City of Hobart	Clean Date:	08/28/2021	Shape:	C

Street:	North Virginia Street	Flow Control:	Not Controlled
City:	Hobart, IN	Year Renewed:	
Location:	Alley	Tape/Media #:	
Purpose:	Routine Assessment	Dia/Height:	12"
Use:	Sanitary Sewage Pipe	Material:	CP
Drain Area:		Lining:	None
Category:	NA		
Comment:			
Location Details:		Direction of Survey:	Downstream
US MH:	M-504-130	DS MH:	M-504-105
		Total Length Surveyed (ft):	255.7

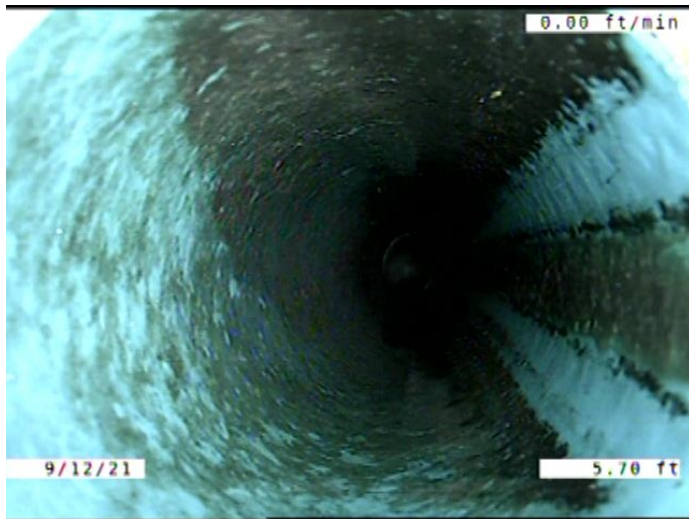
Code: **MWL**
Description: **Miscellaneous Water Level**

Distance (ft): **.0**
Structural Grade: **0**
O&M Grade: **0**
Clock Start/From:
Clock To:
1st Value:
2nd Value:
Value Percent: **5.000**
Continuous Index:
Within 8" of Joint: **NO**
Remarks:

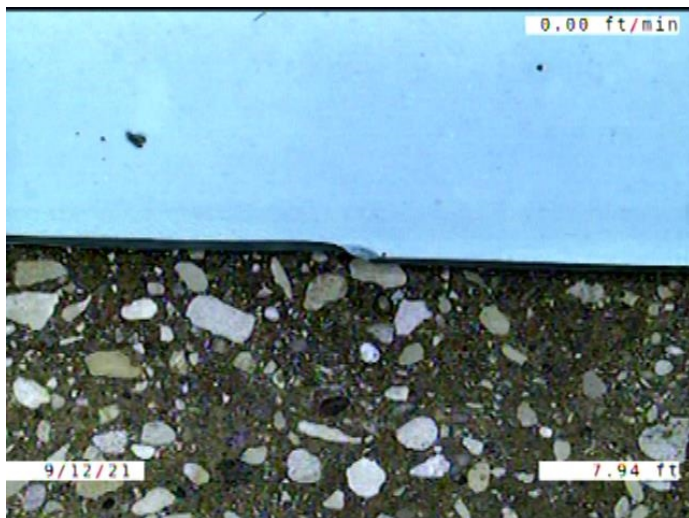
Code: **TF**
 Description: **Tap Factory**

Distance (ft): **5.7**
 Structural Grade: **0**
 O&M Grade: **0**
 Clock Start/From: **2**
 Clock To:
 1st Value: **6.000**
 2nd Value:
 Value Percent:
 Continuous Index:
 Within 8" of Joint: **YES**
 Remarks:

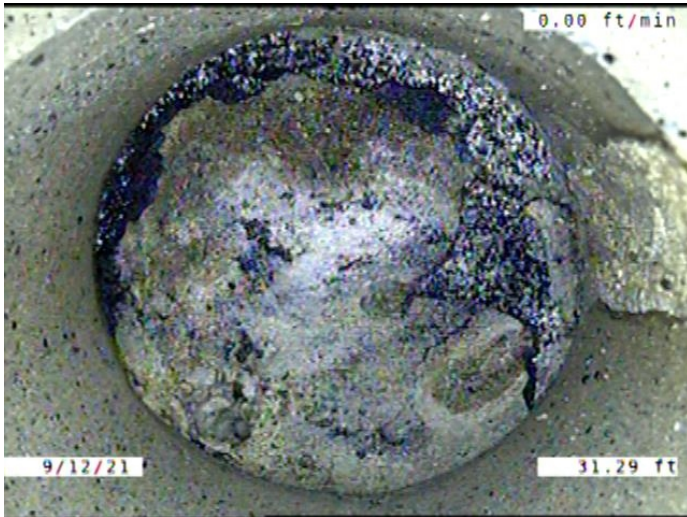
Code: **CM**
Description: **Crack Multiple**

Distance (ft): **30.5**
Structural Grade: **3**
O&M Grade: **0**
Clock Start/From: **9**
Clock To: **2**
1st Value:
2nd Value:
Value Percent:
Continuous Index:
Within 8" of Joint: **YES**
Remarks:

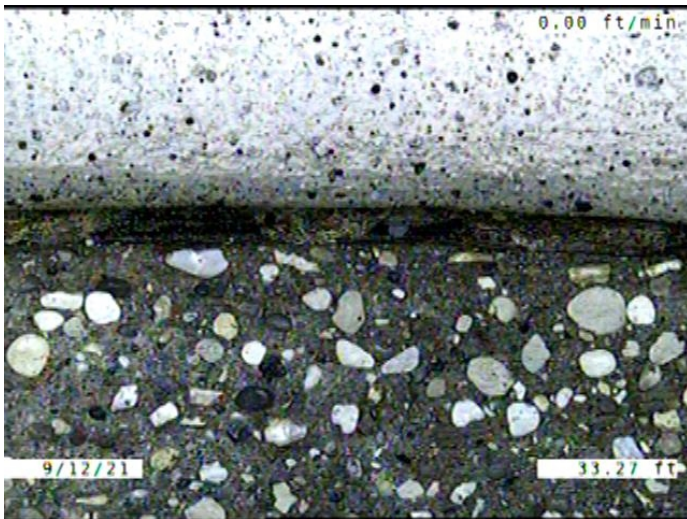
Code: **TFC**
 Description: **Tap Factory Capped**

Distance (ft): **31.3**
 Structural Grade: **0**
 O&M Grade: **0**
 Clock Start/From: **2**
 Clock To:
 1st Value: **4.000**
 2nd Value:
 Value Percent:
 Continuous Index:
 Within 8" of Joint: **YES**
 Remarks:
