Profile/Photo Observation Report

Date:	08/09/2022	Weather:		Coding:	PACP 7.0
Pipe Length (ft):	230.0	Owner:	City of Hobart	Pre Clean:	Heavy Cleaning
P.O.#:	YES502259	Surveyor:	S. Bucklin	PSR:	P-505-005-004
Customer:	City of Hobart	Clean Date:	07/23/2022	Shape:	C

Street:	Lake George Drive	Flow Control:	Not Controlled
City:	Hobart, IN	Year Renewed:	
Location:	Local rural streets with light traffic, t	Tape/Media #:	
Purpose:	Routine Assessment	Dia/Height:	15"
Use:	Sanitary Sewage Pipe	Material:	VCP
Drain Area:		Lining:	None
Category:	NA		
Comment:			
Location Details:		Direction of Survey:	Upstream
US MH:	M-505-004	DS MH:	M-505-005
		Total Length Surveyed (ft):	257.6

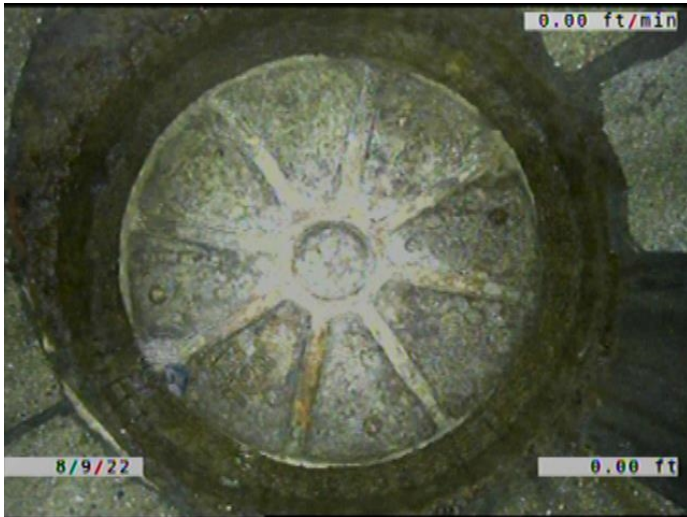
Code: **AMH**
Description: **Manhole**

Distance (ft): **.0**
Structural Grade: **0**
O&M Grade: **0**
Clock Start/From:
Clock To:
1st Value:
2nd Value:
Value Percent:
Continuous Index:
Within 8" of Joint: **NO**
Remarks: **M-505-005**

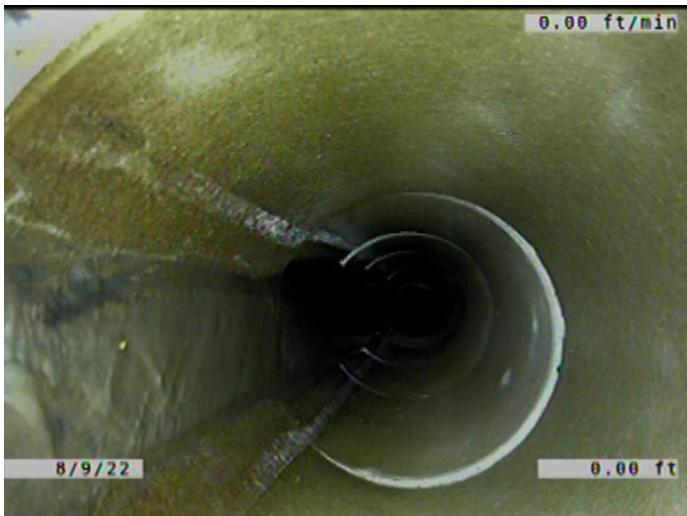
Code: **MWL**
Description: **Miscellaneous Water Level**

Distance (ft): **.0**
Structural Grade: **0**
O&M Grade: **0**
Clock Start/From:
Clock To:
1st Value:
2nd Value:
Value Percent: **5.000**
Continuous Index:
Within 8" of Joint: **NO**
Remarks:

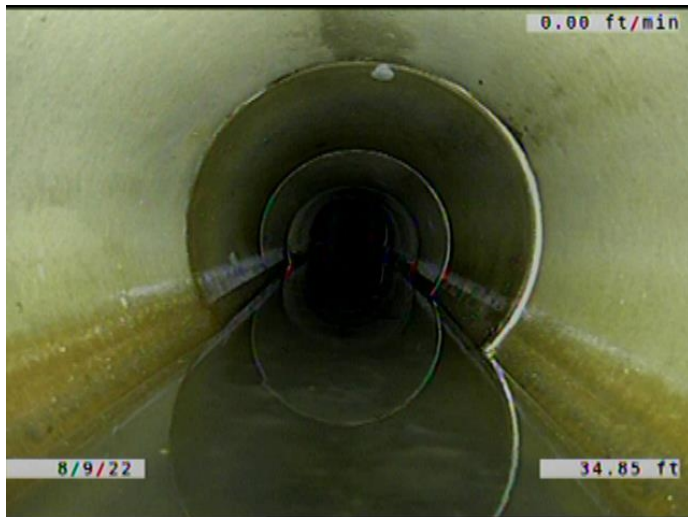
Code: **MWL**
Description: **Miscellaneous Water Level**

Distance (ft): **34.8**
Structural Grade: **0**
O&M Grade: **0**
Clock Start/From:
Clock To:
1st Value:
2nd Value:
Value Percent: **15.000**
Continuous Index:
Within 8" of Joint: **NO**
Remarks:

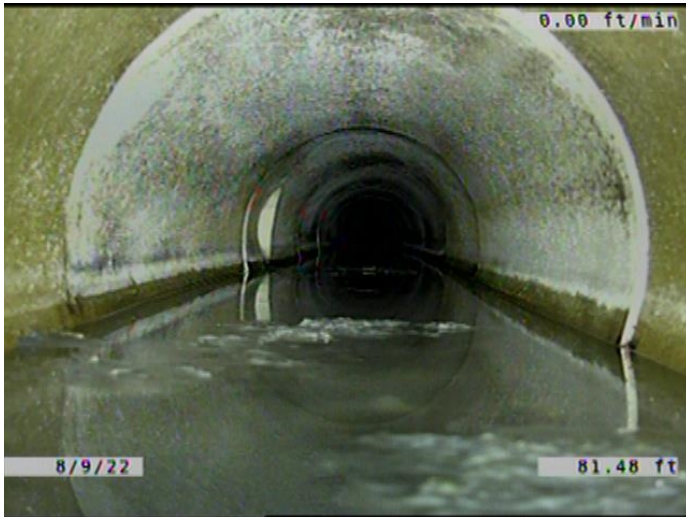
Code: **MWL**
 Description: **Miscellaneous Water Level**

Distance (ft): **81.5**
 Structural Grade: **0**
 O&M Grade: **0**
 Clock Start/From:
 Clock To:
 1st Value:
 2nd Value:
 Value Percent: **25.000**
 Continuous Index:
 Within 8" of Joint: **NO**
 Remarks:

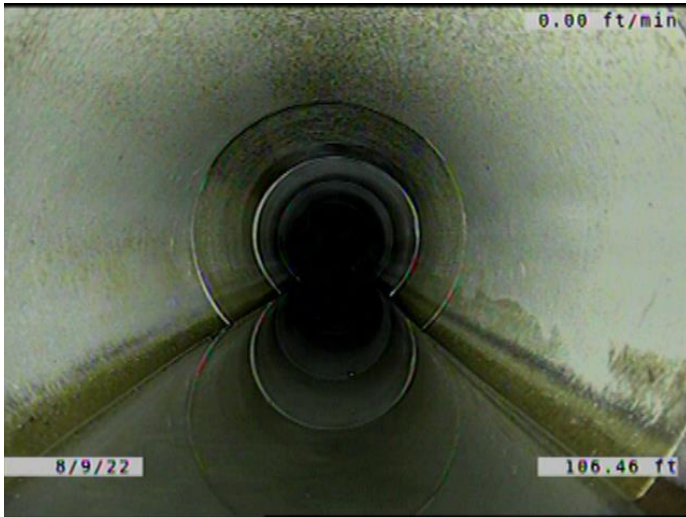
Code: **MWL**
Description: **Miscellaneous Water Level**

Distance (ft): **106.5**
Structural Grade: **0**
O&M Grade: **0**
Clock Start/From:
Clock To:
1st Value:
2nd Value:
Value Percent: **15.000**
Continuous Index:
Within 8" of Joint: **NO**
Remarks:

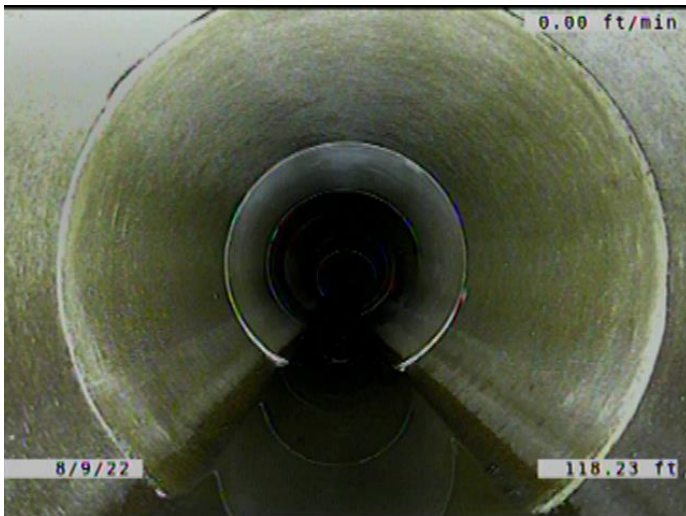
Code: **MWL**
Description: **Miscellaneous Water Level**

Distance (ft): **118.2**
Structural Grade: **0**
O&M Grade: **0**
Clock Start/From:
Clock To:
1st Value:
2nd Value:
Value Percent: **5.000**
Continuous Index:
Within 8" of Joint: **NO**
Remarks:

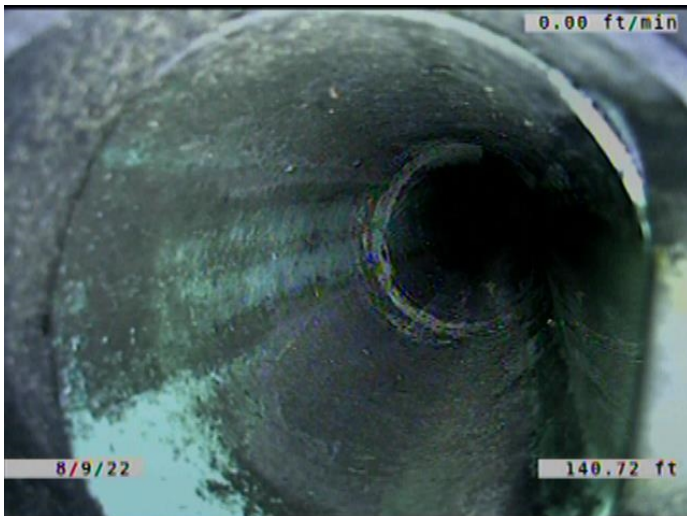
Code: **TS**
 Description: **Tap Saddle**

Distance (ft): **140.7**
 Structural Grade: **0**
 O&M Grade: **0**
 Clock Start/From: **3**
 Clock To:
 1st Value: **6.000**
 2nd Value:
 Value Percent:
 Continuous Index:
 Within 8" of Joint: **NO**
 Remarks:

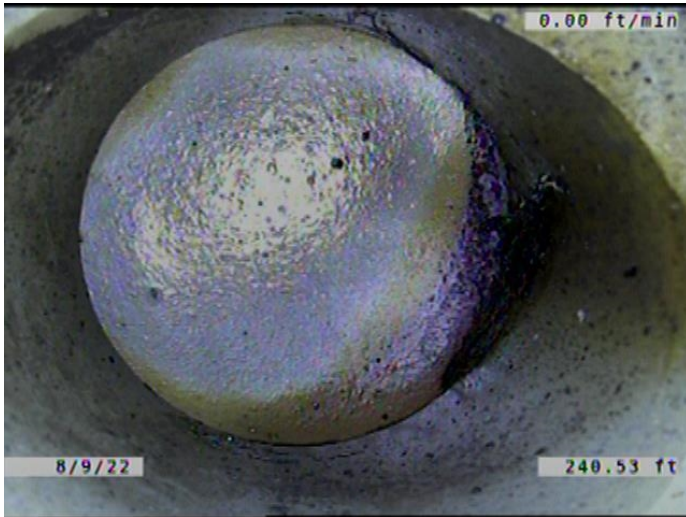
Code: **TFC**
 Description: **Tap Factory Capped**

Distance (ft): **240.5**
 Structural Grade: **0**
 O&M Grade: **0**
 Clock Start/From: **3**
 Clock To:
 1st Value: **6.000**
 2nd Value:
 Value Percent:
 Continuous Index:
 Within 8" of Joint: **YES**
 Remarks:

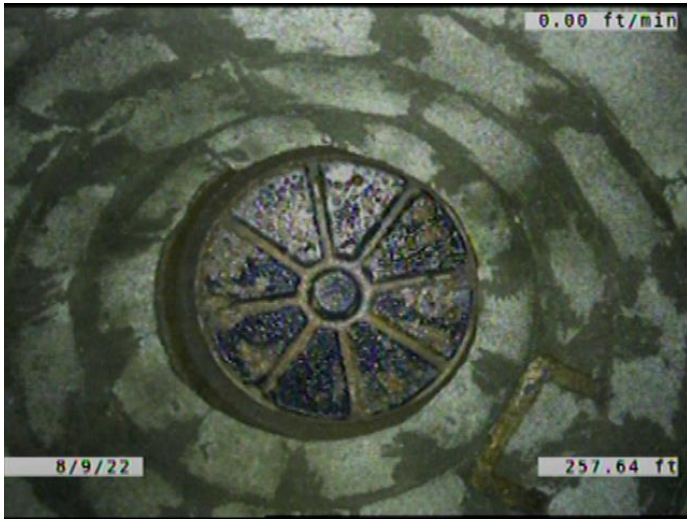
Code:	AMH
Description:	Manhole
Distance (ft):	257.6
Structural Grade:	0
O&M Grade:	0
Clock Start/From:	
Clock To:	
1st Value:	
2nd Value:	
Value Percent:	
Continuous Index:	
Within 8" of Joint:	NO
Remarks:	M-505-004
