Profile/Photo Observation Report

Date:	08/09/2022	Weather:		Coding:	PACP 7.0
Pipe Length (ft):	250.0	Owner:	City of Hobart	Pre Clean:	Heavy Cleaning
P.O.#:	YES502259	Surveyor:	S. Bucklin	PSR:	P-505-008-007
Customer:	City of Hobart	Clean Date:	07/22/2022	Shape:	C

Street:	Lake George Drive	Flow Control:	Not Controlled
City:	Hobart, IN	Year Renewed:	
Location:	Local rural streets with light traffic, t	Tape/Media #:	
Purpose:	Routine Assessment	Dia/Height:	15"
Use:	Sanitary Sewage Pipe	Material:	VCP
Drain Area:		Lining:	None
Category:	NA		
Comment:			
Location Details:		Direction of Survey:	Downstream
US MH:	M-505-007	DS MH:	M-505-008
		Total Length Surveyed (ft):	270.1

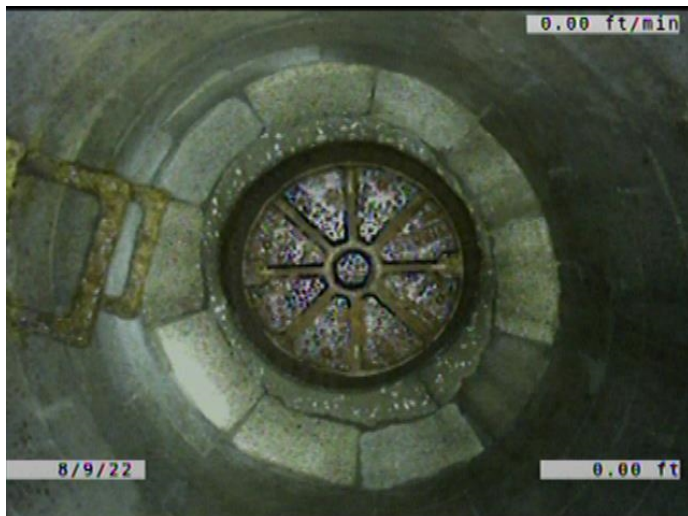
Code: **AMH**
 Description: **Manhole**

Distance (ft): **.0**
 Structural Grade: **0**
 O&M Grade: **0**
 Clock Start/From:
 Clock To:
 1st Value:
 2nd Value:
 Value Percent:
 Continuous Index:
 Within 8" of Joint: **NO**
 Remarks: **M-505-007**

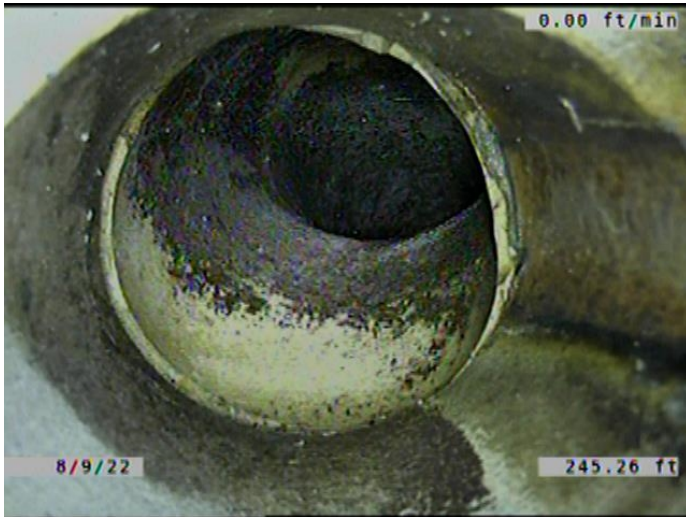
Code: **TF**
Description: **Tap Factory**

Distance (ft): **245.3**
Structural Grade: **0**
O&M Grade: **0**
Clock Start/From: **2**
Clock To:
1st Value: **6.000**
2nd Value:
Value Percent:
Continuous Index:
Within 8" of Joint: **YES**
Remarks:

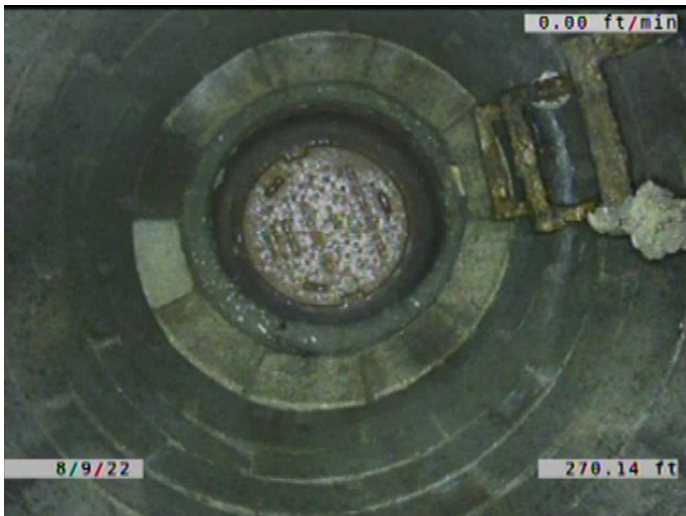
Code: **AMH**
 Description: **Manhole**

Distance (ft): **270.1**
 Structural Grade: **0**
 O&M Grade: **0**
 Clock Start/From:
 Clock To:
 1st Value:
 2nd Value:
 Value Percent:
 Continuous Index:
 Within 8" of Joint: **NO**
 Remarks: **M-505-008**
