# Profile/Photo Observation Report

Date:	11/02/2021	Weather:		Coding:	PACP 7.0
Pipe Length (ft):	291.8	Owner:	City of Hobart	Pre Clean:	Heavy Cleaning
P.O.#:	YES502259	Surveyor:	S. Bucklin	PSR:	P-505-059-054
Customer:	City of Hobart	Clean Date:	10/28/2021	Shape:	C

Street:	West 2nd Street	Flow Control:	Not Controlled
City:	Hobart, IN	Year Renewed:	
Location:	Local rural streets with light traffic, t	Tape/Media #:	
Purpose:	Routine Assessment	Dia/Height:	10"
Use:	Sanitary Sewage Pipe	Material:	VCP
Drain Area:		Lining:	None
Category:	NA		
Comment:			
Location Details:		Direction of Survey:	Downstream
US MH:	M-505-059	DS MH:	M-505-054
		Total Length Surveyed (ft):	291.8

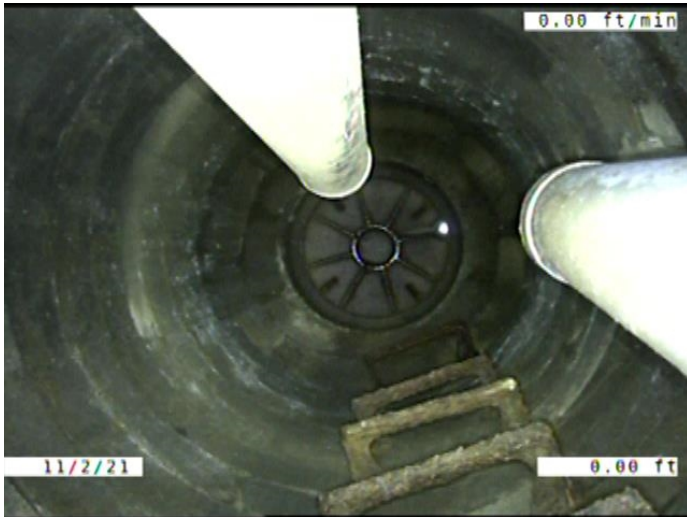
Code: **AMH**  
 Description: **Manhole**

Distance (ft): **.0**  
 Structural Grade: **0**  
 O&M Grade: **0**  
 Clock Start/From:  
 Clock To:  
 1st Value:  
 2nd Value:  
 Value Percent:  
 Continuous Index:  
 Within 8" of Joint: **NO**  
 Remarks: **M-505-059**

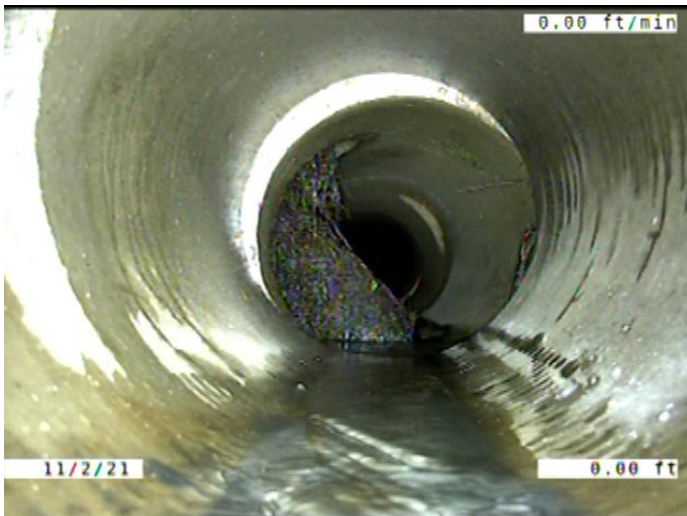
Code: **MWL**  
 Description: **Miscellaneous Water Level**

Distance (ft): **.0**  
 Structural Grade: **0**  
 O&M Grade: **0**  
 Clock Start/From:  
 Clock To:  
 1st Value:  
 2nd Value:  
 Value Percent: **5.000**  
 Continuous Index:  
 Within 8" of Joint: **NO**  
 Remarks:

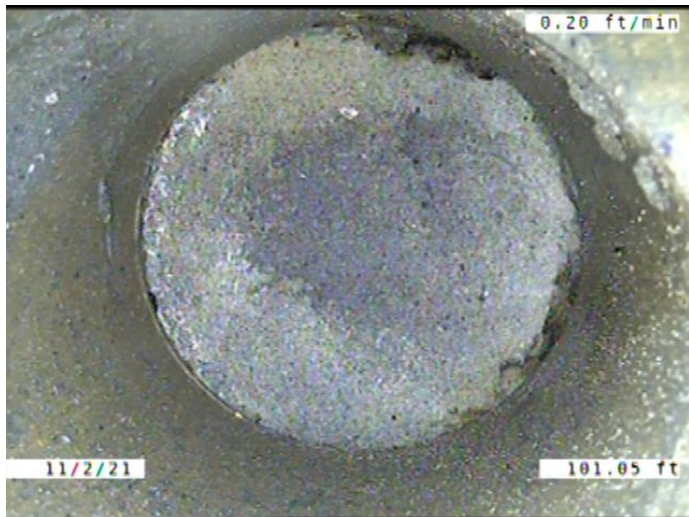
Code: **TFC**  
Description: **Tap Factory Capped**

Distance (ft): **101.0**  
Structural Grade: **0**  
O&M Grade: **0**  
Clock Start/From: **2**  
Clock To:  
1st Value: **4.000**  
2nd Value:  
Value Percent:  
Continuous Index:  
Within 8" of Joint: **YES**  
Remarks:

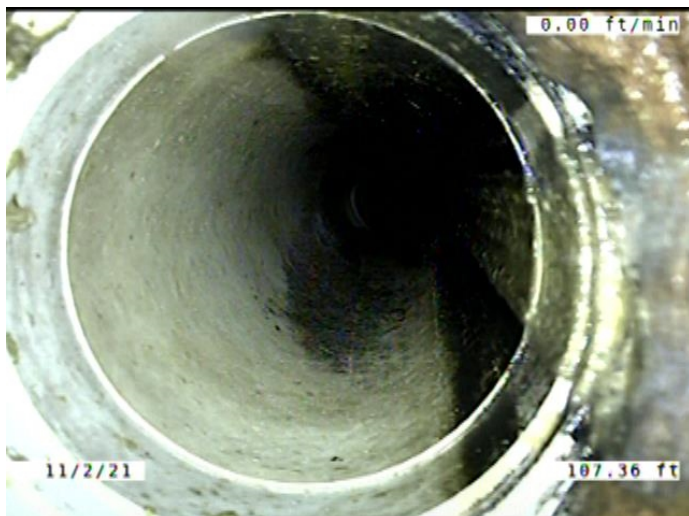
Code: **TB**  
Description: **Tap Break-in/Hammer**

Distance (ft): **107.4**  
Structural Grade: **0**  
O&M Grade: **0**  
Clock Start/From: **1**  
Clock To:  
1st Value: **4.000**  
2nd Value:  
Value Percent:  
Continuous Index:  
Within 8" of Joint: **YES**  
Remarks:

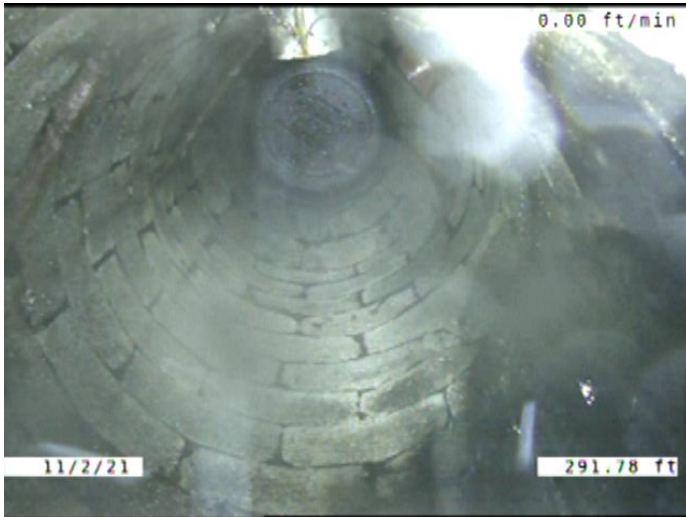
Code:	<b>AMH</b>
Description:	<b>Manhole</b>
Distance (ft):	<b>291.8</b>
Structural Grade:	<b>0</b>
O&M Grade:	<b>0</b>
Clock Start/From:	
Clock To:	
1st Value:	
2nd Value:	
Value Percent:	
Continuous Index:	
Within 8" of Joint:	<b>NO</b>
Remarks:	<b>M-505-054</b>
