Profile/Photo Observation Report

Date:	11/02/2021	Weather:		Coding:	PACP 7.0
Pipe Length (ft):	291.8	Owner:	City of Hobart	Pre Clean:	Heavy Cleaning
P.O.#:	YES502259	Surveyor:	S. Bucklin	PSR:	P-505-059-054
Customer:	City of Hobart	Clean Date:	10/28/2021	Shape:	C

Street:	West 2nd Street	Flow Control:	Not Controlled
City:	Hobart, IN	Year Renewed:	
Location:	Local rural streets with light traffic, t	Tape/Media #:	
Purpose:	Routine Assessment	Dia/Height:	10"
Use:	Sanitary Sewage Pipe	Material:	VCP
Drain Area:		Lining:	None
Category:	NA		
Comment:			
Location Details:		Direction of Survey:	Downstream
US MH:	M-505-059	DS MH:	M-505-054
		Total Length Surveyed (ft):	291.8

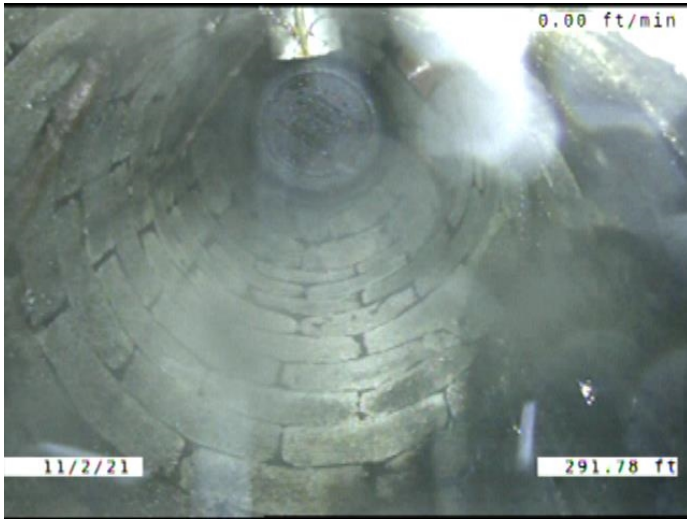
Code: **CM**
Description: **Crack Multiple**

Distance (ft): **272.7**
Structural Grade: **3**
O&M Grade: **0**
Clock Start/From: **7**
Clock To: **5**
1st Value:
2nd Value:
Value Percent:
Continuous Index: **F04**
Within 8" of Joint: **YES**
Remarks: **Wandering**
