Profile/Photo Observation Report

| Street: | South Colorado Street | Flow Control: | Not Controlled |
| Purpose: | Sewer System Evaluation Survey (SS | Dia/Height: | 18" |
| US MH: | M-505-055 | DS MH: | M-505-054 |

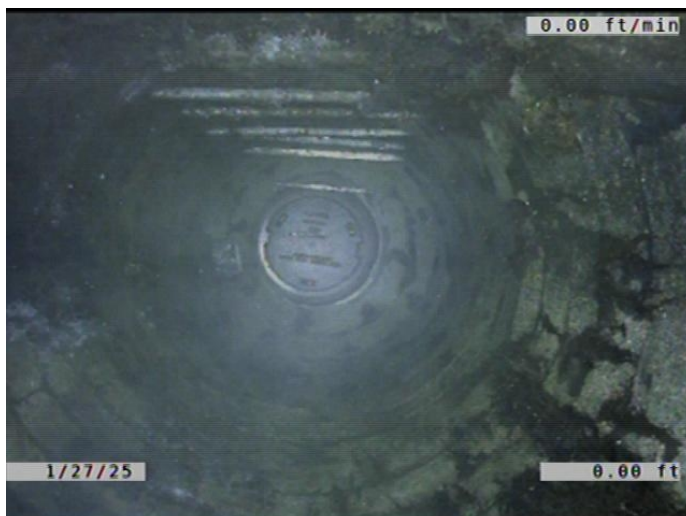
Code: **AMH**
Description: **Manhole**

Distance (ft): **.0**
Structural Grade: **0**
O&M Grade: **0**
Clock Start/From:
Clock To:
1st Value:
2nd Value:
Value Percent:
Continuous Index:
Within 8" of Joint: **NO**
Remarks: **M-505-055**

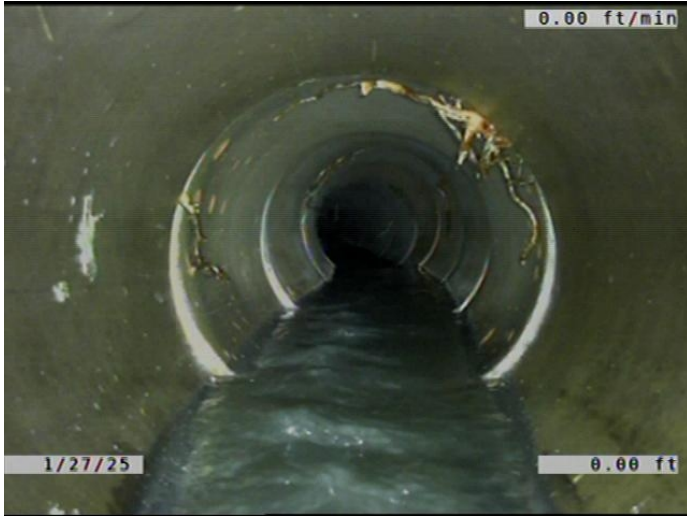
| Code: | MWL |
| Description: | Miscellaneous Water Level |
| Value Percent: | 15.000 |

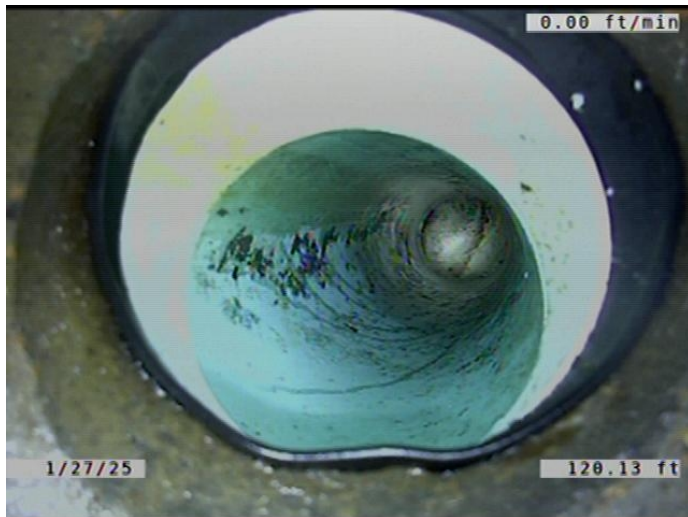
Code: **TF**
Description: **Tap Factory**

Distance (ft): **120.1**
Structural Grade: **0**
O&M Grade: **0**
Clock Start/From: **11**
Clock To:
1st Value: **6.000**
2nd Value:
Value Percent:
Continuous Index:
Within 8" of Joint: **YES**
Remarks: **SERVICE IS PVC. TAP IS VCP.**

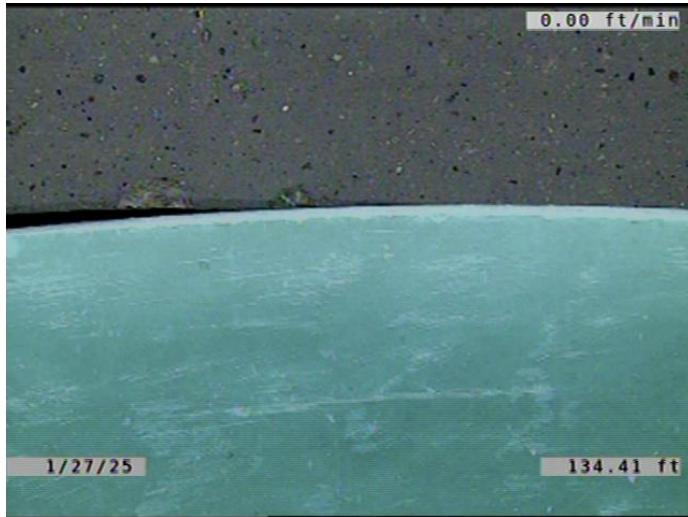
Code: **RPR**
Description: **Point Repair Replacement**

Distance (ft): **134.4**
Structural Grade: **0**
O&M Grade: **0**
Clock Start/From:
Clock To:
1st Value:
2nd Value:
Value Percent:
Continuous Index: **S02**
Within 8" of Joint: **YES**
Remarks: **REPLACED WITH PVC.**

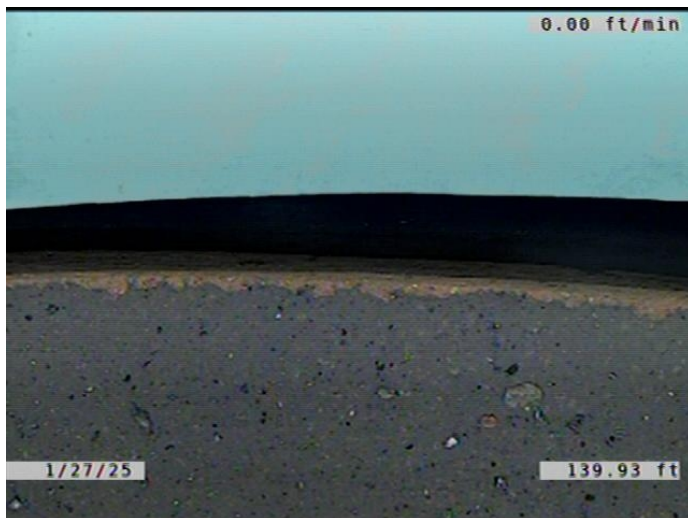
Code: **RPR**
Description: **Point Repair Replacement**

Distance (ft): **139.9**
Structural Grade: **0**
O&M Grade: **0**
Clock Start/From:
Clock To:
1st Value:
2nd Value:
Value Percent:
Continuous Index: **F02**
Within 8" of Joint: **YES**
Remarks: **REPLACED WITH PVC.**

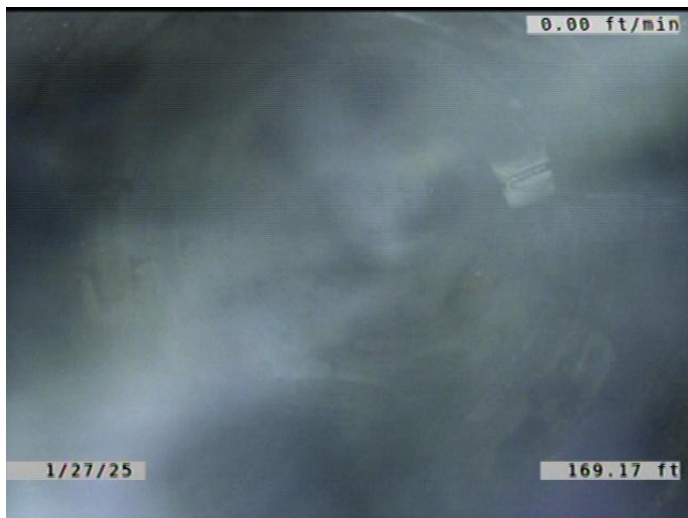
| Code: | AMH |
| Description: | Manhole |
