Profile/Photo Observation Report

Date:	11/02/2021	Weather:		Coding:	PACP 7.0
Pipe Length (ft):	247.1	Owner:	City of Hobart	Pre Clean:	Heavy Cleaning
P.O.#:	YES502259	Surveyor:	S. Bucklin	PSR:	P-505-060-059
Customer:	City of Hobart	Clean Date:	10/28/2021	Shape:	C

Street:	West 2nd Street	Flow Control:	Not Controlled
City:	Hobart, IN	Year Renewed:	
Location:	Local rural streets with light traffic, t	Tape/Media #:	
Purpose:	Routine Assessment	Dia/Height:	10"
Use:	Sanitary Sewage Pipe	Material:	VCP
Drain Area:		Lining:	None
Category:	NA		
Comment:			
Location Details:		Direction of Survey:	Downstream
US MH:	M-505-059	DS MH:	M-505-060
		Total Length Surveyed (ft):	247.1

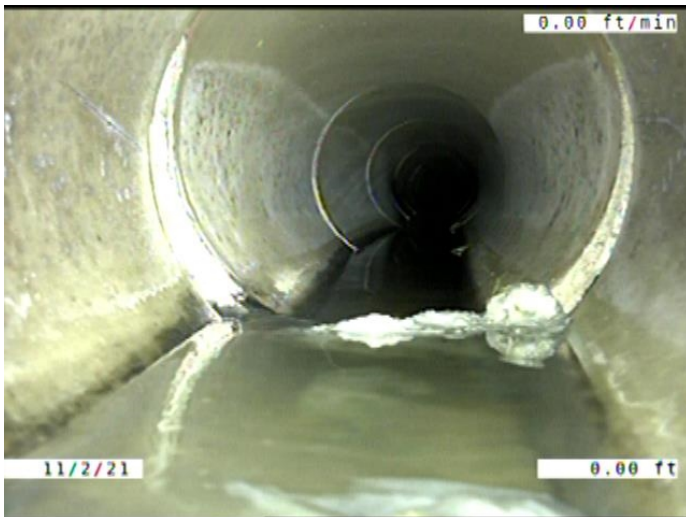
Code: **AMH**
 Description: **Manhole**

Distance (ft): **.0**
 Structural Grade: **0**
 O&M Grade: **0**
 Clock Start/From:
 Clock To:
 1st Value:
 2nd Value:
 Value Percent:
 Continuous Index:
 Within 8" of Joint: **NO**
 Remarks: **M-505-059**

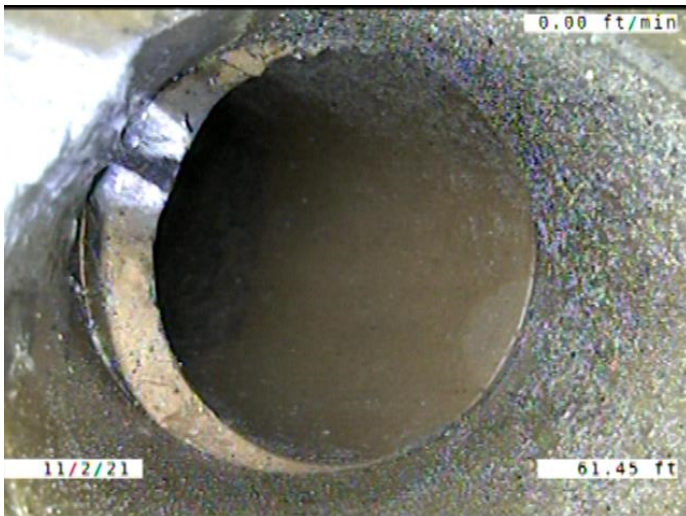
Code: **DAE**
Description: **Deposits Attached Encrustation**

Distance (ft): **60.6**
Structural Grade: **0**
O&M Grade: **2**
Clock Start/From: **4**
Clock To: **8**
1st Value:
2nd Value:
Value Percent: **5.000**
Continuous Index: **F01**
Within 8" of Joint: **YES**
Remarks:
