# Profile/Photo Observation Report

Date:	<b>11/07/2021</b>	Weather:		Coding:	<b>PACP 7.0</b>
Pipe Length (ft):	<b>259.9</b>	Owner:	<b>City of Hobart</b>	Pre Clean:	<b>Heavy Cleaning</b>
P.O.#:	<b>YES502259</b>	Surveyor:	<b>Steven Bucklin</b>	PSR:	<b>P-505-066-067</b>
Customer:	<b>City of Hobart, IN (Red</b>	Clean Date:	<b>11/06/2021</b>	Shape:	<b>C</b>

Street:	<b>West 2nd Street</b>	Flow Control:	<b>Not Controlled</b>
City:	<b>City of Hobart</b>	Year Renewed:	
Location:	<b>Alley</b>	Tape/Media #:	
Purpose:	<b>Routine Assessment</b>	Dia/Height:	<b>10"</b>
Use:	<b>Sanitary Sewage Pipe</b>	Material:	<b>VCP</b>
Drain Area:		Lining:	<b>None</b>
Category:	<b>NA</b>		
Comment:			
Location Details:		Direction of Survey:	<b>Downstream</b>
US MH:	<b>M-505-067</b>	DS MH:	<b>M-505-066</b>
		Total Length Surveyed (ft):	<b>259.9</b>

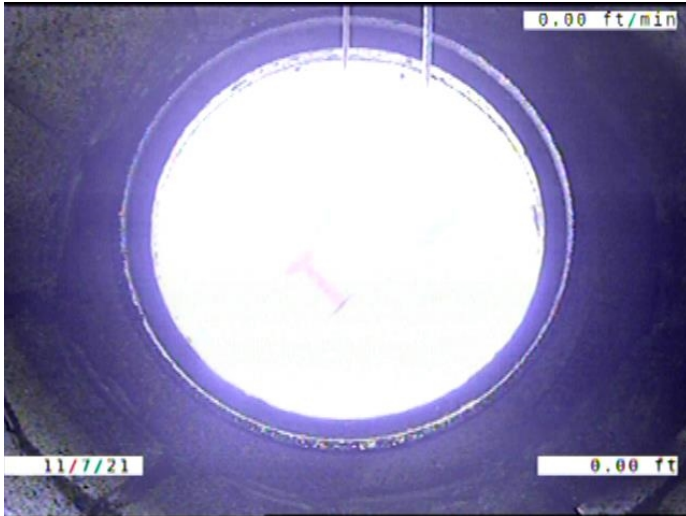
Code: **AMH**  
Description: **Manhole**

Distance (ft): **.0**  
Structural Grade: **0**  
O&M Grade: **0**  
Clock Start/From:  
Clock To:  
1st Value:  
2nd Value:  
Value Percent:  
Continuous Index:  
Within 8" of Joint: **NO**  
Remarks: **M-505-067**

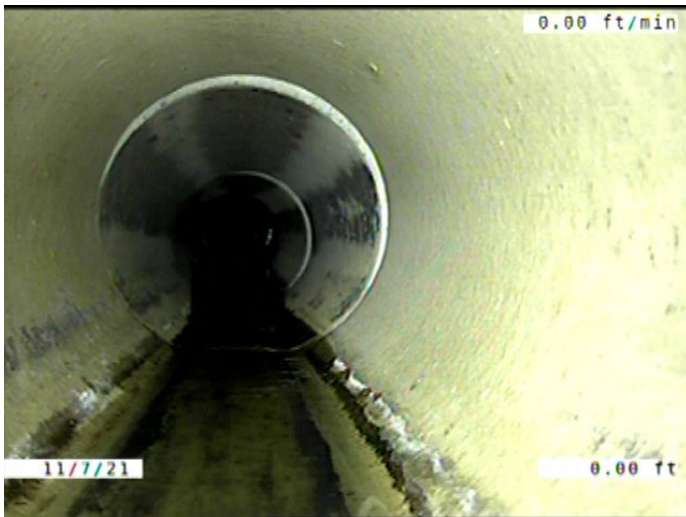
Code: **MWL**  
Description: **Miscellaneous Water Level**

Distance (ft): **.0**  
Structural Grade: **0**  
O&M Grade: **0**  
Clock Start/From:  
Clock To:  
1st Value:  
2nd Value:  
Value Percent: **5.000**  
Continuous Index:  
Within 8" of Joint: **NO**  
Remarks:

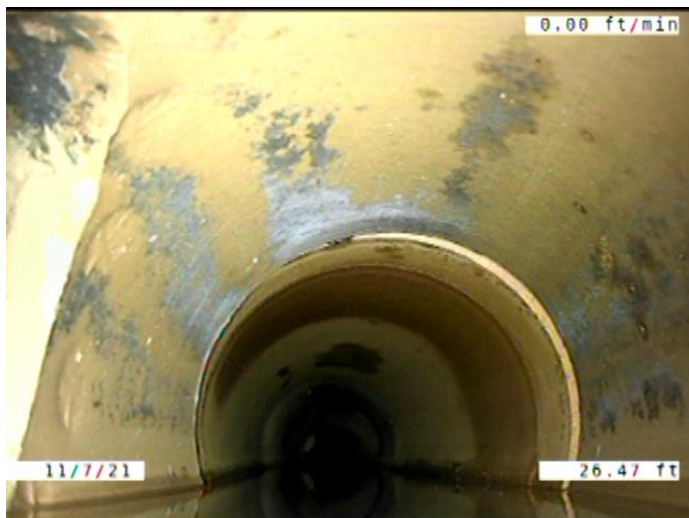
Code:	<b>MWL</b>
Description:	<b>Miscellaneous Water Level</b>
Distance (ft):	<b>26.5</b>
Structural Grade:	<b>0</b>
O&M Grade:	<b>0</b>
Clock Start/From:	
Clock To:	
1st Value:	
2nd Value:	
Value Percent:	<b>15.000</b>
Continuous Index:	
Within 8" of Joint:	<b>NO</b>
Remarks:

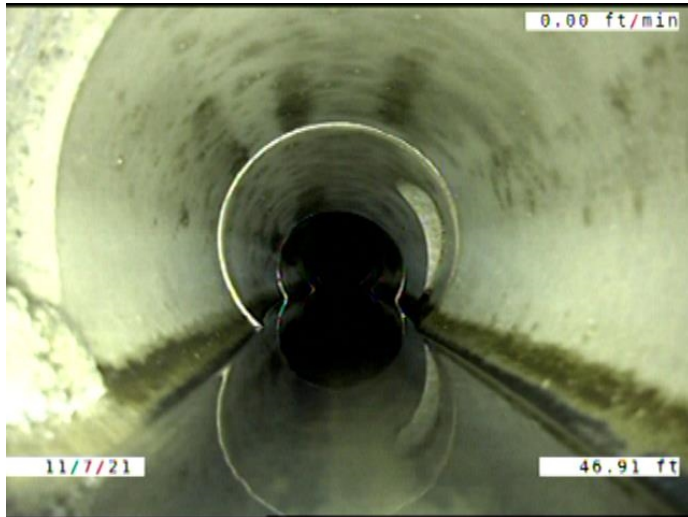
Code: **MWL**  
 Description: **Miscellaneous Water Level**

Distance (ft): **46.9**  
 Structural Grade: **0**  
 O&M Grade: **0**  
 Clock Start/From:  
 Clock To:  
 1st Value:  
 2nd Value:  
 Value Percent: **5.000**  
 Continuous Index:  
 Within 8" of Joint: **NO**  
 Remarks:

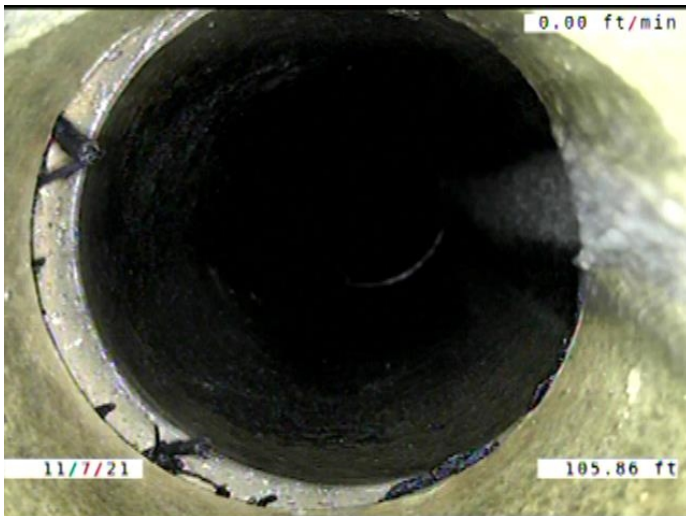
Code:	<b>TFA</b>
Description:	<b>Tap Factory Activity</b>
Distance (ft):	<b>105.9</b>
Structural Grade:	<b>0</b>
O&M Grade:	<b>0</b>
Clock Start/From:	<b>2</b>
Clock To:	
1st Value:	<b>4.000</b>
2nd Value:	
Value Percent:	
Continuous Index:	
Within 8" of Joint:	<b>YES</b>
Remarks:

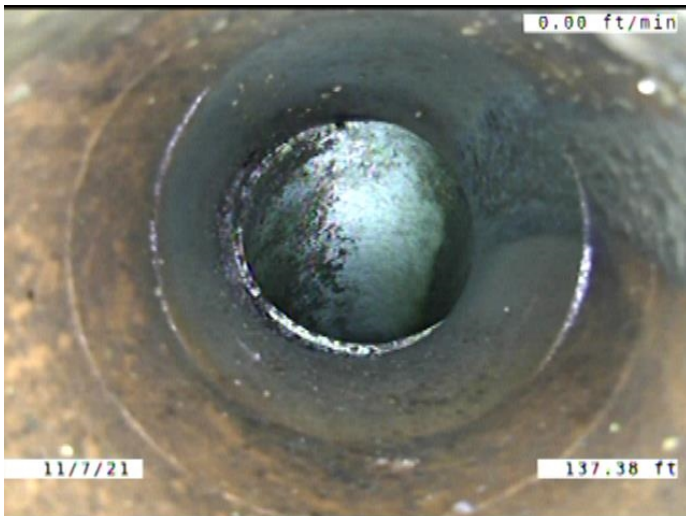
Code: **TF**  
Description: **Tap Factory**

Distance (ft): **137.4**  
Structural Grade: **0**  
O&M Grade: **0**  
Clock Start/From: **2**  
Clock To:  
1st Value: **4.000**  
2nd Value:  
Value Percent:  
Continuous Index:  
Within 8" of Joint: **YES**  
Remarks:

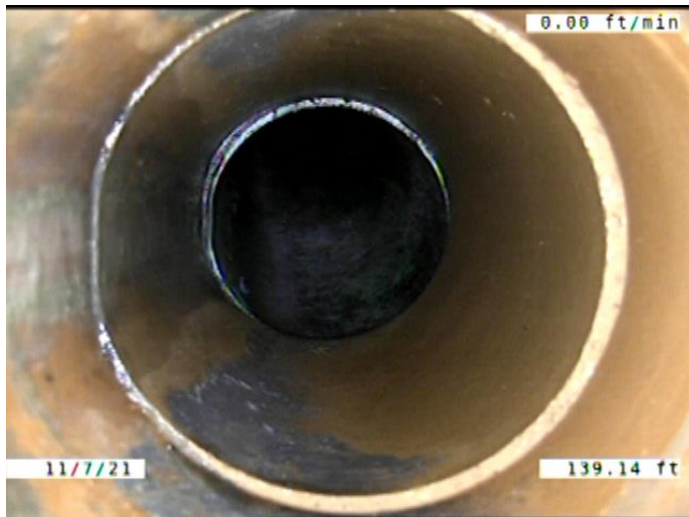
Code: **TF**  
 Description: **Tap Factory**

Distance (ft): **139.1**  
 Structural Grade: **0**  
 O&M Grade: **0**  
 Clock Start/From: **9**  
 Clock To:  
 1st Value: **4.000**  
 2nd Value:  
 Value Percent:  
 Continuous Index:  
 Within 8" of Joint: **YES**  
 Remarks:

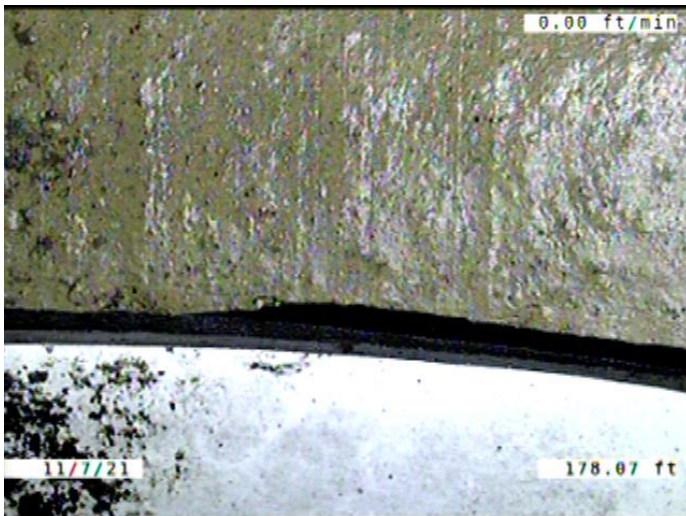
Code: **MMC**  
 Description: **Miscellaneous Material Change**

Distance (ft): **178.1**  
 Structural Grade: **0**  
 O&M Grade: **0**  
 Clock Start/From:  
 Clock To:  
 1st Value:  
 2nd Value:  
 Value Percent:  
 Continuous Index:  
 Within 8" of Joint: **NO**  
 Remarks: **VCP TO PVC**

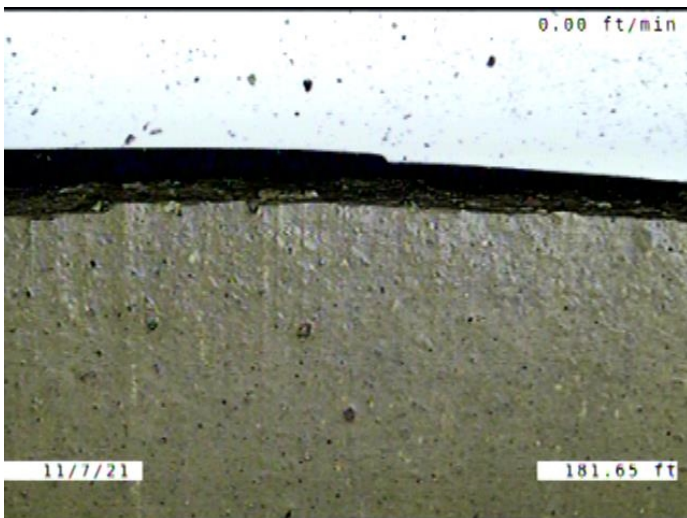
Code: **MMC**  
Description: **Miscellaneous Material Change**

Distance (ft): **181.7**  
Structural Grade: **0**  
O&M Grade: **0**  
Clock Start/From:  
Clock To:  
1st Value:  
2nd Value:  
Value Percent:  
Continuous Index:  
Within 8" of Joint: **NO**  
Remarks: **PVC TO VCP**

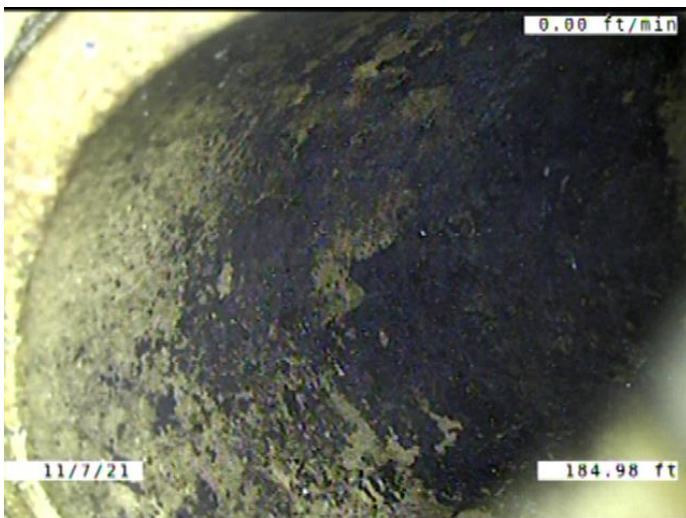
Code: **TB**  
 Description: **Tap Break-in/Hammer**

Distance (ft): **185.0**  
 Structural Grade: **0**  
 O&M Grade: **0**  
 Clock Start/From: **1**  
 Clock To:  
 1st Value: **4.000**  
 2nd Value:  
 Value Percent:  
 Continuous Index:  
 Within 8" of Joint: **YES**  
 Remarks:

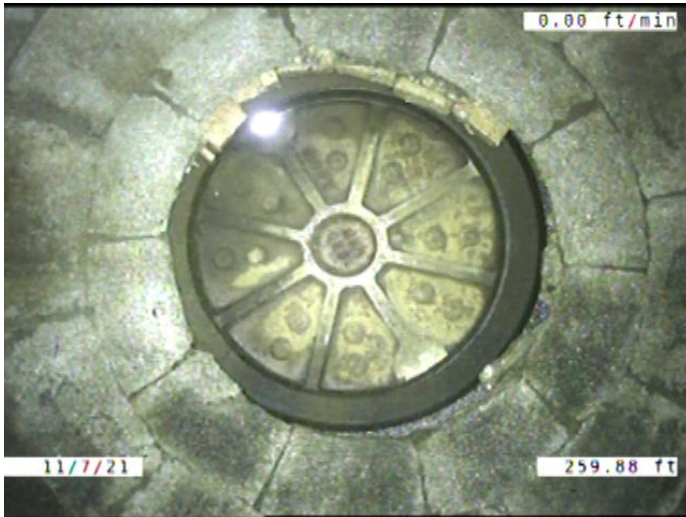
Code:	<b>AMH</b>
Description:	<b>Manhole</b>
Distance (ft):	<b>259.9</b>
Structural Grade:	<b>0</b>
O&M Grade:	<b>0</b>
Clock Start/From:	
Clock To:	
1st Value:	
2nd Value:	
Value Percent:	
Continuous Index:	
Within 8" of Joint:	<b>NO</b>
Remarks:	<b>M-505-066</b>
