Profile/Photo Observation Report

Date: **11/07/2021** Weather: _____ Coding: **PACP 7.0**
 Pipe Length (ft): **260.2** Owner: **City of Hobart** Pre Clean: **Heavy Cleaning**
 P.O.#: **YES502259** Surveyor: **Steven Bucklin** PSR: **P-505-068-069**
 Customer: **City of Hobart, IN (Red** Clean Date: **11/07/2021** Shape: **C**

Street: **West 1st Place** Flow Control: **Not Controlled**
 City: **City of Hobart** Year Renewed: _____
 Location: **Alley** Tape/Media #: _____
 Purpose: **Routine Assessment** Dia/Height: **10"**
 Use: **Sanitary Sewage Pipe** Material: **VCP**
 Drain Area: _____ Lining: **None**
 Category: **NA**
 Comment: _____
 Location Details: _____ Direction of Survey: **Downstream**
 US MH: **M-505-069** DS MH: **M-505-068** Total Length Surveyed (ft): **260.2**

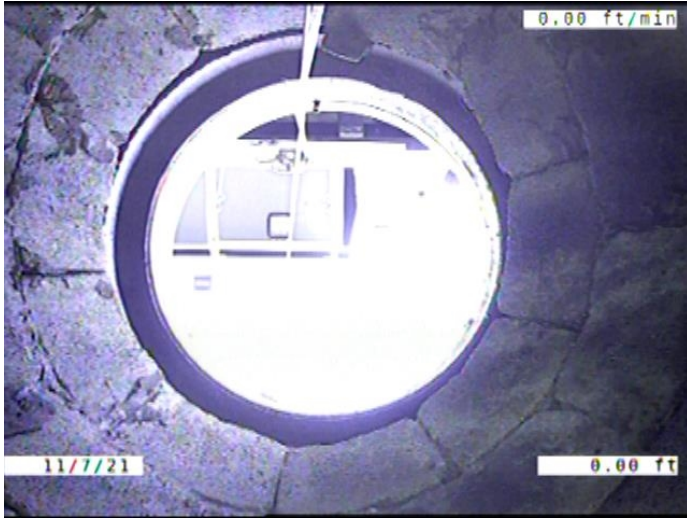
Code: **AMH**
 Description: **Manhole**

Distance (ft): **.0**
 Structural Grade: **0**
 O&M Grade: **0**
 Clock Start/From:
 Clock To:
 1st Value:
 2nd Value:
 Value Percent:
 Continuous Index:
 Within 8" of Joint: **NO**
 Remarks: **M-505-069**

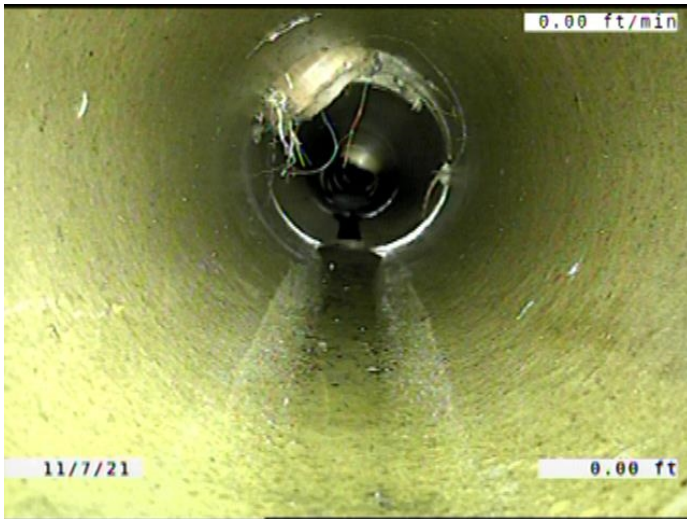
Code: **MWL**
 Description: **Miscellaneous Water Level**

Distance (ft): **.0**
 Structural Grade: **0**
 O&M Grade: **0**
 Clock Start/From:
 Clock To:
 1st Value:
 2nd Value:
 Value Percent: **5.000**
 Continuous Index:
 Within 8" of Joint: **NO**
 Remarks:

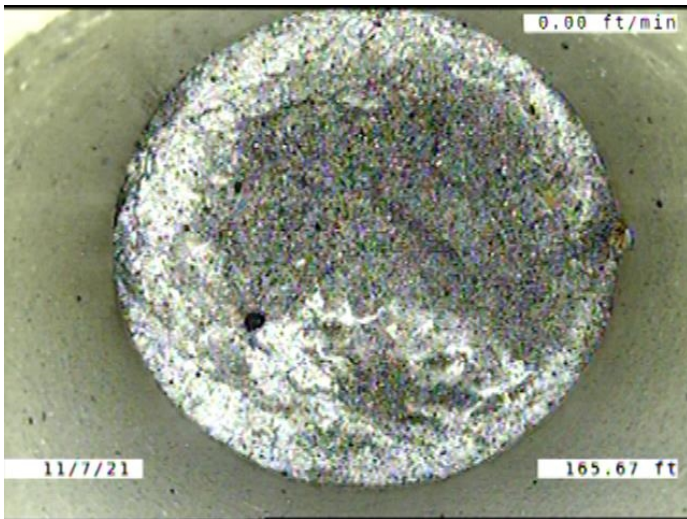
Code: **TFC**
Description: **Tap Factory Capped**

Distance (ft): **165.7**
Structural Grade: **0**
O&M Grade: **0**
Clock Start/From: **11**
Clock To:
1st Value: **4.000**
2nd Value:
Value Percent:
Continuous Index:
Within 8" of Joint: **YES**
Remarks:

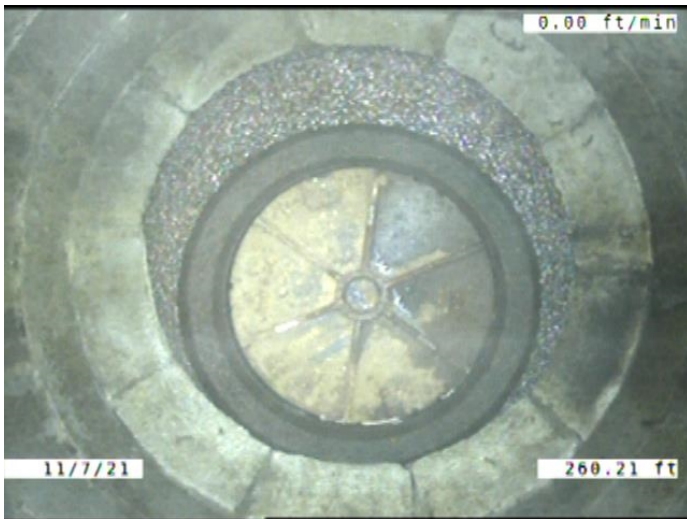
Code: **AMH**
 Description: **Manhole**

Distance (ft): **260.2**
 Structural Grade: **0**
 O&M Grade: **0**
 Clock Start/From:
 Clock To:
 1st Value:
 2nd Value:
 Value Percent:
 Continuous Index:
 Within 8" of Joint: **NO**
 Remarks: **M-505-068**
