# Profile/Photo Observation Report

Date:	<b>11/07/2021</b>	Weather:		Coding:	<b>PACP 7.0</b>
Pipe Length (ft):	<b>260.2</b>	Owner:	<b>City of Hobart</b>	Pre Clean:	<b>Heavy Cleaning</b>
P.O.#:	<b>YES502259</b>	Surveyor:	<b>Steven Bucklin</b>	PSR:	<b>P-505-068-069</b>
Customer:	<b>City of Hobart, IN (Red</b>	Clean Date:	<b>11/07/2021</b>	Shape:	<b>C</b>

Street:	<b>West 1st Place</b>	Flow Control:	<b>Not Controlled</b>
City:	<b>City of Hobart</b>	Year Renewed:	
Location:	<b>Alley</b>	Tape/Media #:	
Purpose:	<b>Routine Assessment</b>	Dia/Height:	<b>10"</b>
Use:	<b>Sanitary Sewage Pipe</b>	Material:	<b>VCP</b>
Drain Area:		Lining:	<b>None</b>
Category:	<b>NA</b>		
Comment:			
Location Details:		Direction of Survey:	<b>Downstream</b>
US MH:	<b>M-505-069</b>	DS MH:	<b>M-505-068</b>
		Total Length Surveyed (ft):	<b>260.2</b>

O&M Index:	<b>1.81</b>	O&M Quick:	<b>4132</b>	O&M Rating:	<b>47.00</b>
Structural Index:	<b>2.39</b>	Structural Quick:	<b>5444</b>	Structural Rating:	<b>129.00</b>
Overall Index:	<b>2.20</b>	Overall Quick:	<b>5445</b>	Overall Rating:	<b>176.00</b>

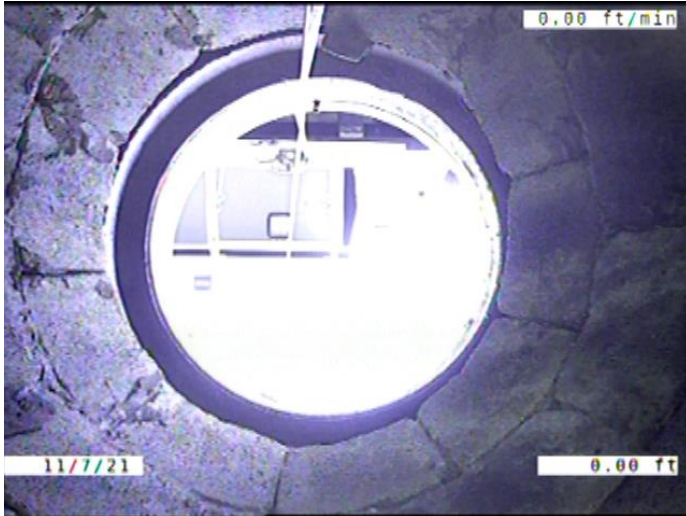
Code: **AMH**  
 Description: **Manhole**

Distance (ft): **.0**  
 Structural Grade: **0**  
 O&M Grade: **0**  
 Clock Start/From:  
 Clock To:  
 1st Value:  
 2nd Value:  
 Value Percent:  
 Continuous Index:  
 Within 8" of Joint: **NO**  
 Remarks: **M-505-069**

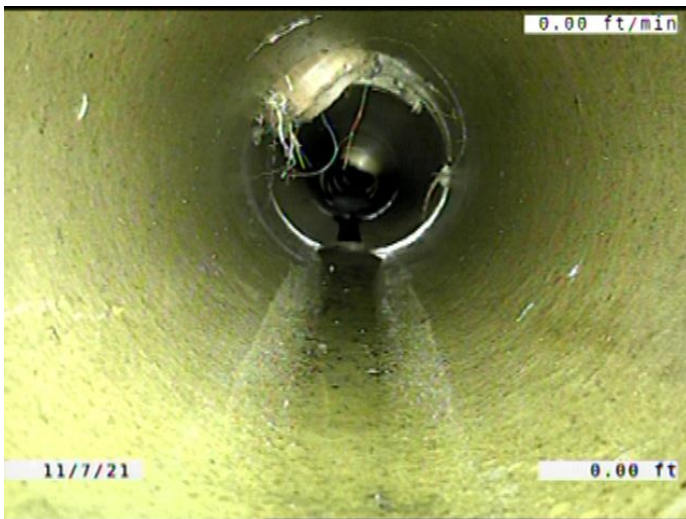
Code: **MWL**  
 Description: **Miscellaneous Water Level**

Distance (ft): **.0**  
 Structural Grade: **0**  
 O&M Grade: **0**  
 Clock Start/From:  
 Clock To:  
 1st Value:  
 2nd Value:  
 Value Percent: **5.000**  
 Continuous Index:  
 Within 8" of Joint: **NO**  
 Remarks:

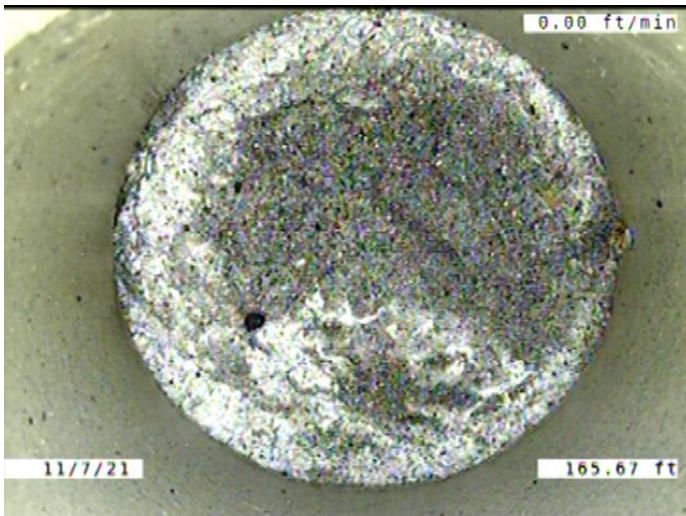
Code: **TFC**  
 Description: **Tap Factory Capped**

Distance (ft): **165.7**  
 Structural Grade: **0**  
 O&M Grade: **0**  
 Clock Start/From: **11**  
 Clock To:  
 1st Value: **4.000**  
 2nd Value:  
 Value Percent:  
 Continuous Index:  
 Within 8" of Joint: **YES**  
 Remarks:

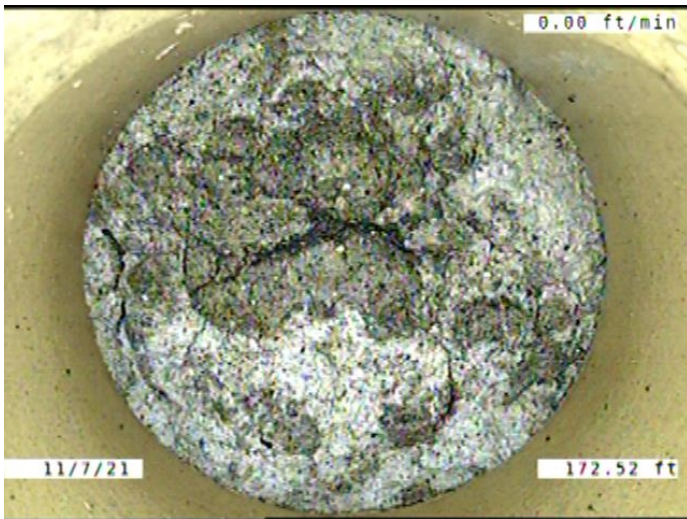
Code: **TFC**  
Description: **Tap Factory Capped**

Distance (ft): **172.5**  
Structural Grade: **0**  
O&M Grade: **0**  
Clock Start/From: **1**  
Clock To:  
1st Value: **4.000**  
2nd Value:  
Value Percent:  
Continuous Index:  
Within 8" of Joint: **YES**  
Remarks:

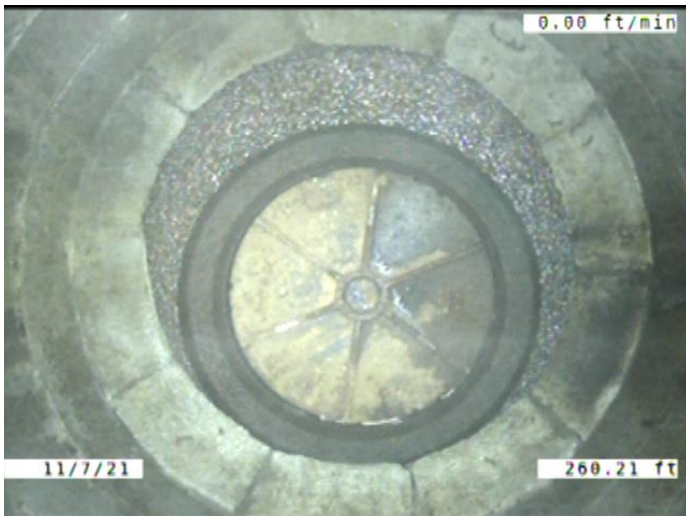
Code: **AMH**  
 Description: **Manhole**

Distance (ft): **260.2**  
 Structural Grade: **0**  
 O&M Grade: **0**  
 Clock Start/From:  
 Clock To:  
 1st Value:  
 2nd Value:  
 Value Percent:  
 Continuous Index:  
 Within 8" of Joint: **NO**  
 Remarks: **M-505-068**
