Profile/Photo Observation Report

Street:	FOXCROFT STREET	Flow Control:	Not Controlled
City:	Hobart, IN	Year Renewed:	
Location:	Yard	Tape/Media #:	
Purpose:	Routine Assessment	Dia/Height:	10"
Use:	Sanitary	Material:	VCP
Drain Area:	NA	Lining:	
Category:	NA		
Comment:

Location Details:		Direction of Survey:	Downstream
US MH:	M-505-085	DS MH:	M-505-086
		Total Length Surveyed (ft):	68.6

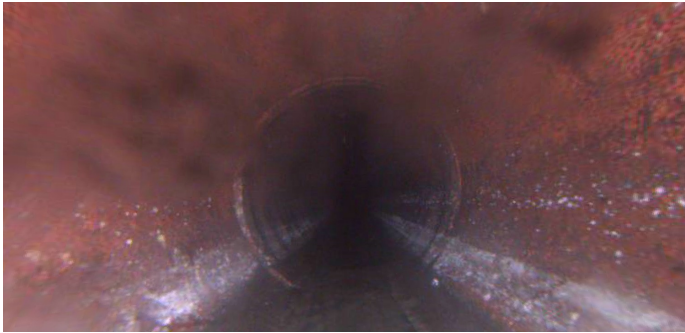
Code:	MWL
Description:	Water Level

Distance (ft):	.0
Structural Grade:	0
O&M Grade:	0
Clock Start/From:	
Clock To:	
1st Value:	
2nd Value:	
Value Percent:	5.000
Continuous Index:	
Within 8" of Joint:	NO
Remarks:

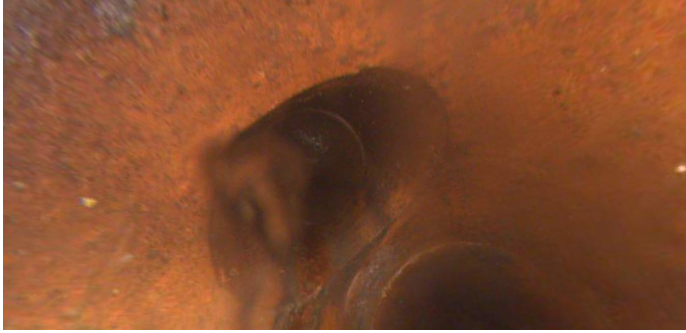
Code: **TF**
Description: **Tap Factory**

Distance (ft): **13.7**
Structural Grade: **0**
O&M Grade: **0**
Clock Start/From: **2**
Clock To:
1st Value: **4.000**
2nd Value:
Value Percent:
Continuous Index:
Within 8" of Joint:
Remarks:
