Profile/Photo Observation Report

Date:	01/14/2022	Weather:		Coding:	PACP 7.0
Pipe Length (ft):	285.1	Owner:	City of Hobart	Pre Clean:	Heavy Cleaning
P.O.#:	YES502259	Surveyor:	S. Bucklin	PSR:	P-505-086-087
Customer:	City of Hobart	Clean Date:	01/12/2021	Shape:	C

Street:	West 4th Place	Flow Control:	Not Controlled
City:	Hobart, IN	Year Renewed:	
Location:	Local rural streets with light traffic, t	Tape/Media #:	
Purpose:	Routine Assessment	Dia/Height:	10"
Use:	Sanitary Sewage Pipe	Material:	VCP
Drain Area:		Lining:	None
Category:	NA		
Comment:			
Location Details:		Direction of Survey:	Downstream
US MH:	M-505-086	DS MH:	M-505-087
		Total Length Surveyed (ft):	285.0

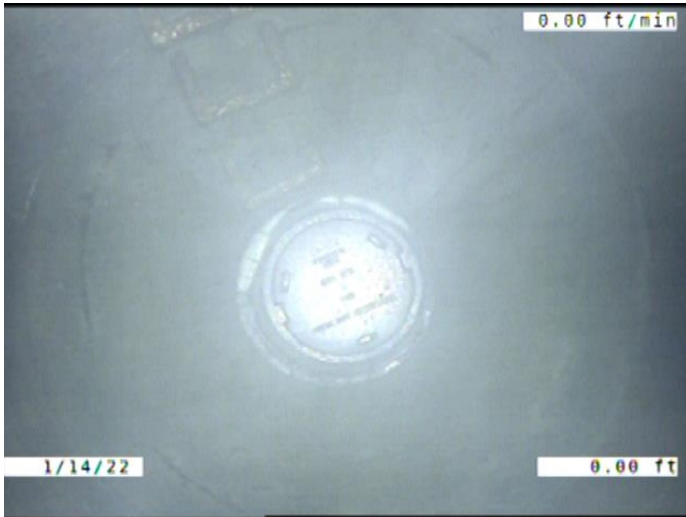
Code: **AMH**
Description: **Manhole**

Distance (ft): **.0**
Structural Grade: **0**
O&M Grade: **0**
Clock Start/From:
Clock To:
1st Value:
2nd Value:
Value Percent:
Continuous Index:
Within 8" of Joint: **NO**
Remarks: **M-505-086**

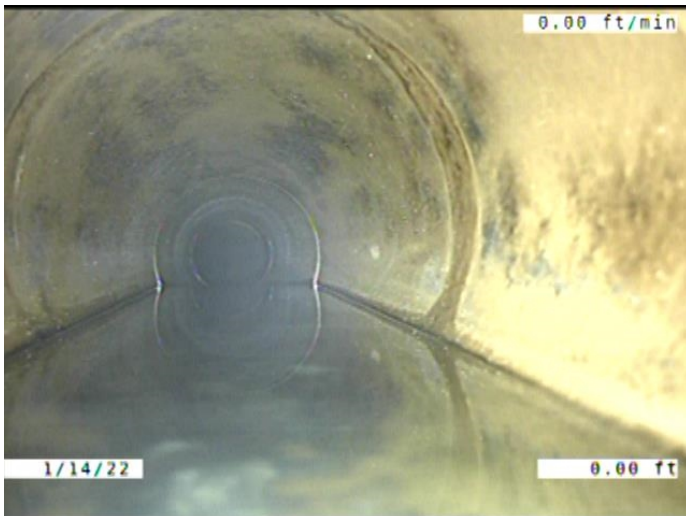
Code: **MWL**
Description: **Miscellaneous Water Level**

Distance (ft): **.0**
Structural Grade: **0**
O&M Grade: **0**
Clock Start/From:
Clock To:
1st Value:
2nd Value:
Value Percent: **10.000**
Continuous Index:
Within 8" of Joint: **NO**
Remarks:

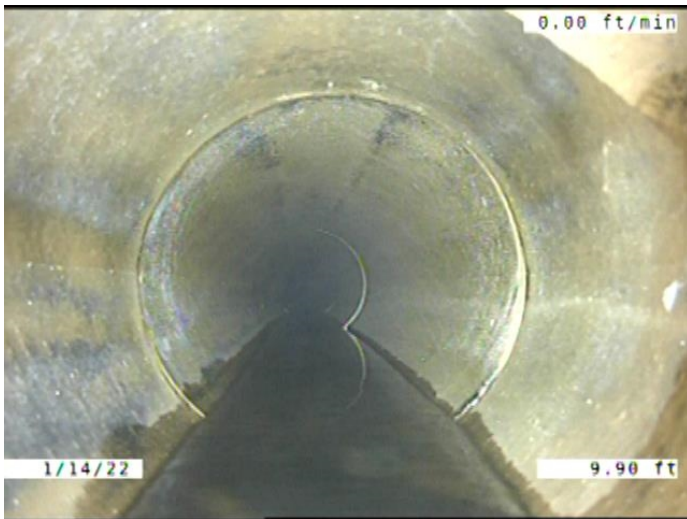
Code: **MWL**
 Description: **Miscellaneous Water Level**

Distance (ft): **9.9**
 Structural Grade: **0**
 O&M Grade: **0**
 Clock Start/From:
 Clock To:
 1st Value:
 2nd Value:
 Value Percent: **5.000**
 Continuous Index:
 Within 8" of Joint: **NO**
 Remarks:

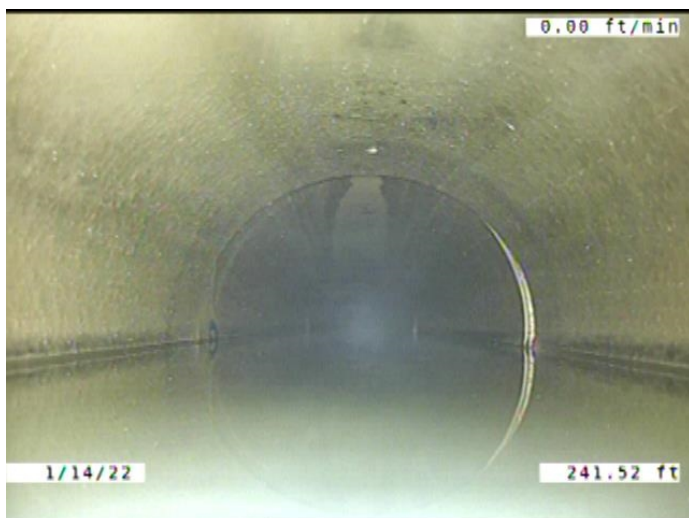
Code: **MWL**
 Description: **Miscellaneous Water Level**

Distance (ft): **241.5**
 Structural Grade: **0**
 O&M Grade: **0**
 Clock Start/From:
 Clock To:
 1st Value:
 2nd Value:
 Value Percent: **25.000**
 Continuous Index:
 Within 8" of Joint: **NO**
 Remarks:

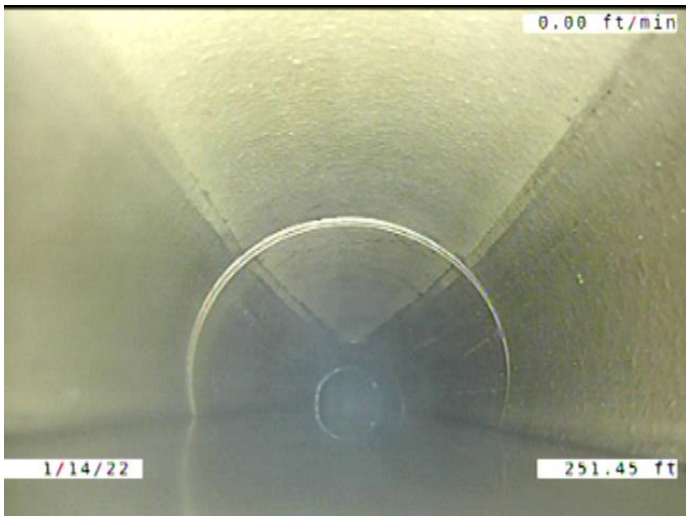
Code: **MWL**
 Description: **Miscellaneous Water Level**

Distance (ft): **251.4**
 Structural Grade: **0**
 O&M Grade: **0**
 Clock Start/From:
 Clock To:
 1st Value:
 2nd Value:
 Value Percent: **15.000**
 Continuous Index:
 Within 8" of Joint: **NO**
 Remarks:

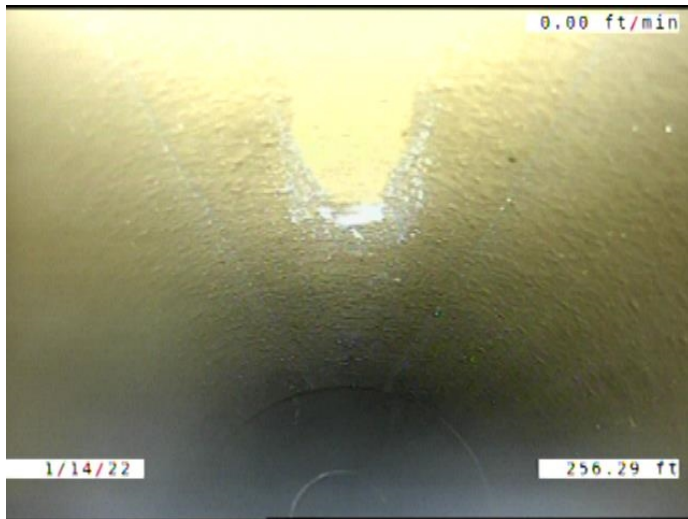
Code: **MWL**
 Description: **Miscellaneous Water Level**

Distance (ft): **256.3**
 Structural Grade: **0**
 O&M Grade: **0**
 Clock Start/From:
 Clock To:
 1st Value:
 2nd Value:
 Value Percent: **25.000**
 Continuous Index:
 Within 8" of Joint: **NO**
 Remarks:

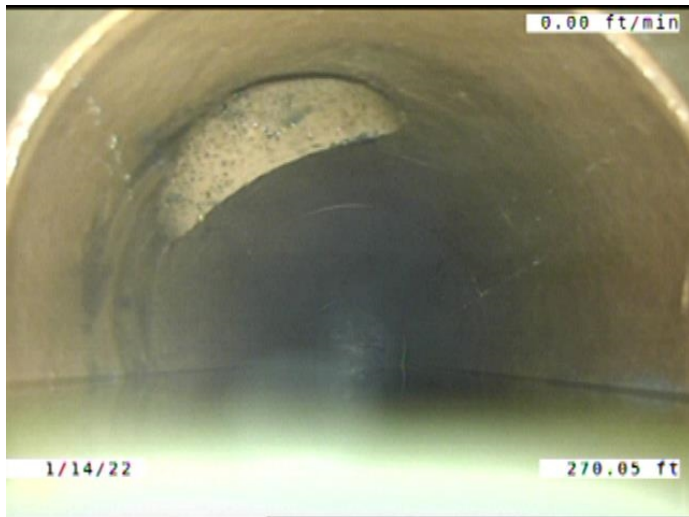
Code: **MWL**
 Description: **Miscellaneous Water Level**

Distance (ft): **270.1**
 Structural Grade: **0**
 O&M Grade: **0**
 Clock Start/From:
 Clock To:
 1st Value:
 2nd Value:
 Value Percent: **15.000**
 Continuous Index:
 Within 8" of Joint: **NO**
 Remarks:

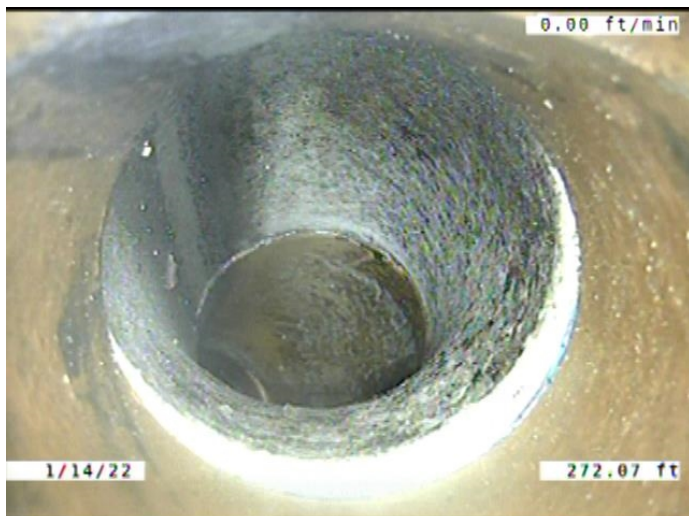
Code: **TF**
 Description: **Tap Factory**

Distance (ft): **272.1**
 Structural Grade: **0**
 O&M Grade: **0**
 Clock Start/From: **11**
 Clock To:
 1st Value: **4.000**
 2nd Value:
 Value Percent:
 Continuous Index:
 Within 8" of Joint: **YES**
 Remarks:

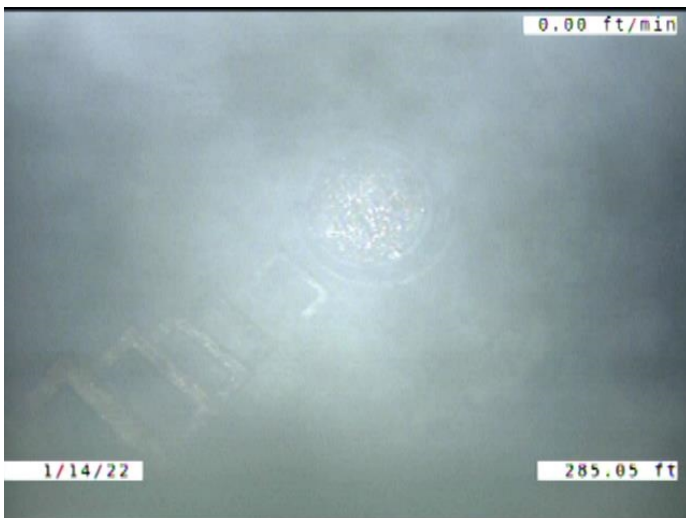
Code: **AMH**
 Description: **Manhole**

Distance (ft): **285.0**
 Structural Grade: **0**
 O&M Grade: **0**
 Clock Start/From:
 Clock To:
 1st Value:
 2nd Value:
 Value Percent:
 Continuous Index:
 Within 8" of Joint: **NO**
 Remarks: **M-505-087**
