Profile/Photo Observation Report

Date:	02/06/2022	Weather:		Coding:	PACP 7.0
Pipe Length (ft):	296.7	Owner:	City of Hobart	Pre Clean:	Heavy Cleaning
P.O.#:	YES502259	Surveyor:	S. Bucklin	PSR:	P-506-003-002
Customer:	City of Hobart	Clean Date:	02/03/2022	Shape:	C

Street:	South 8th Street	Flow Control:	Not Controlled
City:	Hobart, IN	Year Renewed:	
Location:	Easement/Right of Way	Tape/Media #:	
Purpose:	Routine Assessment	Dia/Height:	12"
Use:	Sanitary Sewage Pipe	Material:	VCP
Drain Area:		Lining:	None
Category:	NA		
Comment:			
Location Details:		Direction of Survey:	Downstream
US MH:	M-506-003	DS MH:	M-506-002
		Total Length Surveyed (ft):	296.7

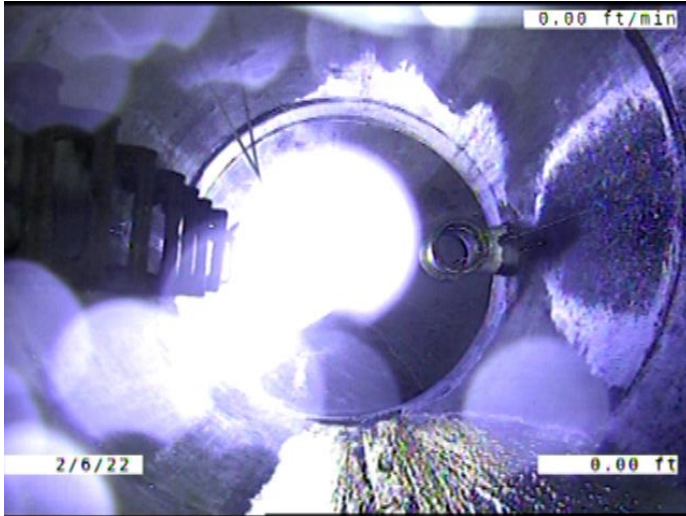
Code: **AMH**
Description: **Manhole**

Distance (ft): **.0**
Structural Grade: **0**
O&M Grade: **0**
Clock Start/From:
Clock To:
1st Value:
2nd Value:
Value Percent:
Continuous Index:
Within 8" of Joint: **NO**
Remarks: **M-506-003**

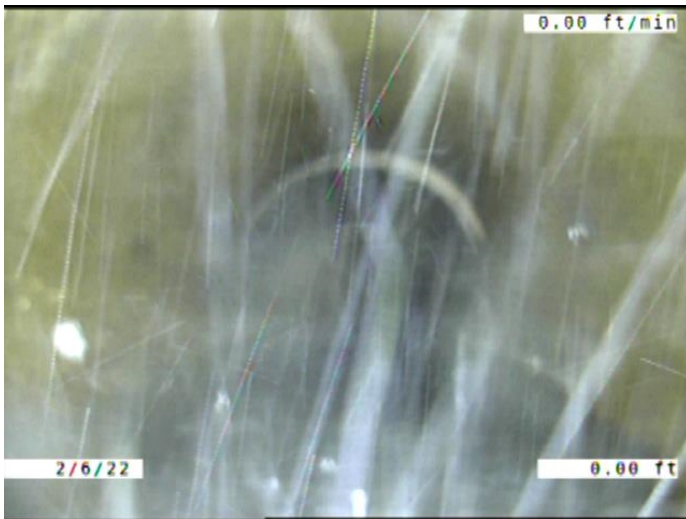
Code: **MWL**
Description: **Miscellaneous Water Level**

Distance (ft): **.0**
Structural Grade: **0**
O&M Grade: **0**
Clock Start/From:
Clock To:
1st Value:
2nd Value:
Value Percent: **15.000**
Continuous Index:
Within 8" of Joint: **NO**
Remarks:

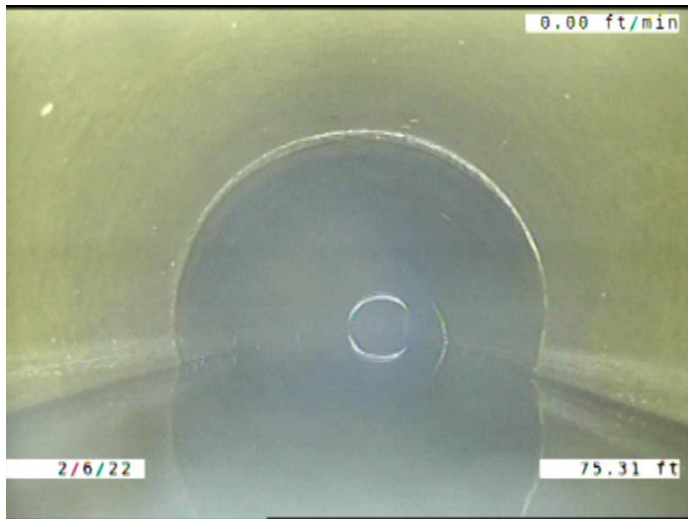
Code: **MWL**
Description: **Miscellaneous Water Level**

Distance (ft): **75.3**
Structural Grade: **0**
O&M Grade: **0**
Clock Start/From:
Clock To:
1st Value:
2nd Value:
Value Percent: **35.000**
Continuous Index:
Within 8" of Joint: **NO**
Remarks:

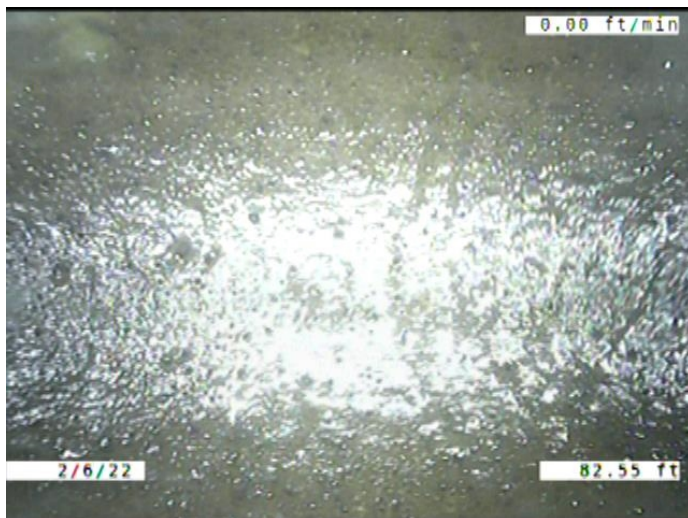
Code: **MWL**
Description: **Miscellaneous Water Level**

Distance (ft): **82.5**
Structural Grade: **0**
O&M Grade: **0**
Clock Start/From:
Clock To:
1st Value:
2nd Value:
Value Percent: **50.000**
Continuous Index:
Within 8" of Joint: **NO**
Remarks:

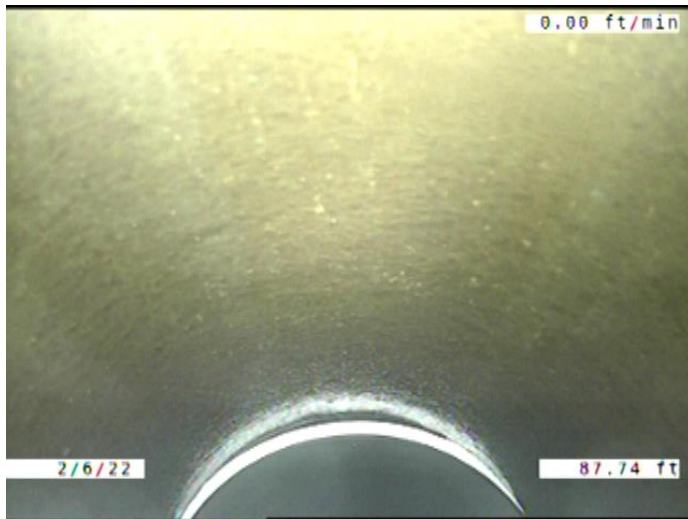
Code: **MWL**
 Description: **Miscellaneous Water Level**

Distance (ft): **87.7**
 Structural Grade: **0**
 O&M Grade: **0**
 Clock Start/From:
 Clock To:
 1st Value:
 2nd Value:
 Value Percent: **35.000**
 Continuous Index:
 Within 8" of Joint: **NO**
 Remarks:

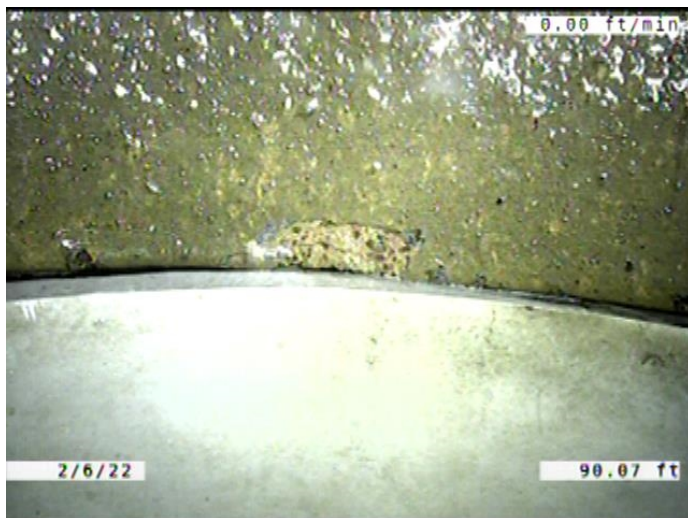
Code: **MMC**
 Description: **Miscellaneous Material Change**

Distance (ft): **90.0**
 Structural Grade: **0**
 O&M Grade: **0**
 Clock Start/From:
 Clock To:
 1st Value:
 2nd Value:
 Value Percent:
 Continuous Index:
 Within 8" of Joint: **NO**
 Remarks: **VCP TO PVC**

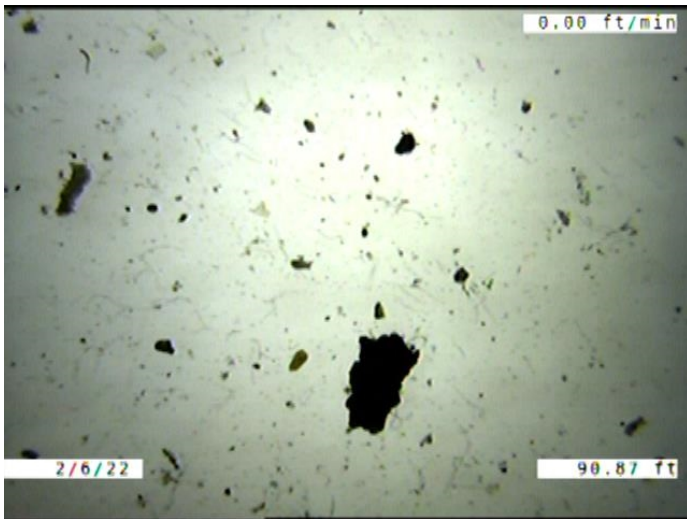
Code: **MWL**
Description: **Miscellaneous Water Level**

Distance (ft): **90.8**
Structural Grade: **0**
O&M Grade: **0**
Clock Start/From:
Clock To:
1st Value:
2nd Value:
Value Percent: **50.000**
Continuous Index:
Within 8" of Joint: **NO**
Remarks:

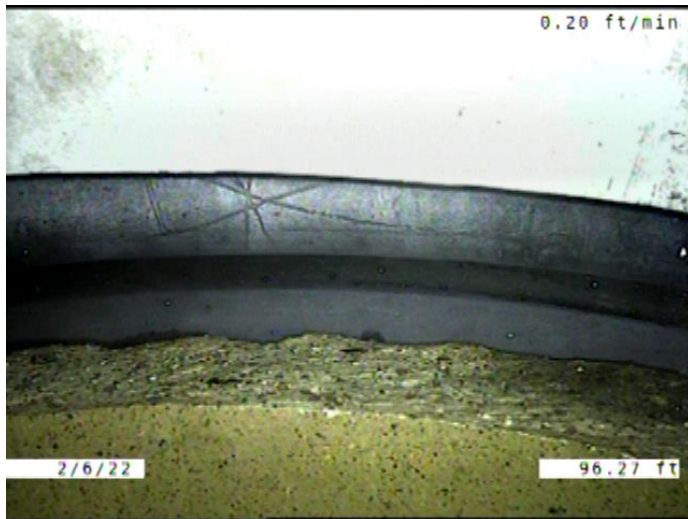
Code: **MMC**
 Description: **Miscellaneous Material Change**

Distance (ft): **96.3**
 Structural Grade: **0**
 O&M Grade: **0**
 Clock Start/From:
 Clock To:
 1st Value:
 2nd Value:
 Value Percent:
 Continuous Index:
 Within 8" of Joint: **NO**
 Remarks: **PVC TO VCP**

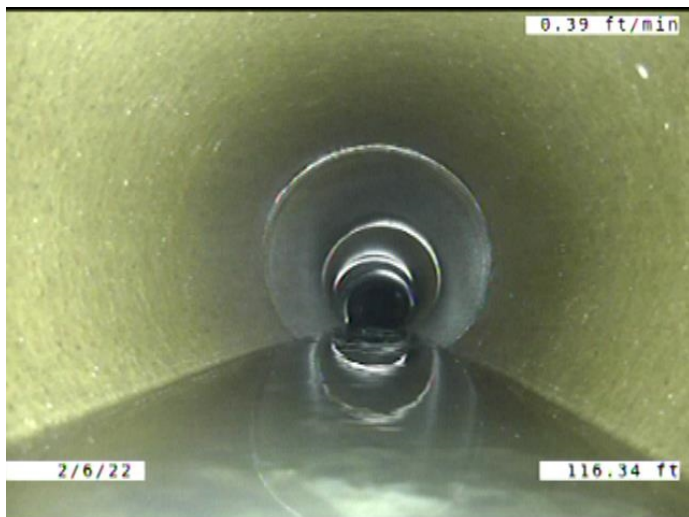
Code: **MWL**
 Description: **Miscellaneous Water Level**

Distance (ft): **116.3**
 Structural Grade: **0**
 O&M Grade: **0**
 Clock Start/From:
 Clock To:
 1st Value:
 2nd Value:
 Value Percent: **15.000**
 Continuous Index:
 Within 8" of Joint: **NO**
 Remarks:

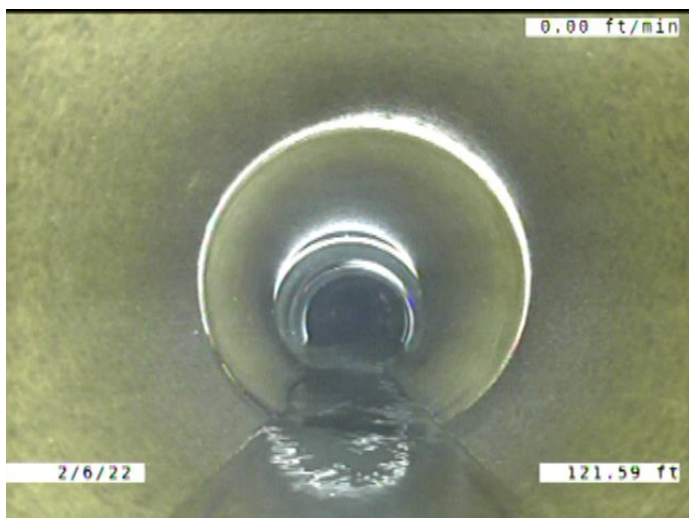
Code: **MWL**
 Description: **Miscellaneous Water Level**

Distance (ft): **121.6**
 Structural Grade: **0**
 O&M Grade: **0**
 Clock Start/From:
 Clock To:
 1st Value:
 2nd Value:
 Value Percent: **5.000**
 Continuous Index:
 Within 8" of Joint: **NO**
 Remarks:

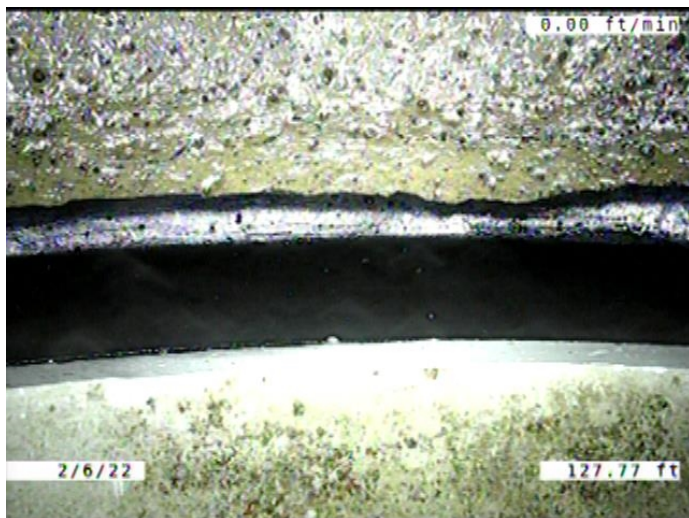
Code: **MMC**
 Description: **Miscellaneous Material Change**

Distance (ft): **127.8**
 Structural Grade: **0**
 O&M Grade: **0**
 Clock Start/From:
 Clock To:
 1st Value:
 2nd Value:
 Value Percent:
 Continuous Index:
 Within 8" of Joint: **NO**
 Remarks: **VCP TO PVC**

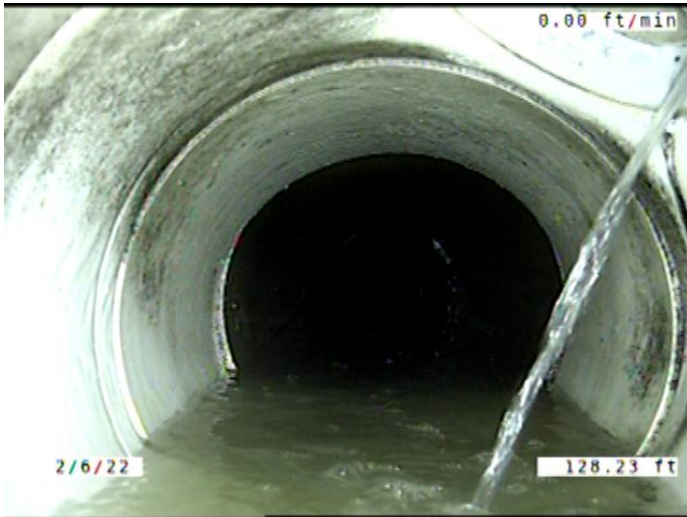
Code:	MWL
Description:	Miscellaneous Water Level
Distance (ft):	128.2
Structural Grade:	0
O&M Grade:	0
Clock Start/From:	
Clock To:	
1st Value:	
2nd Value:	
Value Percent:	35.000
Continuous Index:	
Within 8" of Joint:	NO
Remarks:

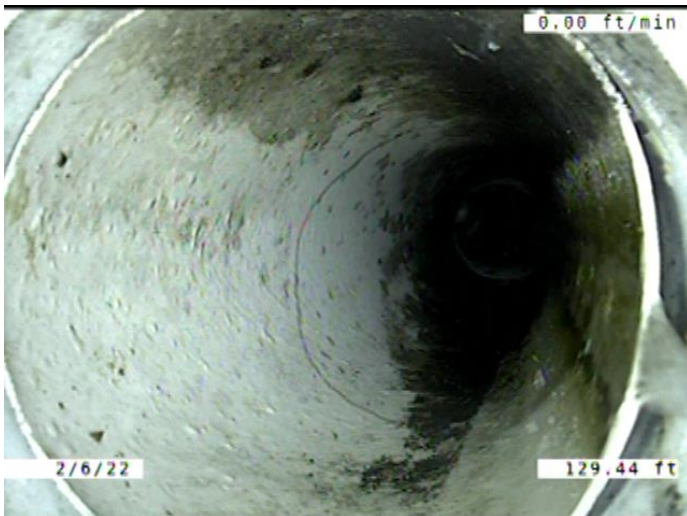
Code:	TFA
Description:	Tap Factory Activity
Distance (ft):	129.4
Structural Grade:	0
O&M Grade:	0
Clock Start/From:	1
Clock To:	
1st Value:	6.000
2nd Value:	
Value Percent:	
Continuous Index:	
Within 8" of Joint:	YES
Remarks:

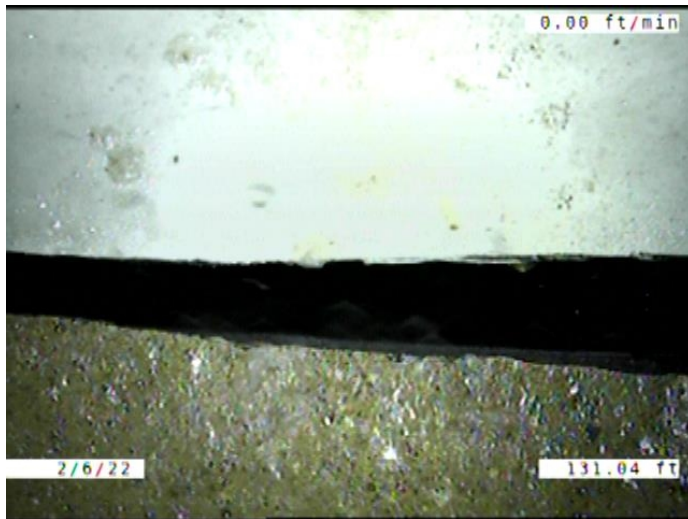
Code: **MMC**
 Description: **Miscellaneous Material Change**

Distance (ft): **131.0**
 Structural Grade: **0**
 O&M Grade: **0**
 Clock Start/From:
 Clock To:
 1st Value:
 2nd Value:
 Value Percent:
 Continuous Index:
 Within 8" of Joint: **NO**
 Remarks: **PVC TO VCP**

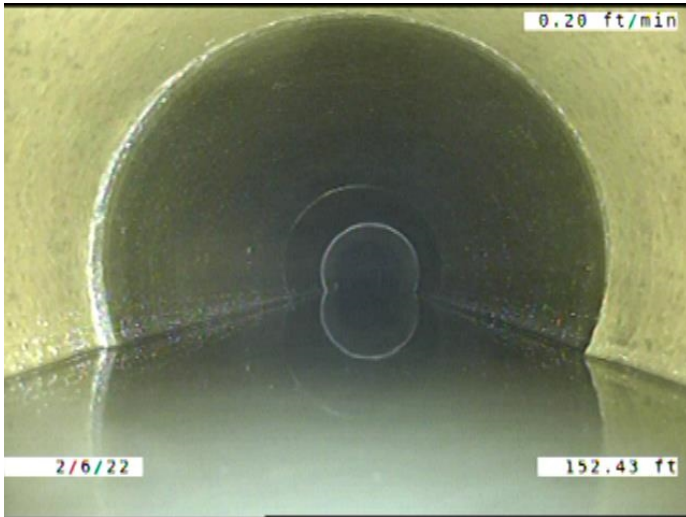
Code: **MWL**
Description: **Miscellaneous Water Level**

Distance (ft): **152.4**
Structural Grade: **0**
O&M Grade: **0**
Clock Start/From:
Clock To:
1st Value:
2nd Value:
Value Percent: **15.000**
Continuous Index:
Within 8" of Joint: **NO**
Remarks:

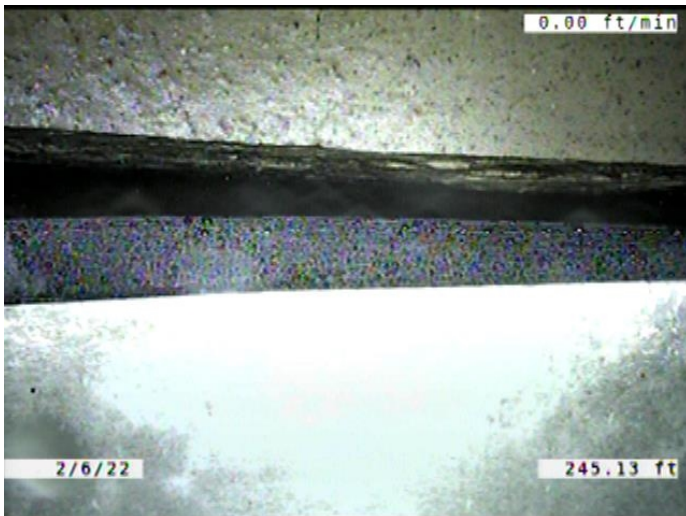
Code: **MMC**
Description: **Miscellaneous Material Change**

Distance (ft): **245.1**
Structural Grade: **0**
O&M Grade: **0**
Clock Start/From:
Clock To:
1st Value:
2nd Value:
Value Percent:
Continuous Index:
Within 8" of Joint: **NO**
Remarks: **VCP TO PVC**

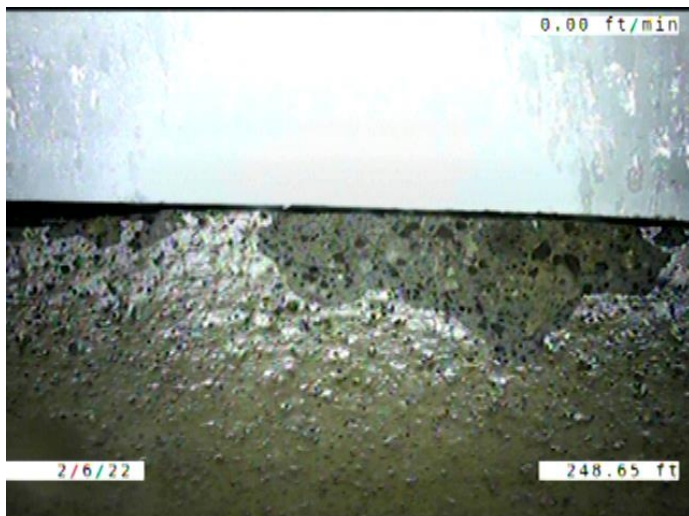
Code: **MMC**
 Description: **Miscellaneous Material Change**

Distance (ft): **248.7**
 Structural Grade: **0**
 O&M Grade: **0**
 Clock Start/From:
 Clock To:
 1st Value:
 2nd Value:
 Value Percent:
 Continuous Index:
 Within 8" of Joint: **NO**
 Remarks: **PVC TO VCP**

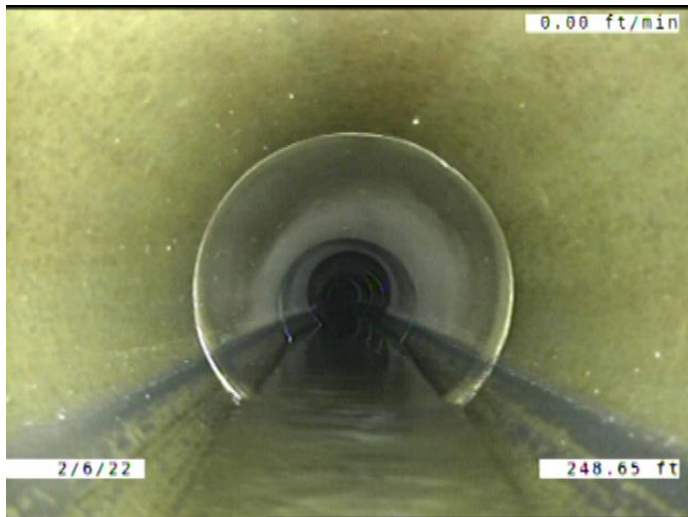
Code: **MWL**
 Description: **Miscellaneous Water Level**

Distance (ft): **248.7**
 Structural Grade: **0**
 O&M Grade: **0**
 Clock Start/From:
 Clock To:
 1st Value:
 2nd Value:
 Value Percent: **5.000**
 Continuous Index:
 Within 8" of Joint: **NO**
 Remarks:

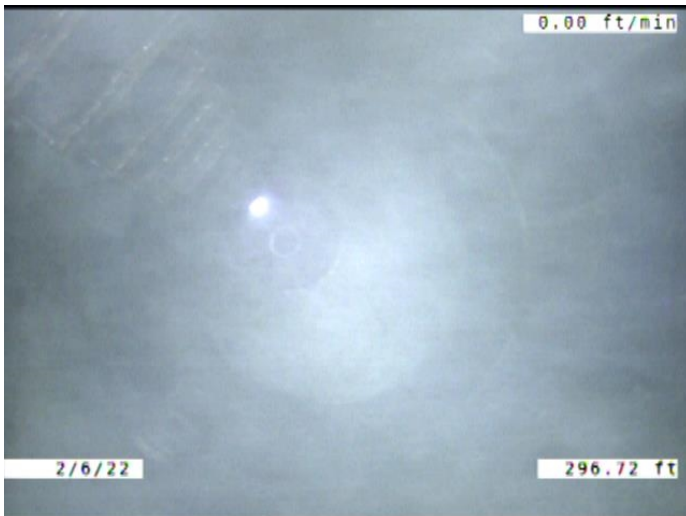
Code: **AMH**
 Description: **Manhole**

Distance (ft): **296.7**
 Structural Grade: **0**
 O&M Grade: **0**
 Clock Start/From:
 Clock To:
 1st Value:
 2nd Value:
 Value Percent:
 Continuous Index:
 Within 8" of Joint: **NO**
 Remarks: **M-506-002**
