Profile/Photo Observation Report

Date:	01/20/2022	Weather:		Coding:	PACP 7.0
Pipe Length (ft):	205.3	Owner:	City of Hobart	Pre Clean:	Heavy Cleaning
P.O.#:	YES502259	Surveyor:	S. Bucklin	PSR:	P-506-017-016
Customer:	City of Hobart	Clean Date:	01/16/2022	Shape:	C

Street:	West 7th Place	Flow Control:	Not Controlled
City:	Hobart, IN	Year Renewed:	
Location:	Local rural streets with light traffic, t	Tape/Media #:	
Purpose:	Routine Assessment	Dia/Height:	10"
Use:	Sanitary Sewage Pipe	Material:	VCP
Drain Area:		Lining:	None
Category:	NA		
Comment:			
Location Details:		Direction of Survey:	Downstream
US MH:	M-506-016	DS MH:	M-506-017
		Total Length Surveyed (ft):	205.3

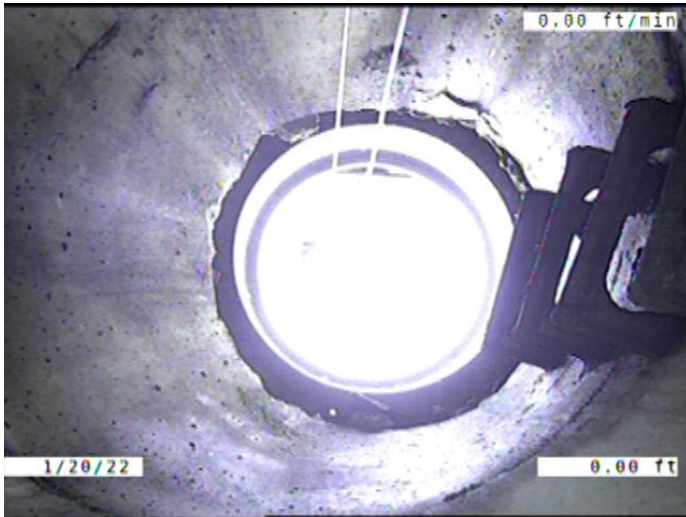
Code: **AMH**
Description: **Manhole**

Distance (ft): **.0**
Structural Grade: **0**
O&M Grade: **0**
Clock Start/From:
Clock To:
1st Value:
2nd Value:
Value Percent:
Continuous Index:
Within 8" of Joint: **NO**
Remarks: **M-506-016**

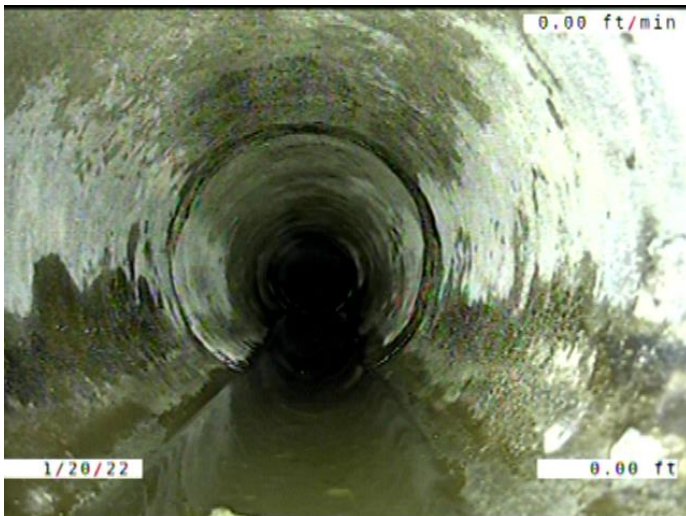
Code: **MWL**
Description: **Miscellaneous Water Level**

Distance (ft): **.0**
Structural Grade: **0**
O&M Grade: **0**
Clock Start/From:
Clock To:
1st Value:
2nd Value:
Value Percent: **5.000**
Continuous Index:
Within 8" of Joint: **NO**
Remarks:

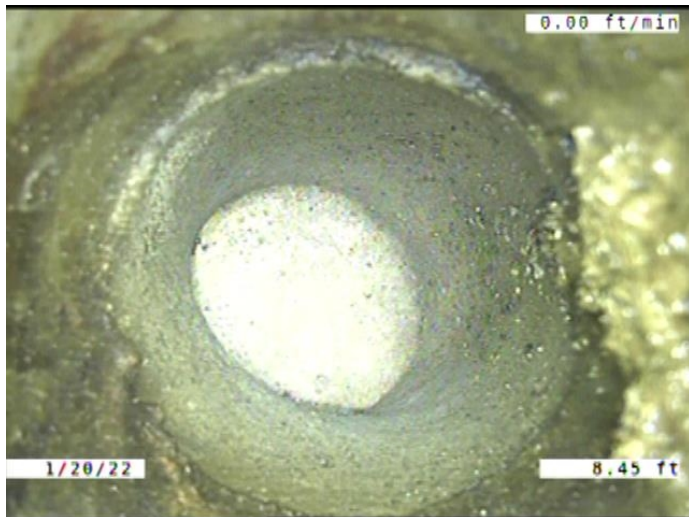
Code: **TFC**
Description: **Tap Factory Capped**

Distance (ft): **8.4**
Structural Grade: **0**
O&M Grade: **0**
Clock Start/From: **2**
Clock To:
1st Value: **4.000**
2nd Value:
Value Percent:
Continuous Index:
Within 8" of Joint: **YES**
Remarks:

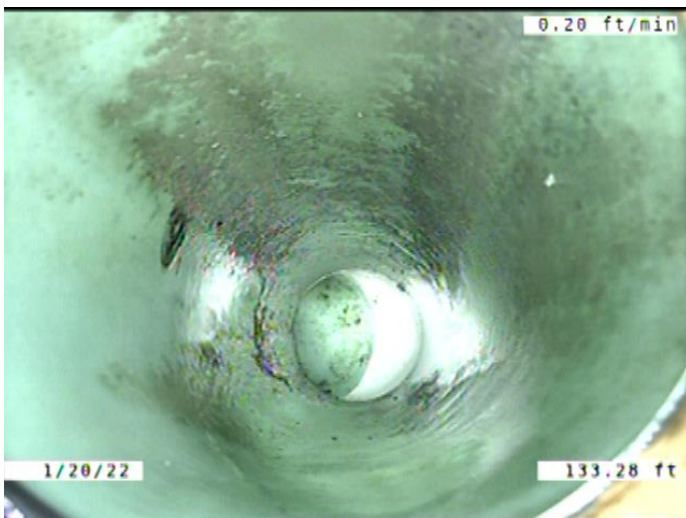
Code: **TB**
 Description: **Tap Break-in/Hammer**

Distance (ft): **133.3**
 Structural Grade: **0**
 O&M Grade: **0**
 Clock Start/From: **12**
 Clock To:
 1st Value: **4.000**
 2nd Value:
 Value Percent:
 Continuous Index:
 Within 8" of Joint: **YES**
 Remarks:

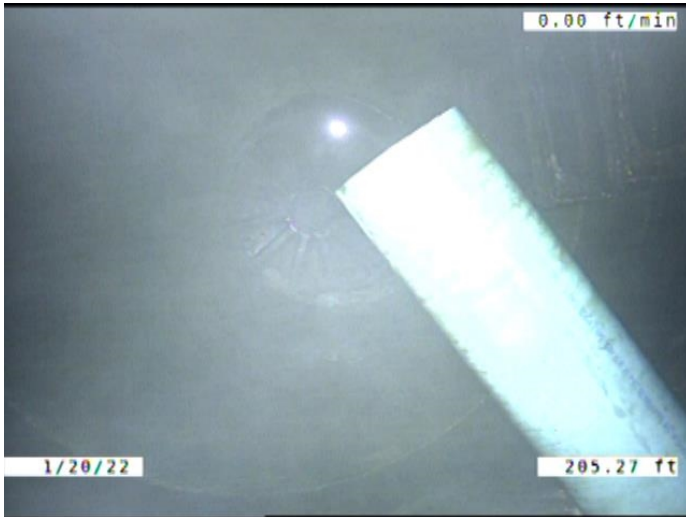
Code:	AMH
Description:	Manhole
Distance (ft):	205.3
Structural Grade:	0
O&M Grade:	0
Clock Start/From:	
Clock To:	
1st Value:	
2nd Value:	
Value Percent:	
Continuous Index:	
Within 8" of Joint:	NO
Remarks:	M-506-017
