Profile/Photo Observation Report

Date:	01/30/2022	Weather:		Coding:	PACP 7.0
Pipe Length (ft):	228.3	Owner:	City of Hobart	Pre Clean:	Heavy Cleaning
P.O.#:	YES502259	Surveyor:	S. Bucklin	PSR:	P-506-018-019
Customer:	City of Hobart	Clean Date:	01/28/2022	Shape:	C

Street:	South Wisconsin Street	Flow Control:	Not Controlled
City:	Hobart, IN	Year Renewed:	
Location:	Yard	Tape/Media #:	
Purpose:	Routine Assessment	Dia/Height:	10"
Use:	Sanitary Sewage Pipe	Material:	VCP
Drain Area:		Lining:	None
Category:	NA		
Comment:			
Location Details:	WEST OF THE NW CORNER OF THE H	Direction of Survey:	Downstream
US MH:	M-506-018	DS MH:	M-506-019
		Total Length Surveyed (ft):	228.3

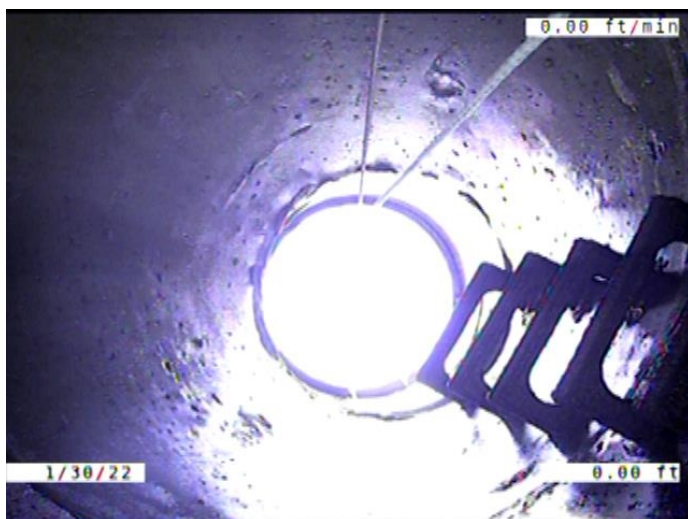
Code: **AMH**
Description: **Manhole**

Distance (ft): **.0**
Structural Grade: **0**
O&M Grade: **0**
Clock Start/From:
Clock To:
1st Value:
2nd Value:
Value Percent:
Continuous Index:
Within 8" of Joint: **NO**
Remarks: **M-506-018**

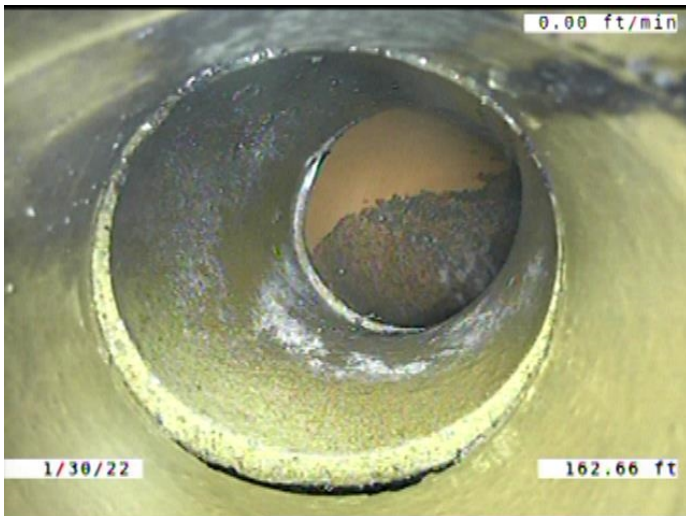
Code: **JAM**
Description: **Joint Angular Medium**

Distance (ft): **157.7**
Structural Grade: **3**
O&M Grade: **0**
Clock Start/From:
Clock To:
1st Value:
2nd Value:
Value Percent:
Continuous Index:
Within 8" of Joint: **NO**
Remarks:

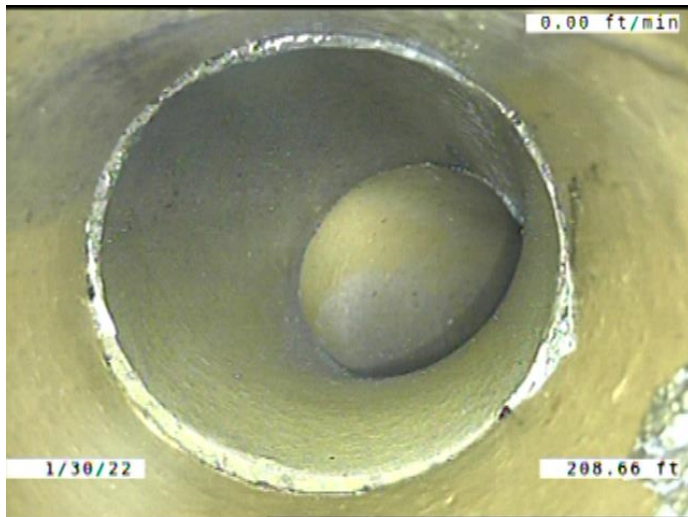
Code: **SSS**
 Description: **Surface Damage Surface Spalling**

Distance (ft): **206.0**
 Structural Grade: **2**
 O&M Grade: **0**
 Clock Start/From: **8**
 Clock To:
 1st Value:
 2nd Value:
 Value Percent:
 Continuous Index:
 Within 8" of Joint: **NO**
 Remarks:

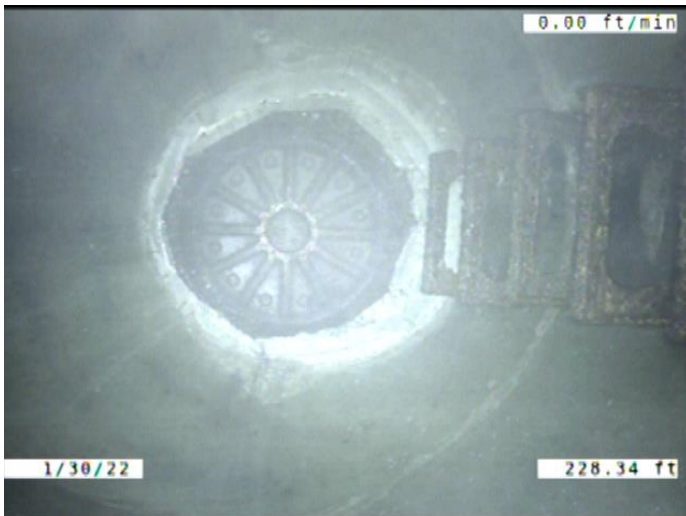
Code: **MWLS**
 Description: **Miscellaneous Water Level Sag**

Distance (ft): **226.9**
 Structural Grade: **2**
 O&M Grade: **0**
 Clock Start/From:
 Clock To:
 1st Value:
 2nd Value:
 Value Percent: **15.000**
 Continuous Index: **F10**
 Within 8" of Joint: **NO**
 Remarks:
