## Profile/Photo Observation Report

Date:	<b>04/06/2018</b>	Weather:		Coding:	<b>PACP 6.0</b>
Pipe Length (ft):	<b>190.4</b>	Owner:	<b>NA</b>	Pre Clean:	<b>No Pre-Cleaning</b>
P.O.#:		Surveyor:	<b>Mark Ruby</b>	PSR:	<b>P-506-024-023</b>
Customer:		Clean Date:	<b>01/01/1900</b>	Shape:	<b>C</b>

Street:	<b>RIVER TERR</b>	Flow Control:	<b>Not Controlled</b>
City:	<b>Hobart, IN</b>	Year Renewed:	
Location:	<b>Yard</b>	Tape/Media #:	
Purpose:	<b>Routine Assessment</b>	Dia/Height:	<b>10"</b>
Use:	<b>Sanitary</b>	Material:	<b>VCP</b>
Drain Area:	<b>NA</b>	Lining:	
Category:	<b>NA</b>		
Comment:			
Location Details:		Direction of Survey:	<b>Downstream</b>
US MH:	<b>M-506-024</b>	DS MH:	<b>M-506-023</b>
		Total Length Surveyed (ft):	<b>110.0</b>

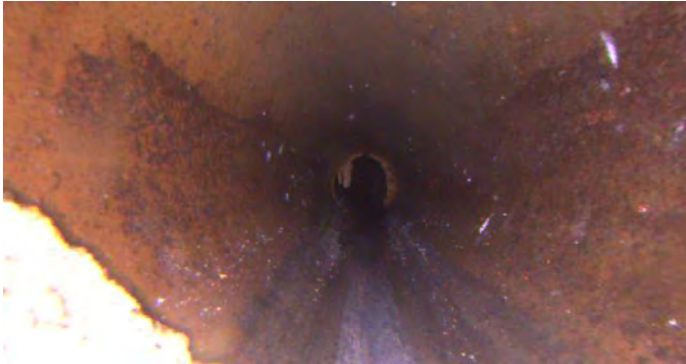
Code: **AMH**  
Description: **Manhole**

Distance (ft): **.0**  
Structural Grade: **0**  
O&M Grade: **0**  
Clock Start/From:  
Clock To:  
1st Value:  
2nd Value:  
Value Percent:  
Continuous Index:  
Within 8" of Joint: **NO**  
Remarks: **M-506-024**

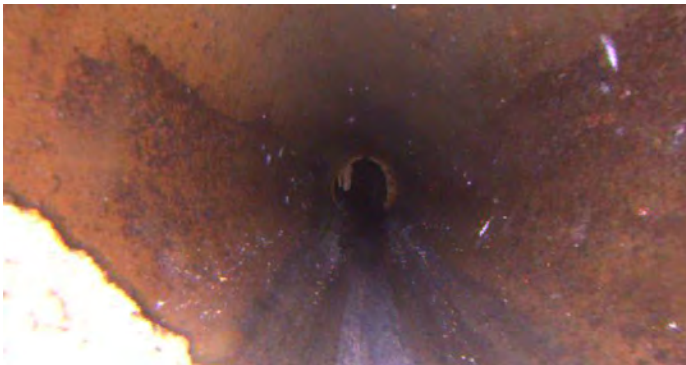
Code: **MWL**  
Description: **Water Level**

Distance (ft): **.0**  
Structural Grade: **0**  
O&M Grade: **0**  
Clock Start/From:  
Clock To:  
1st Value:  
2nd Value:  
Value Percent: **10.000**  
Continuous Index:  
Within 8" of Joint: **NO**  
Remarks:

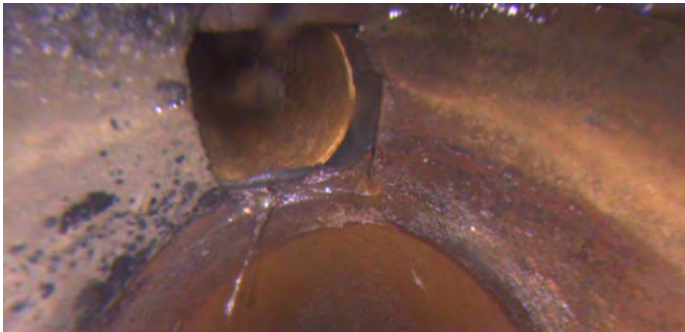
Code: **TSA**  
Description: **Tap Saddle Active**

Distance (ft): **37.1**  
Structural Grade: **0**  
O&M Grade: **0**  
Clock Start/From: **12**  
Clock To:  
1st Value: **4.000**  
2nd Value:  
Value Percent:  
Continuous Index:  
Within 8" of Joint:  
Remarks:

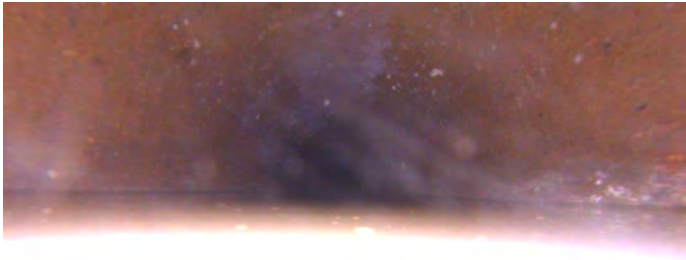
Code: **MWL**  
Description: **Water Level**

Distance (ft): **44.8**  
Structural Grade: **0**  
O&M Grade: **0**  
Clock Start/From:  
Clock To:  
1st Value:  
2nd Value:  
Value Percent: **40.000**  
Continuous Index:  
Within 8" of Joint: **NO**  
Remarks:

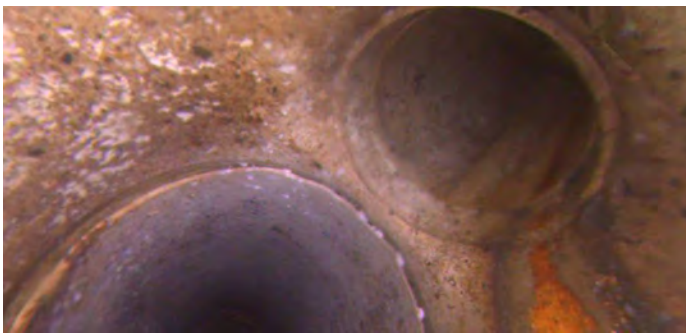
Code: **TF**  
Description: **Tap Factory**

Distance (ft): **58.3**  
Structural Grade: **0**  
O&M Grade: **0**  
Clock Start/From: **2**  
Clock To:  
1st Value: **4.000**  
2nd Value:  
Value Percent:  
Continuous Index:  
Within 8" of Joint:  
Remarks:

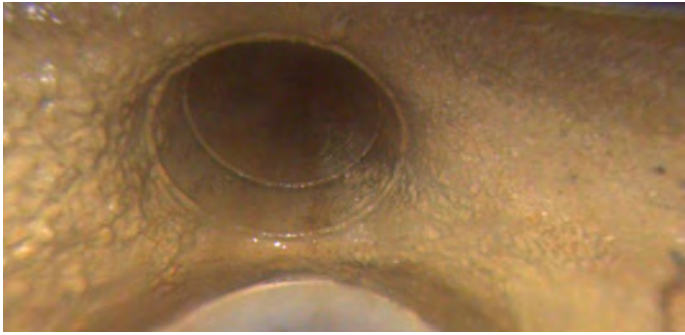
Code: **TF**  
Description: **Tap Factory**

Distance (ft): **63.2**  
Structural Grade: **0**  
O&M Grade: **0**  
Clock Start/From: **12**  
Clock To:  
1st Value: **4.000**  
2nd Value:  
Value Percent:  
Continuous Index:  
Within 8" of Joint:  
Remarks:

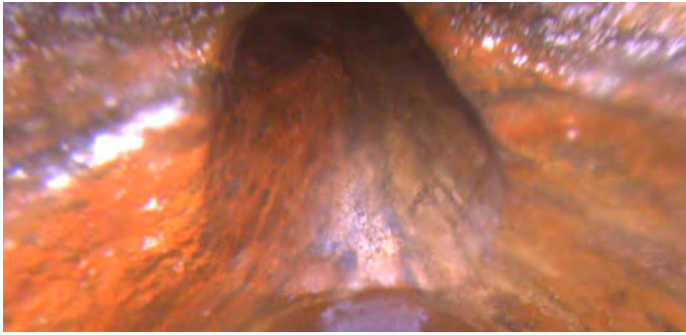
Code: **TF**  
Description: **Tap Factory**

Distance (ft): **108.8**  
Structural Grade: **0**  
O&M Grade: **0**  
Clock Start/From: **12**  
Clock To:  
1st Value: **4.000**  
2nd Value:  
Value Percent:  
Continuous Index:  
Within 8" of Joint:  
Remarks:
