Profile/Photo Observation Report

Date:	01/18/2022	Weather:		Coding:	PACP 7.0
Pipe Length (ft):	169.4	Owner:	City of Hobart	Pre Clean:	Heavy Cleaning
P.O.#:	YES502259	Surveyor:	S. Bucklin	PSR:	P-506-027-026
Customer:	City of Hobart	Clean Date:	01/16/2021	Shape:	C

Street:	South Colorado Street	Flow Control:	Not Controlled
City:	Hobart, IN	Year Renewed:	
Location:	Alley	Tape/Media #:	
Purpose:	Routine Assessment	Dia/Height:	10"
Use:	Sanitary Sewage Pipe	Material:	VCP
Drain Area:		Lining:	None
Category:	NA		
Comment:			
Location Details:		Direction of Survey:	Upstream
US MH:	M-506-026	DS MH:	M-506-027
		Total Length Surveyed (ft):	169.4

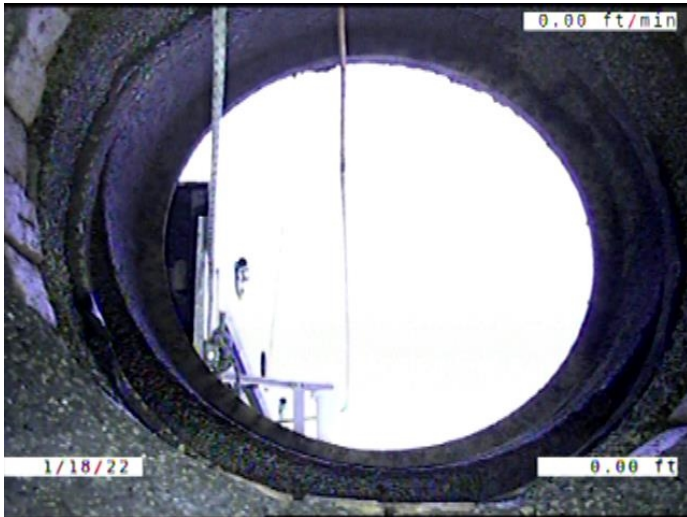
Code: **AMH**
 Description: **Manhole**

Distance (ft): **.0**
 Structural Grade: **0**
 O&M Grade: **0**
 Clock Start/From:
 Clock To:
 1st Value:
 2nd Value:
 Value Percent:
 Continuous Index:
 Within 8" of Joint: **NO**
 Remarks: **M-506-027**

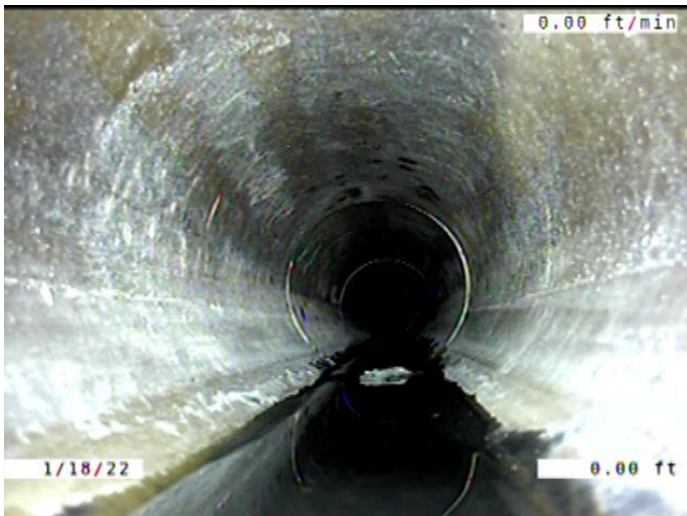
Code: **MWL**
 Description: **Miscellaneous Water Level**

Distance (ft): **.0**
 Structural Grade: **0**
 O&M Grade: **0**
 Clock Start/From:
 Clock To:
 1st Value:
 2nd Value:
 Value Percent: **5.000**
 Continuous Index:
 Within 8" of Joint: **NO**
 Remarks:

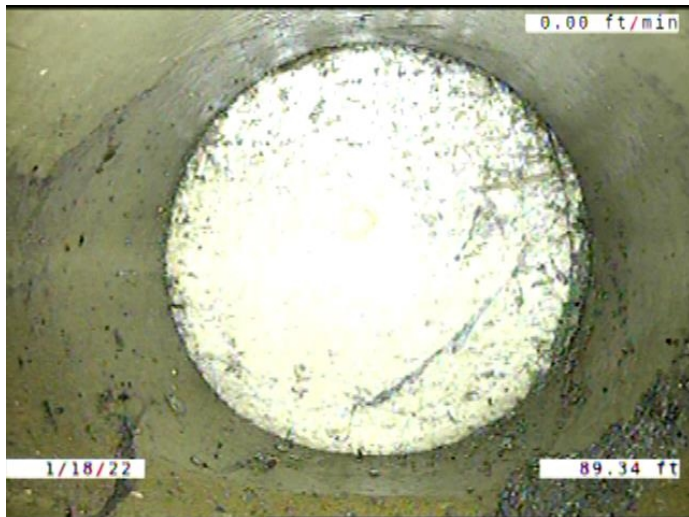
Code: **TF**
Description: **Tap Factory**

Distance (ft): **89.3**
Structural Grade: **0**
O&M Grade: **0**
Clock Start/From: **1**
Clock To:
1st Value: **4.000**
2nd Value:
Value Percent:
Continuous Index:
Within 8" of Joint: **YES**
Remarks:

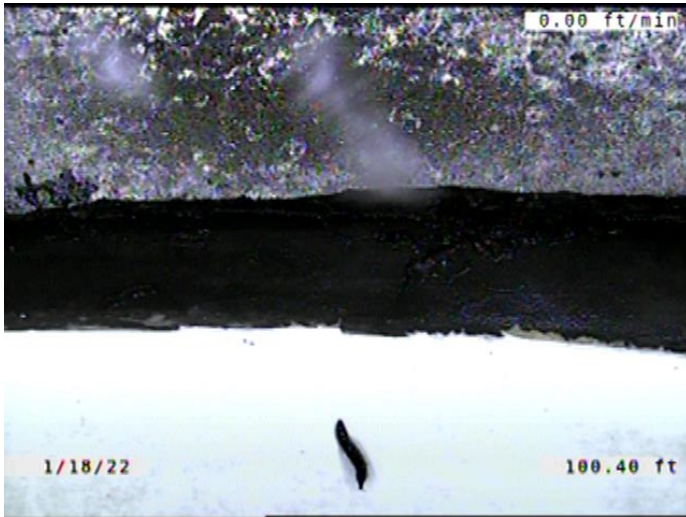
Code: **MMC**
Description: **Miscellaneous Material Change**

Distance (ft): **100.4**
Structural Grade: **0**
O&M Grade: **0**
Clock Start/From:
Clock To:
1st Value:
2nd Value:
Value Percent:
Continuous Index:
Within 8" of Joint: **NO**
Remarks: **VCP TO PVC**

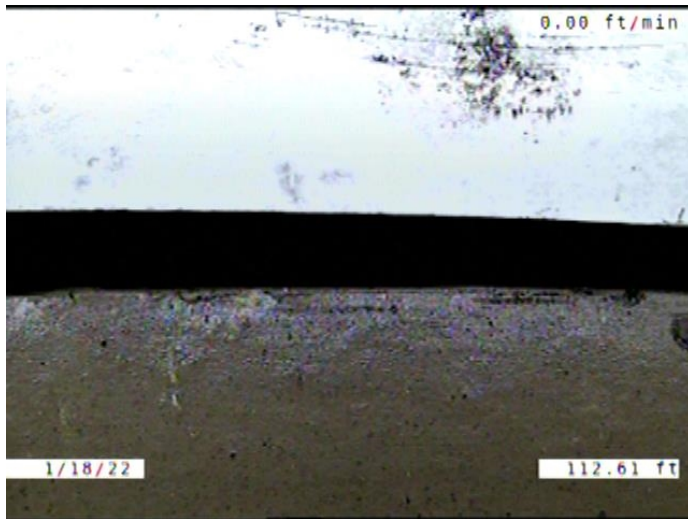
Code: **MMC**
Description: **Miscellaneous Material Change**

Distance (ft): **112.6**
Structural Grade: **0**
O&M Grade: **0**
Clock Start/From:
Clock To:
1st Value:
2nd Value:
Value Percent:
Continuous Index:
Within 8" of Joint: **NO**
Remarks: **PVC TO VCP**

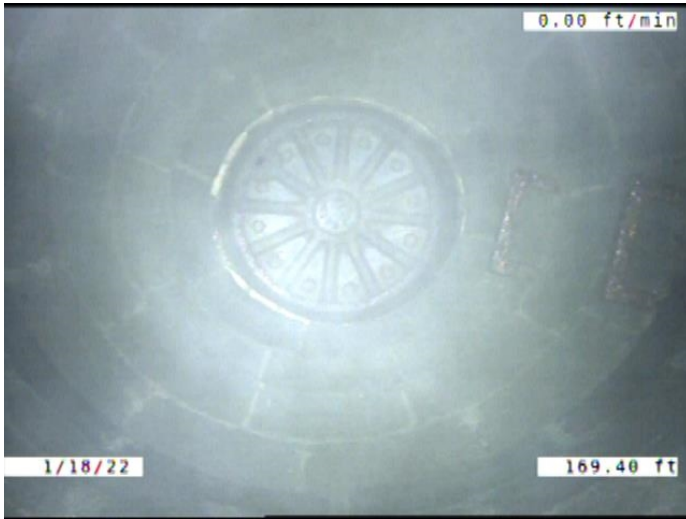
Code:	AMH
Description:	Manhole
Distance (ft):	169.4
Structural Grade:	0
O&M Grade:	0
Clock Start/From:	
Clock To:	
1st Value:	
2nd Value:	
Value Percent:	
Continuous Index:	
Within 8" of Joint:	NO
Remarks:	M-506-026
