Profile/Photo Observation Report

Date:	04/06/2018	Weather:		Coding:	PACP 6.0
Pipe Length (ft):	77.1	Owner:	NA	Pre Clean:	No Pre-Cleaning
P.O.#:		Surveyor:	Jen Costello	PSR:	P-506-029-026
Customer:		Clean Date:	01/01/1900	Shape:	C

Street:	S COLORADO ST	Flow Control:	Not Controlled
City:	Hobart, IN	Year Renewed:	
Location:	Yard	Tape/Media #:	
Purpose:	Routine Assessment	Dia/Height:	10"
Use:	Sanitary	Material:	CP
Drain Area:	NA	Lining:	
Category:	NA		
Comment:			
Location Details:		Direction of Survey:	Upstream
US MH:	M-506-026	DS MH:	M-506-029
		Total Length Surveyed (ft):	7.8

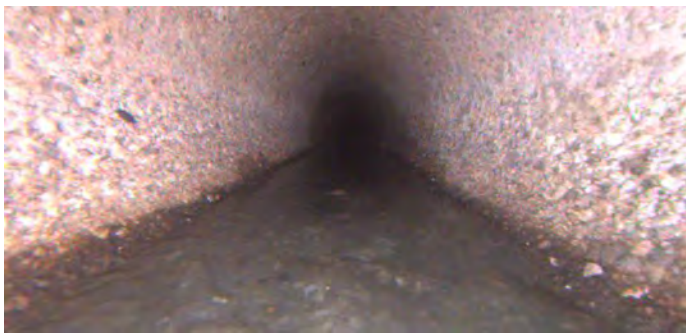
Code: **AMH**
Description: **Manhole**

Distance (ft): **.0**
Structural Grade: **0**
O&M Grade: **0**
Clock Start/From:
Clock To:
1st Value:
2nd Value:
Value Percent:
Continuous Index:
Within 8" of Joint: **NO**
Remarks: **M-506-029**
