## Profile/Photo Observation Report

Date:	<b>01/19/2022</b>	Weather:		Coding:	<b>PACP 7.0</b>
Pipe Length (ft):	<b>148.7</b>	Owner:	<b>City of Hobart</b>	Pre Clean:	<b>Heavy Cleaning</b>
P.O.#:	<b>YES502259</b>	Surveyor:	<b>S. Bucklin</b>	PSR:	<b>P-506-028-027</b>
Customer:	<b>City of Hobart</b>	Clean Date:	<b>01/18/2022</b>	Shape:	<b>C</b>

Street:	<b>River Terrace</b>	Flow Control:	<b>Not Controlled</b>
City:	<b>Hobart, IN</b>	Year Renewed:	
Location:	<b>Alley</b>	Tape/Media #:	
Purpose:	<b>Routine Assessment</b>	Dia/Height:	<b>10"</b>
Use:	<b>Sanitary Sewage Pipe</b>	Material:	<b>VCP</b>
Drain Area:		Lining:	<b>None</b>
Category:	<b>NA</b>		
Comment:

Location Details:		Direction of Survey:	<b>Downstream</b>
US MH:	<b>M-506-027</b>	DS MH:	<b>M-506-028</b>
		Total Length Surveyed (ft):	<b>148.7</b>

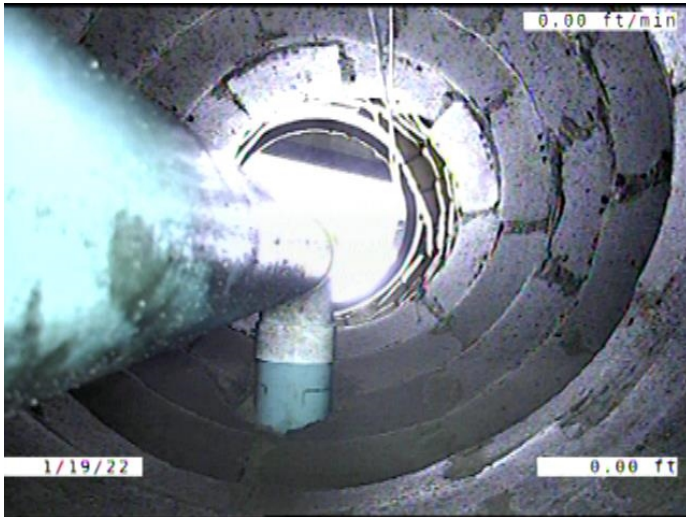
Code: **AMH**  
 Description: **Manhole**

Distance (ft): **.0**  
 Structural Grade: **0**  
 O&M Grade: **0**  
 Clock Start/From:  
 Clock To:  
 1st Value:  
 2nd Value:  
 Value Percent:  
 Continuous Index:  
 Within 8" of Joint: **NO**  
 Remarks: **M-506-027**

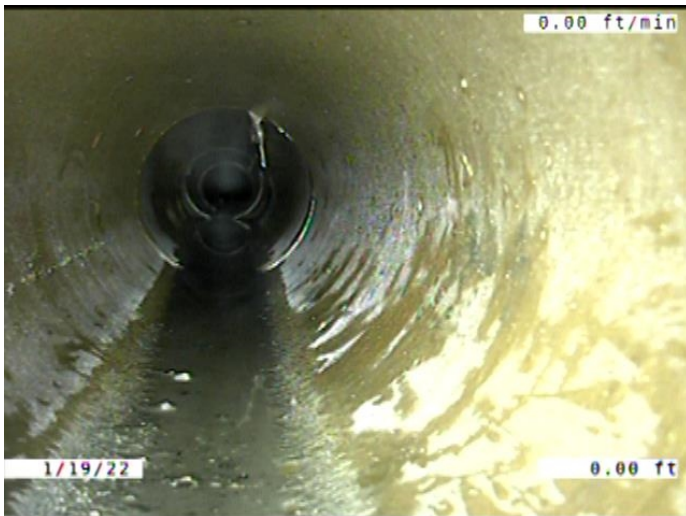
Code: **MWL**  
 Description: **Miscellaneous Water Level**

Distance (ft): **.0**  
 Structural Grade: **0**  
 O&M Grade: **0**  
 Clock Start/From:  
 Clock To:  
 1st Value:  
 2nd Value:  
 Value Percent: **5.000**  
 Continuous Index:  
 Within 8" of Joint: **NO**  
 Remarks:

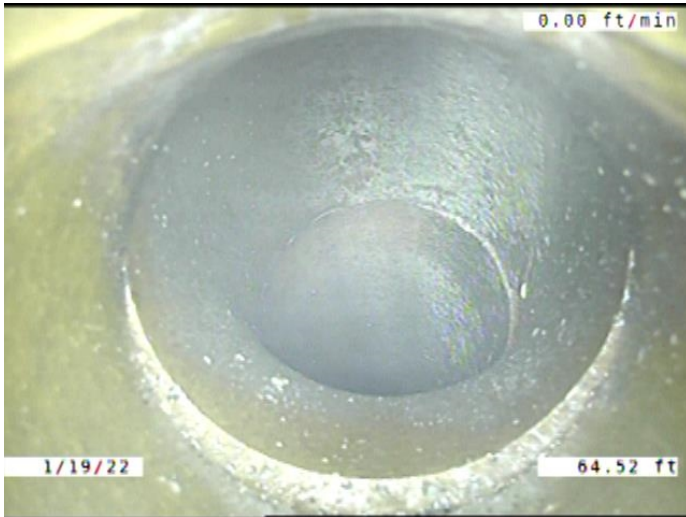
Code: **TF**  
 Description: **Tap Factory**

Distance (ft): **64.5**  
 Structural Grade: **0**  
 O&M Grade: **0**  
 Clock Start/From: **12**  
 Clock To:  
 1st Value: **4.000**  
 2nd Value:  
 Value Percent:  
 Continuous Index:  
 Within 8" of Joint: **YES**  
 Remarks:

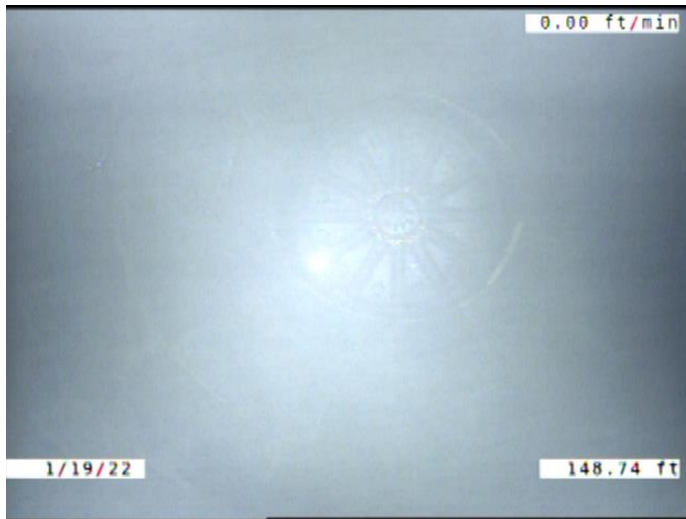
Code:	<b>AMH</b>
Description:	<b>Manhole</b>
Distance (ft):	<b>148.7</b>
Structural Grade:	<b>0</b>
O&M Grade:	<b>0</b>
Clock Start/From:	
Clock To:	
1st Value:	
2nd Value:	
Value Percent:	
Continuous Index:	
Within 8" of Joint:	<b>NO</b>
Remarks:	<b>M-506-028</b>
