RedZone  
ROBOTICS

Street:	South Delaware Street		Flow Control:	Not Controlled	
City:	Hobart, IN		Year Renewed:		
Location:	Easement/Right of Way		Tape/Media #:		
Purpose:	Sewer System Evaluation Survey (SS		Dia/Height:	12"	
Use:	Sanitary Sewage Pipe		Material:	VCP	
Drain Area:			Lining:	None	
Category:	NA				
Comment:					
Location Details:			Direction of Survey:	Upstream	
US MH:	M-507-011	DS MH:	M-507-004	Total Length Surveyed (ft):	218.1

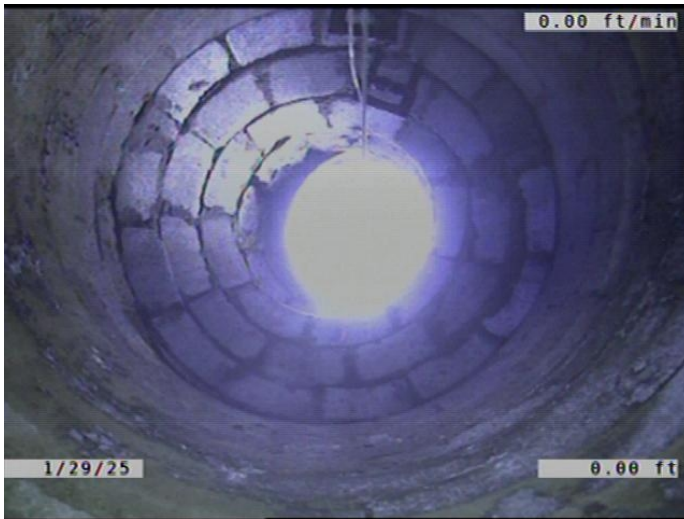
**M-507-011**

Code: **AMH**  
Description: **Manhole**

Distance (ft): **.0**  
Structural Grade: **0**  
O&M Grade: **0**  
Clock Start/From:  
Clock To:  
1st Value:  
2nd Value:  
Value Percent:  
Continuous Index:  
Within 8" of Joint: **NO**  
Remarks: **M-507-004**

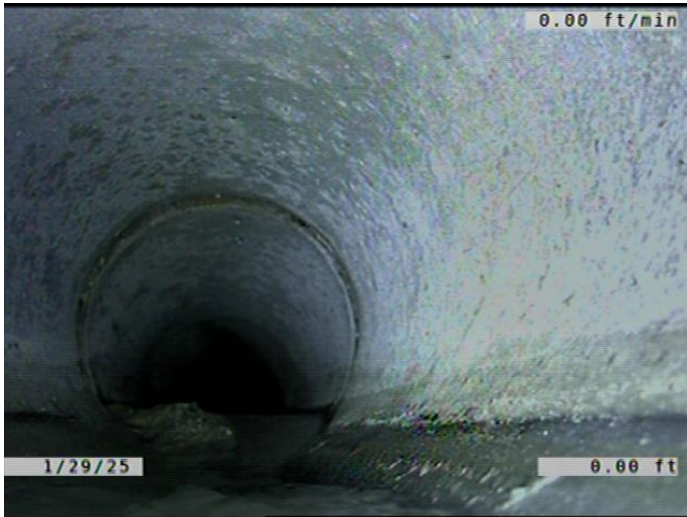
Code: **MWL**  
 Description: **Miscellaneous Water Level**

Distance (ft): **.0**  
 Structural Grade: **0**  
 O&M Grade: **0**  
 Clock Start/From:  
 Clock To:  
 1st Value:  
 2nd Value:  
 Value Percent: **5.000**  
 Continuous Index:  
 Within 8" of Joint: **NO**  
 Remarks:

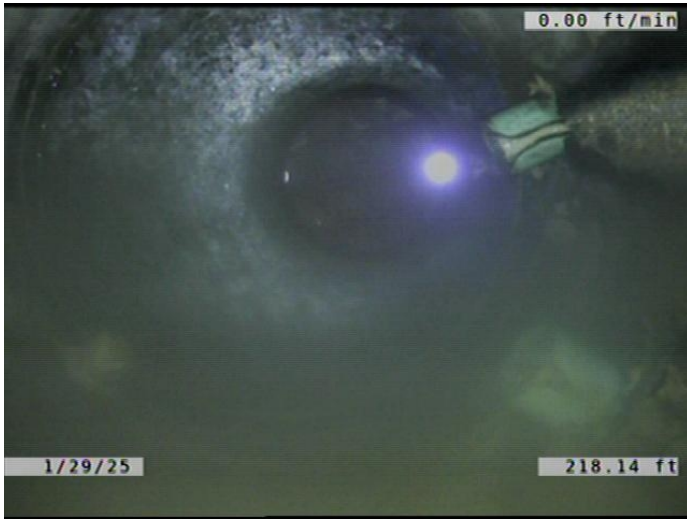
Code:	AMH
Description:	Manhole
Distance (ft):	218.1
Structural Grade:	0
O&M Grade:	0
Clock Start/From:	
Clock To:	
1st Value:	
2nd Value:	
Value Percent:	
Continuous Index:	
Within 8" of Joint:	NO
Remarks:	M-507-011
